Satellite-based Damage Assessment to Cultural Heritage Sites in Syria

The United Nations Institute for Training and Research

UNOSAT

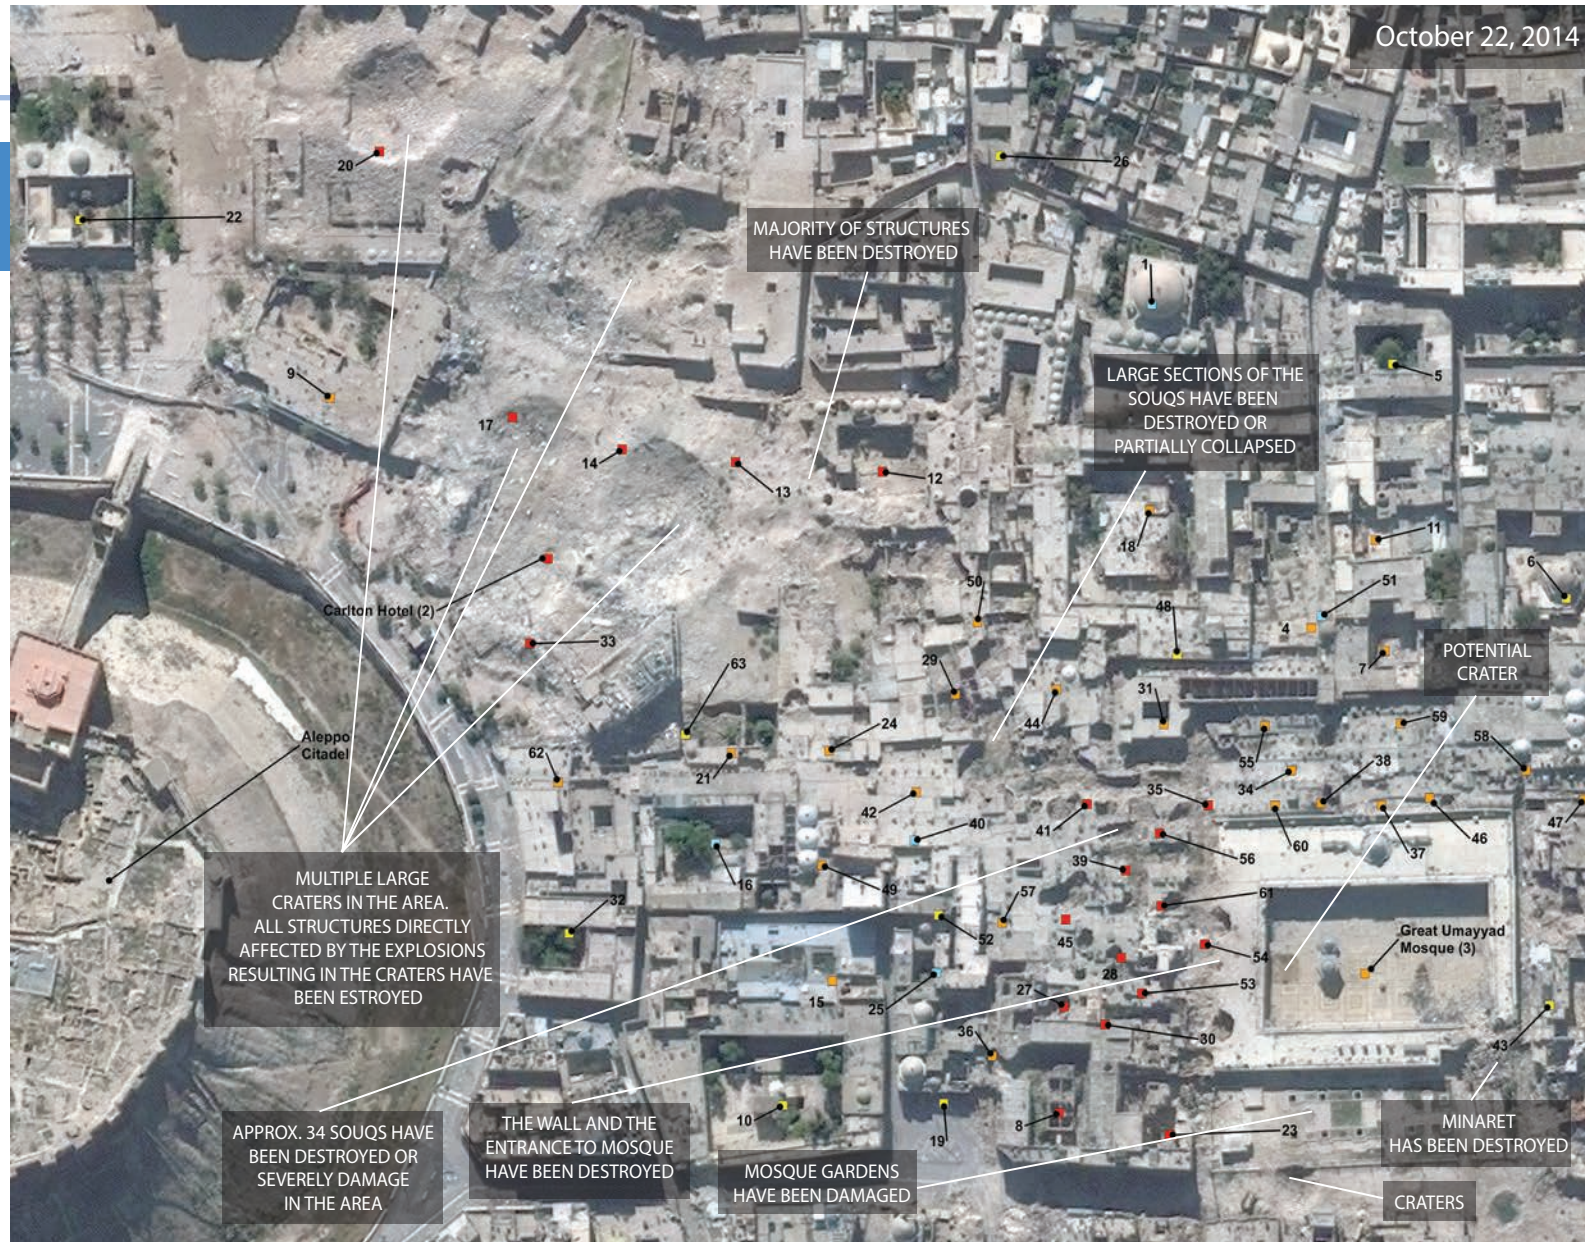
FIGURE 2. Overview of Aleppo and damage to cultural heritage locations.

Satellite imagery confirms the building was completely destroyed—not even the foundations remain (see figure 2). This was caused by explosives that were placed in a tunnel underneath it in May 2014.^(iv)

Many of the souqs were badly damaged in a fire in 2012.^(v) Imagery verified visible damage to 34 of the 45 souqs examined; a 35th souq was reported to have been damaged by the fire, but damage could not be confirmed. Additionally, 20 of these 35 souqs contained 1,121 shops supporting the official estimate that 1,500 of the 1,600 shops were damaged or destroyed.^(vi) Of the 20 souqs which sustained damages, 4 souqs sustained a minimum of moderate damage (and at least one is suspected to have severe damage inside); 19 sustained severe damage; and 11 have been completely destroyed (see figure 2).

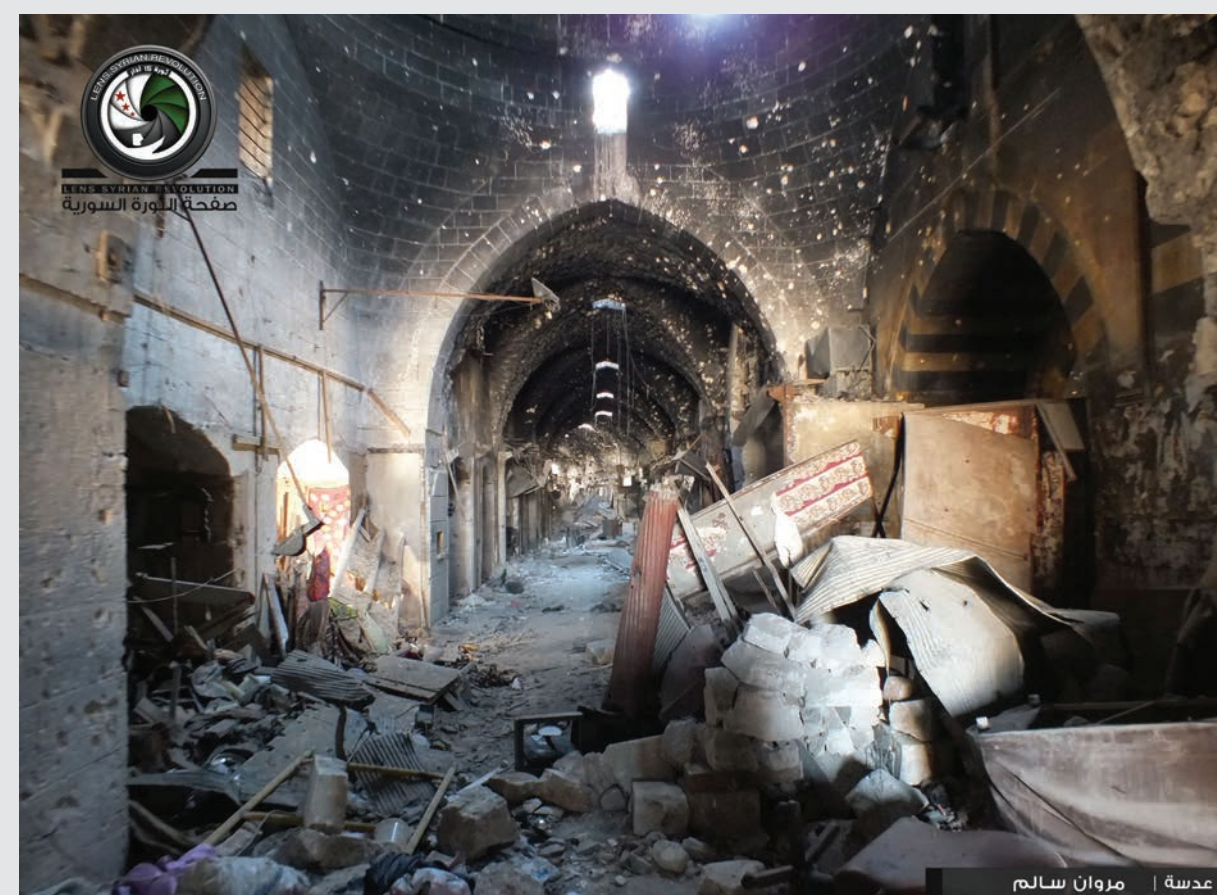
Damages to one of Aleppo's Souq/Photo: Lens Syrian Revolution.

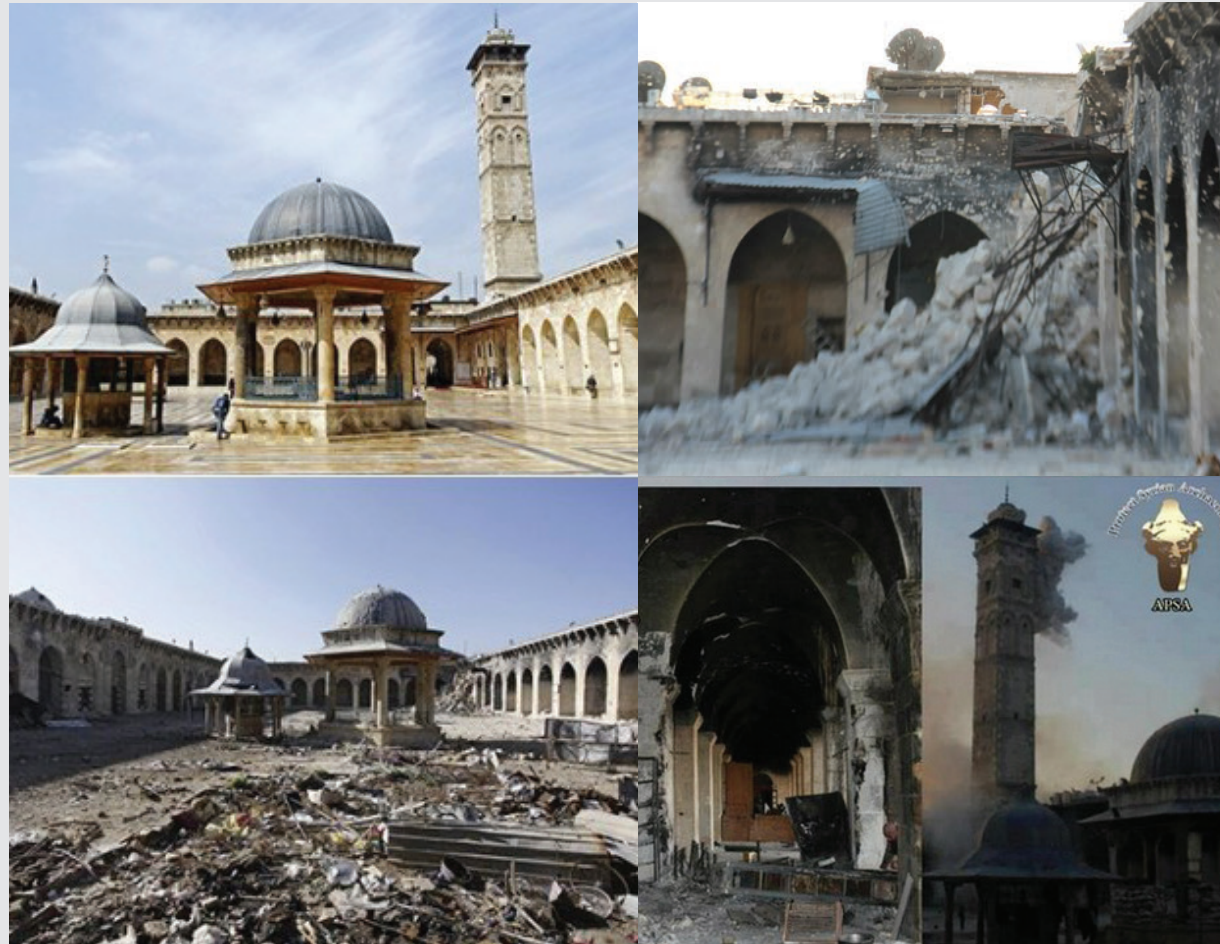
Damages to the Great Umayyad Mosque. Images shown the Gerat Umayyad Mosque Minaret destroyed/Photos: Aleppo Lens/Lens Young Halabi, Lens Syrien Revolution (Sami), al-Fanar Media, and APSA (The Association for the Protection of Syrian Archaeology).

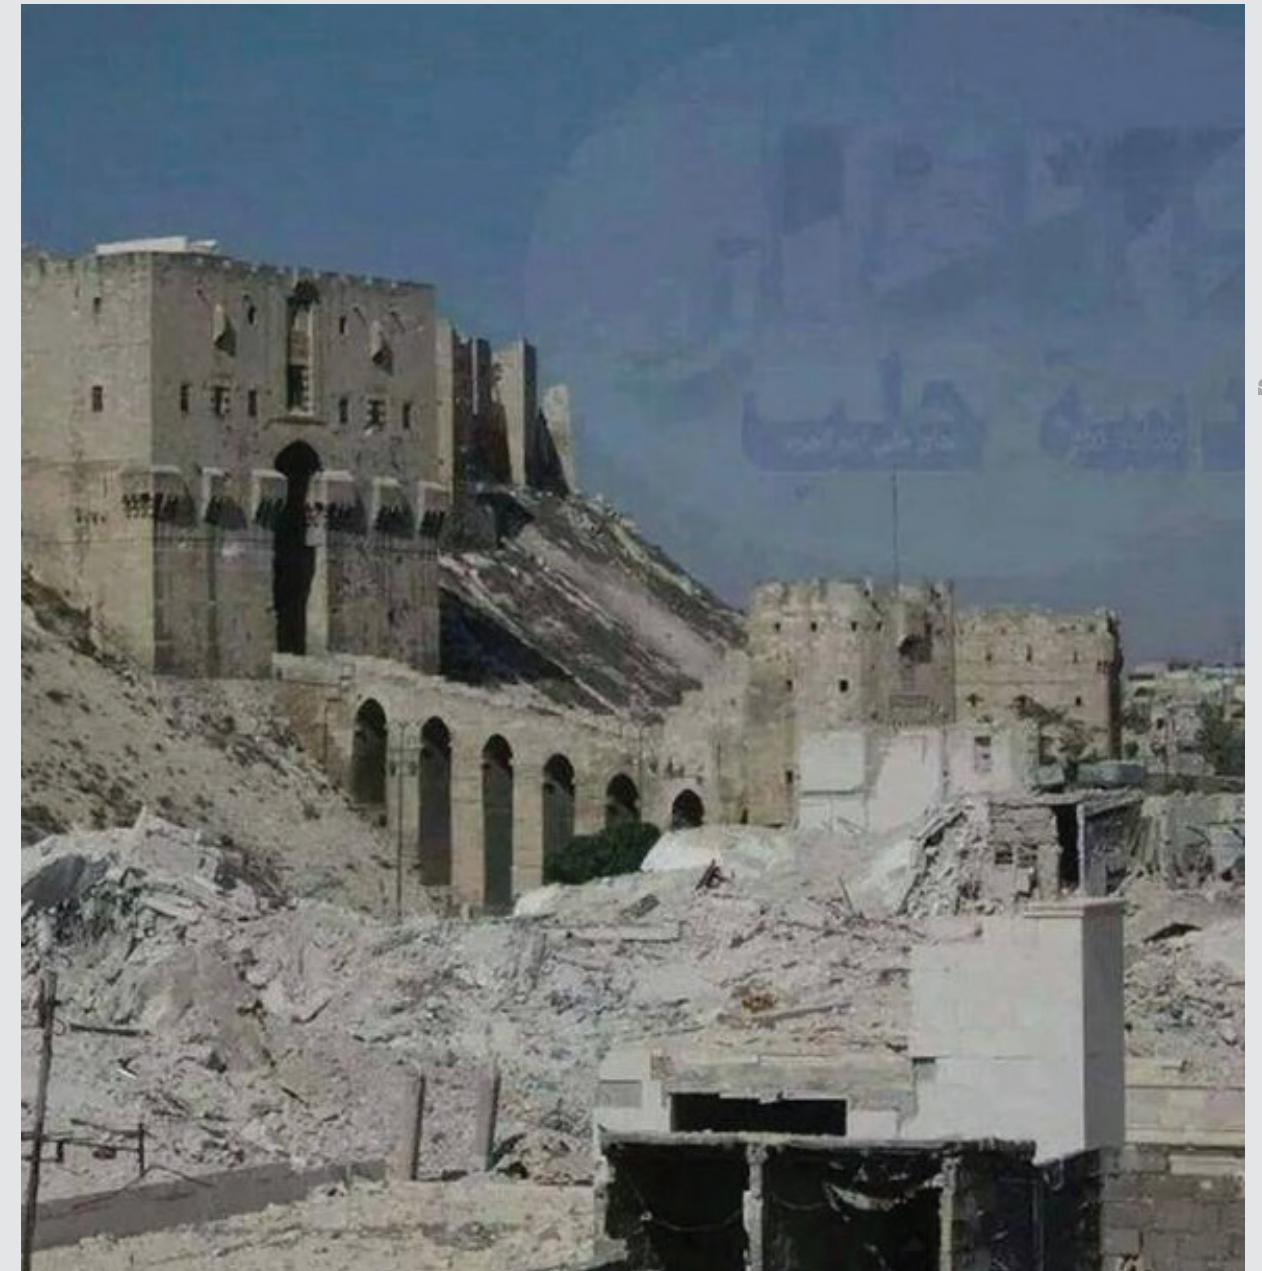
Impact damage visible on Aleppo's Citadel structure/Photo: Facebook.

Impact damage is visible on the stone cladding of the glacis (the damage largely dates back to 2012^(x)). Minor structural damage is visible on some of the other structures, including some of the towers on the wall. The worst damage was done to the Temple to the Storm God. A roof was constructed in 2005 to protect the excavated area; this is no longer present. The state of the excavation underneath is unclear in the imagery, but appears as if it may have been disturbed. Although the Gatehouse is known to have sustained minor to moderate damage from an attack in 2012,^(xi) damage cannot be verified with the imagery.

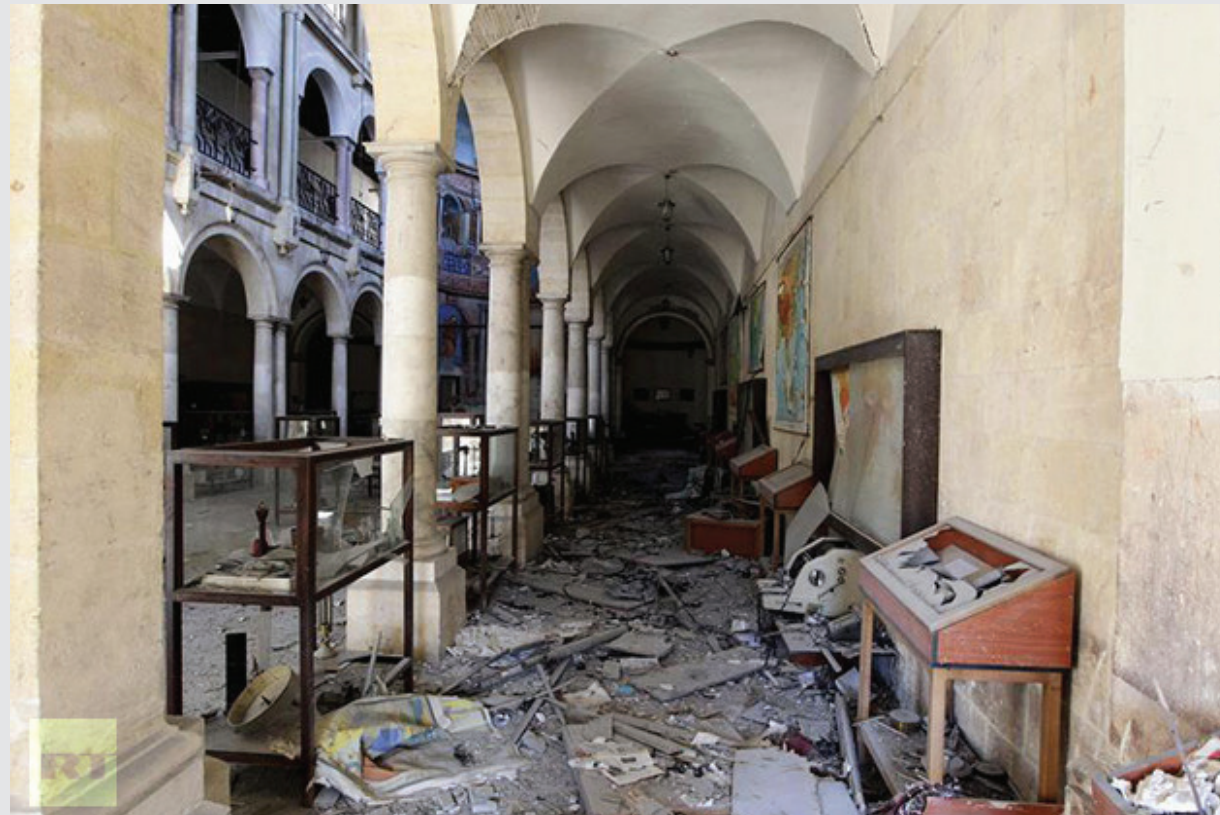
Debris lies on the ground of the damaged Museum of Science in the old city of Aleppo/Photo: REUTERS/Muzaffar Salman.

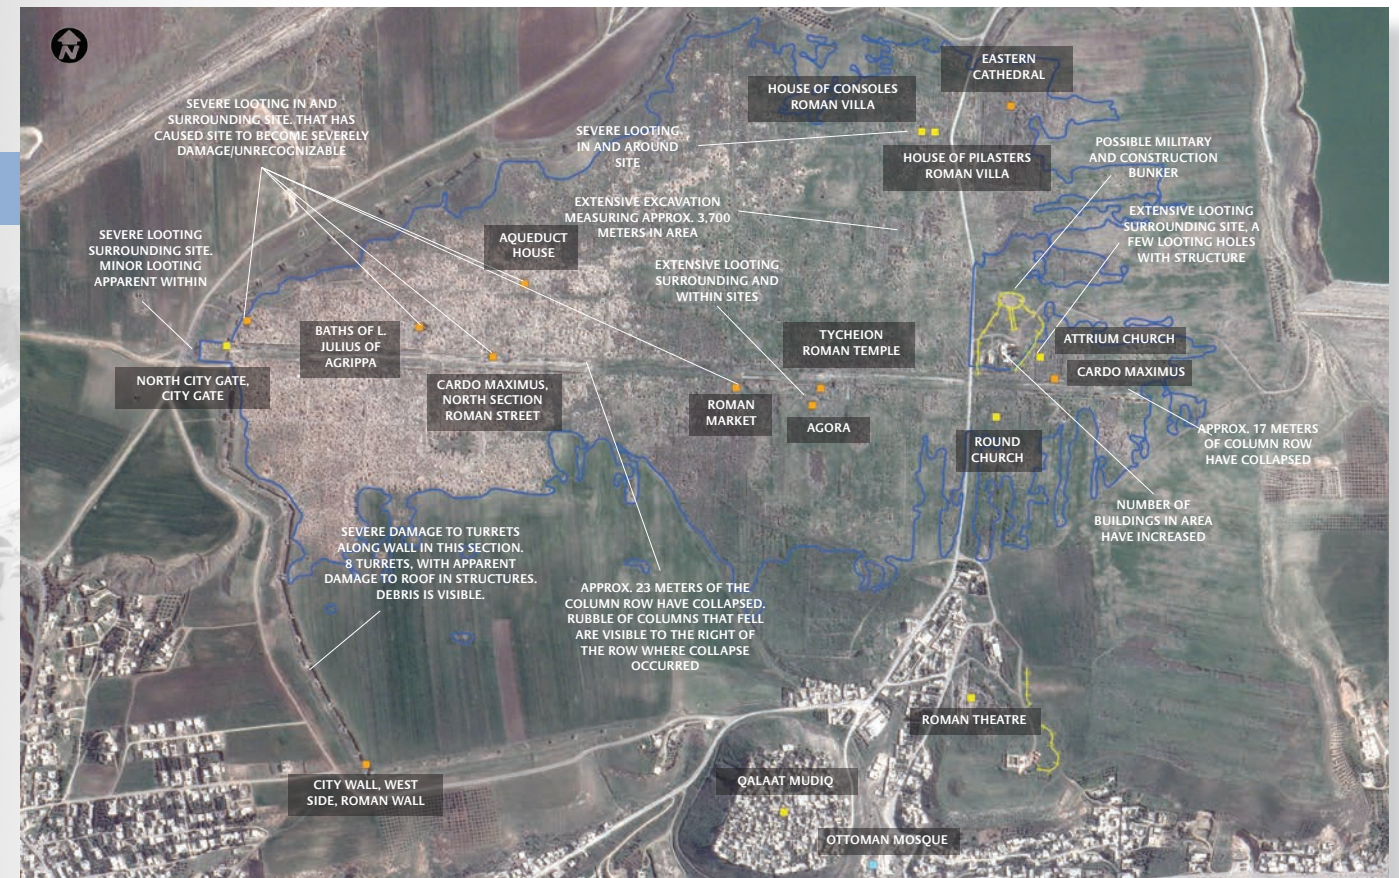
FIGURE 4. Overview of Apamea and damage of cultural heritage locations.

By November 2012, looting holes were starting to encroach into the private areas, but looting outside the walls had largely ended. By November 2013, the road that separates the private- and state-owned parts of the site were no longer visible at the northern end, and the heavy looting covered the northern section of the private arable land. In April 2012, the main part of the looted site was 170 ha, with a further 3 ha of smaller looted areas, mostly outside the walls. A review of imagery from 2013 demonstrates that looting still continues; almost another 20 ha (20,000 m²) of archaeological soil has been looted (see figure 4).

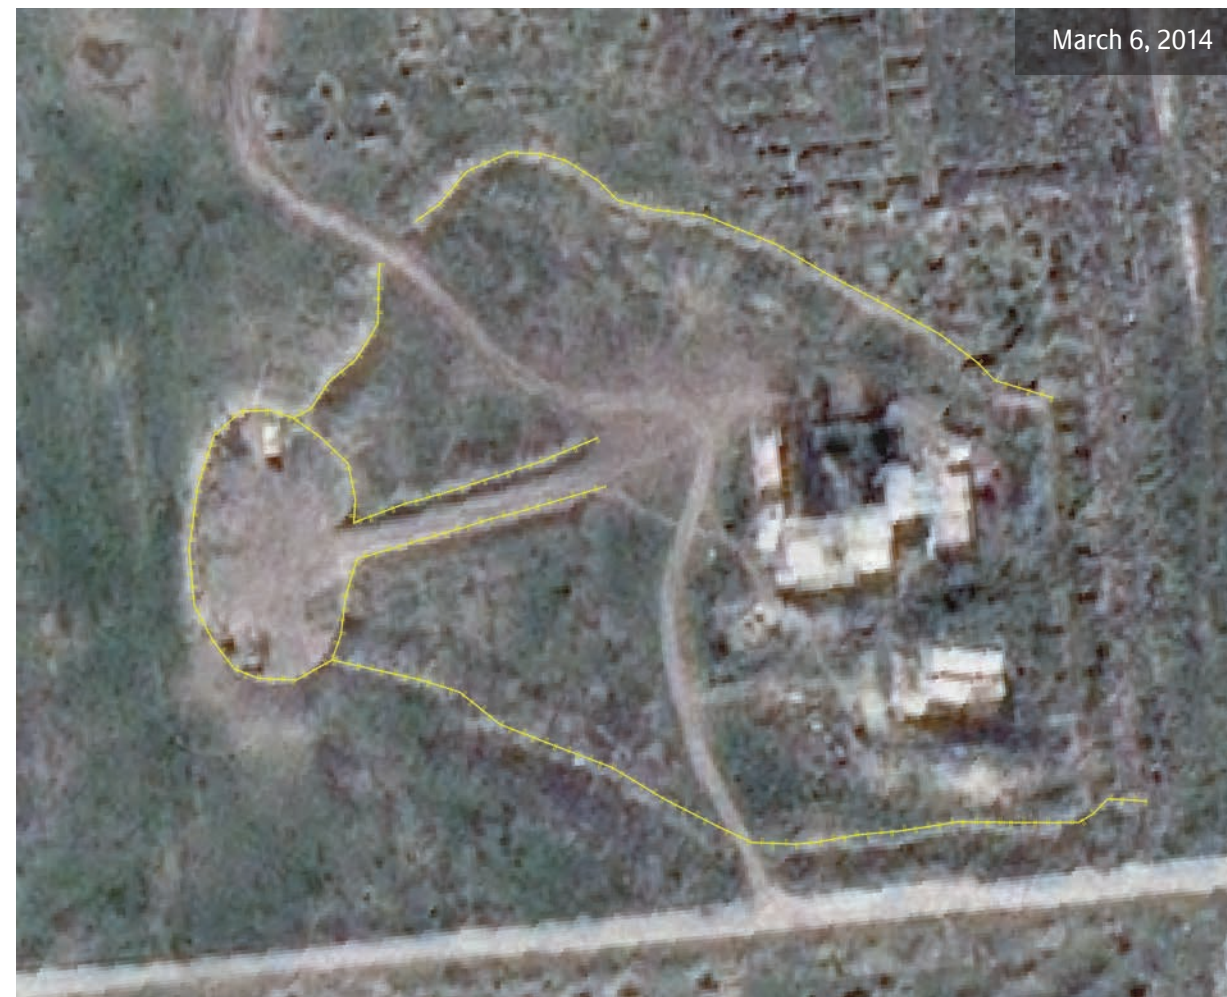
FIGURE 5. Evidence of military garrison around the former café in the centre of the site.

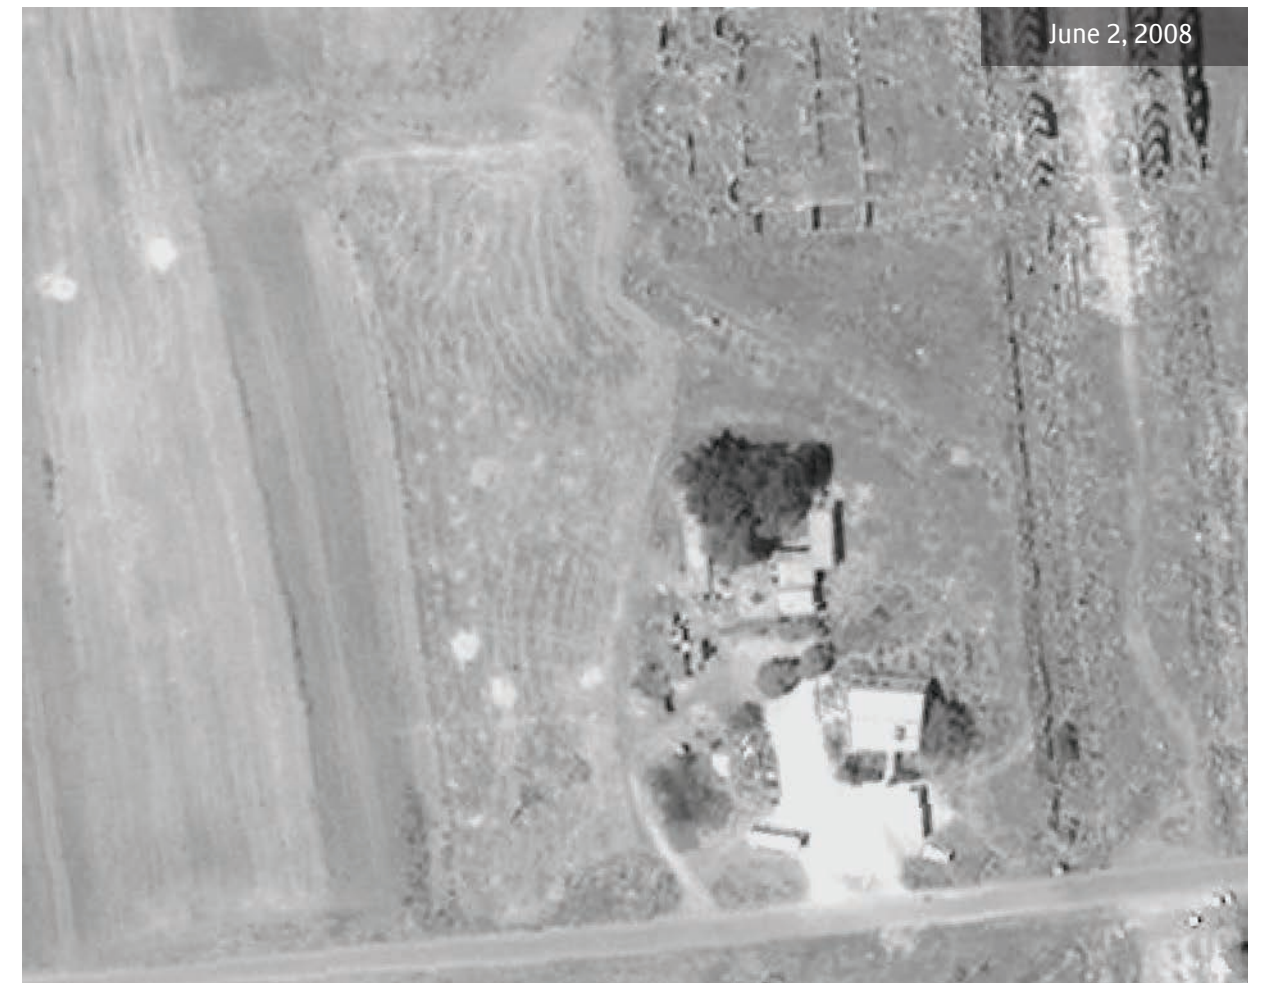
FIGURE 6. Former café in the centre of the site.

In addition, some areas have suffered significant structural damage from unknown causes. Parts of the colonnade have collapsed, and there is damage to a large section of the city wall. A military garrison is now located around the former café in the centre of the site. New buildings have been constructed around the café as well and the area has been surrounded by an earth emplacement, which covers 2 ha, and was constructed with heavy machinery from the archaeological area around it (see figures 5 and 6).

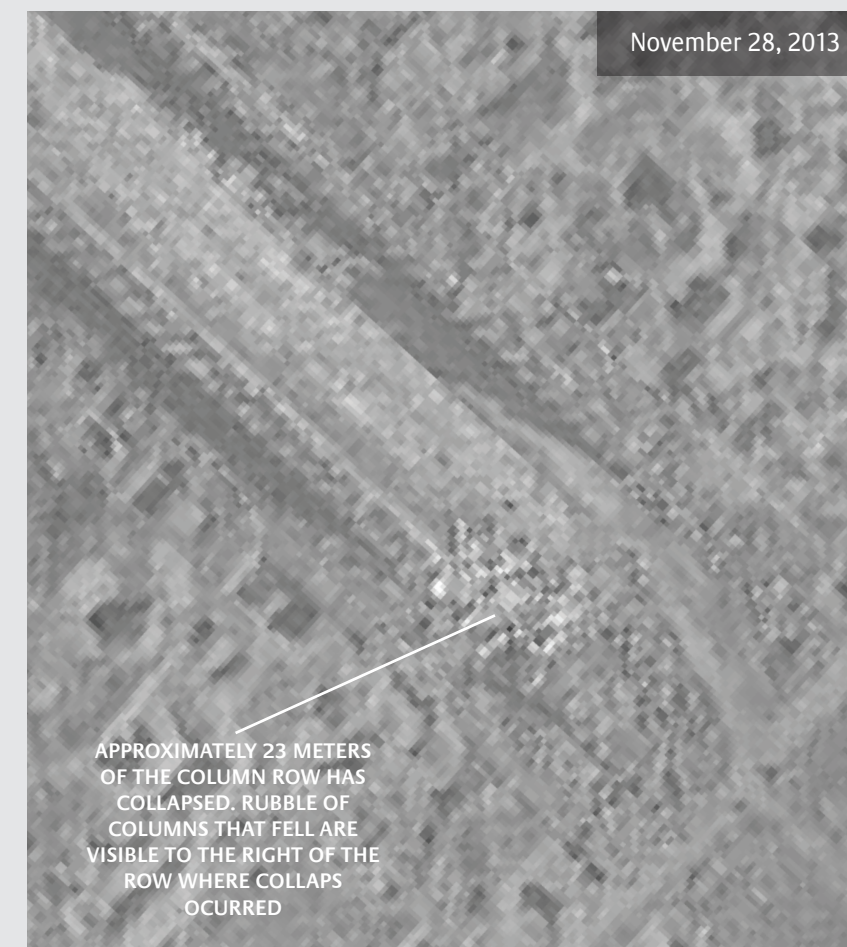
A section of columns, approximately 17 m long, have collapsed. The remains of the collapsed columns are visible.

FIGURE 7. Cardo Maximus in Apamea. c.23m of colonnade has collapsed. The rubble is visible to the right of the row where the collapse occurred.

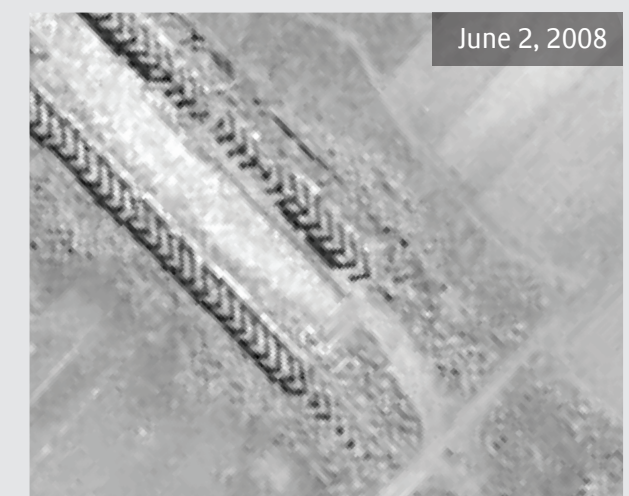
FIGURE 8. The colonnade.

A section of columns, approximately 23 m long, have collapsed (see figures 7 and 8). The remains of the collapsed columns are visible.

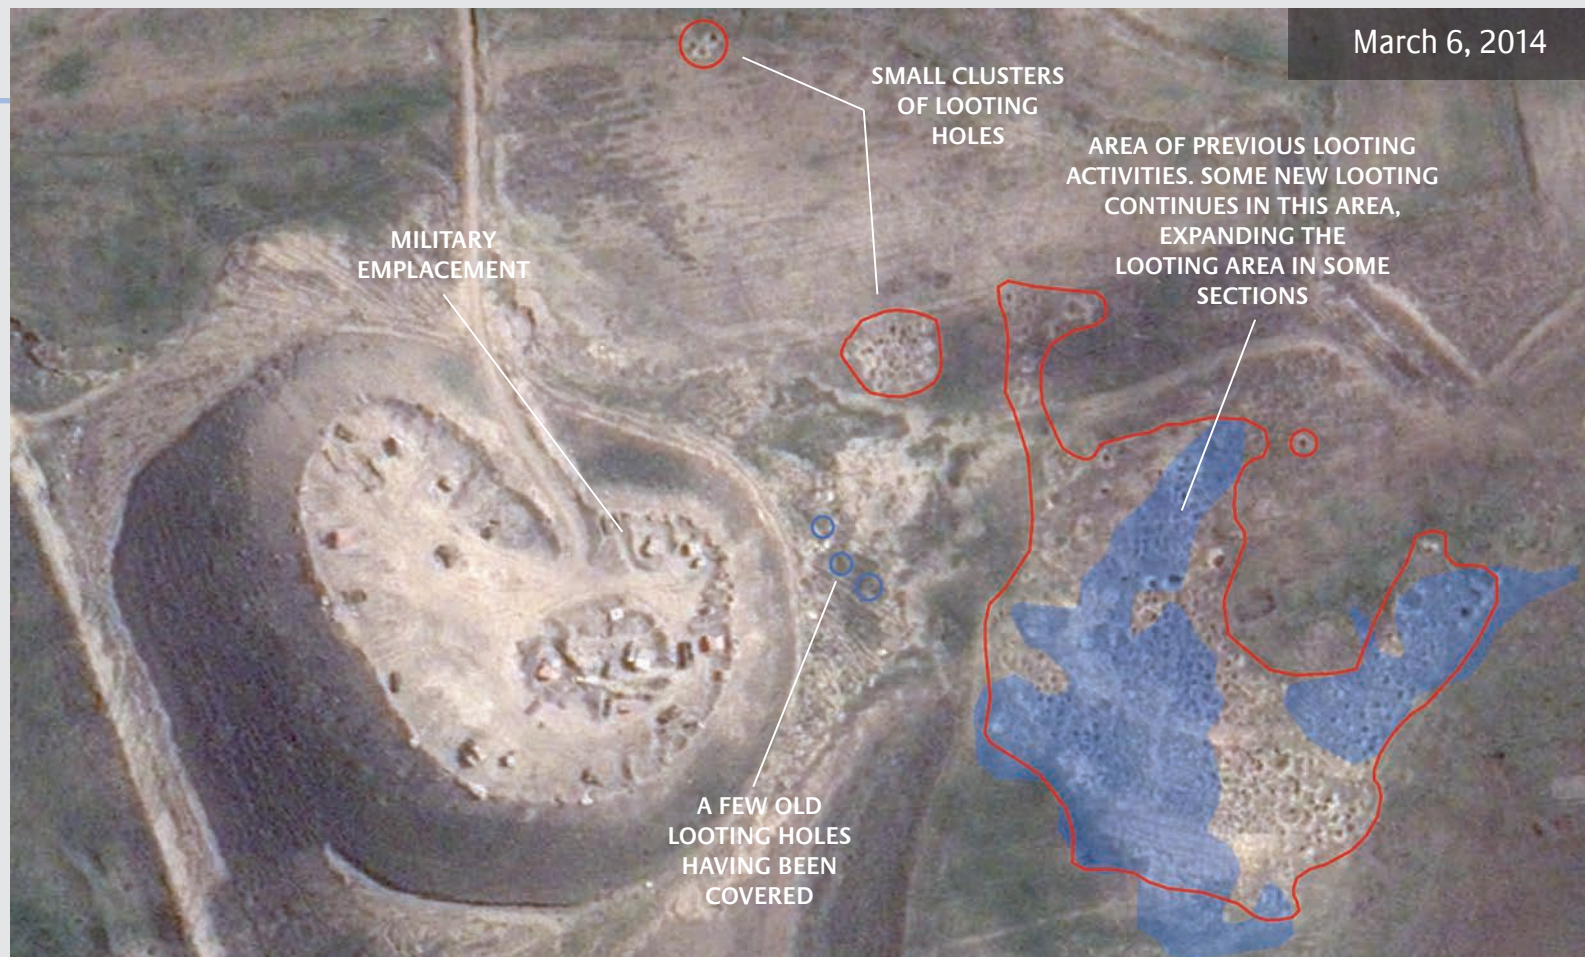
FIGURE 9. Tell Jifar – Military emplacement, new looting holes, smoothed over looting holes at the base of the tell, and earlier looting holes from 2008.

Looting in this area has clearly been a problem for some time. For instance, the 2008 image reveals the lower surrounding town was already looted previously. Holes are visible covering an area of approximately 2.5 ha. The looting also increased; by November 2013, the expanded looted area was approximately 3.1 ha, covering new areas, with some of the old looting holes no longer visible. However, the looting appears to have mostly stopped, as a few of the holes are still sharply defined, and most are smaller indicating many are not fresh. In addition, a military garrison has been built on top of the tell. The road to the summit has been widened, with a raised embankment excavated by heavy machinery along parts of it, together with a raised embankment around the edges of the summit, and a semi-circular emplacement within that on the southern end of the summit. These have been created from and are in archaeological soil. Furthermore, the vibrations caused by heavy traffic are likely to cause damage to the unexcavated remains (see figures 9 and 10).

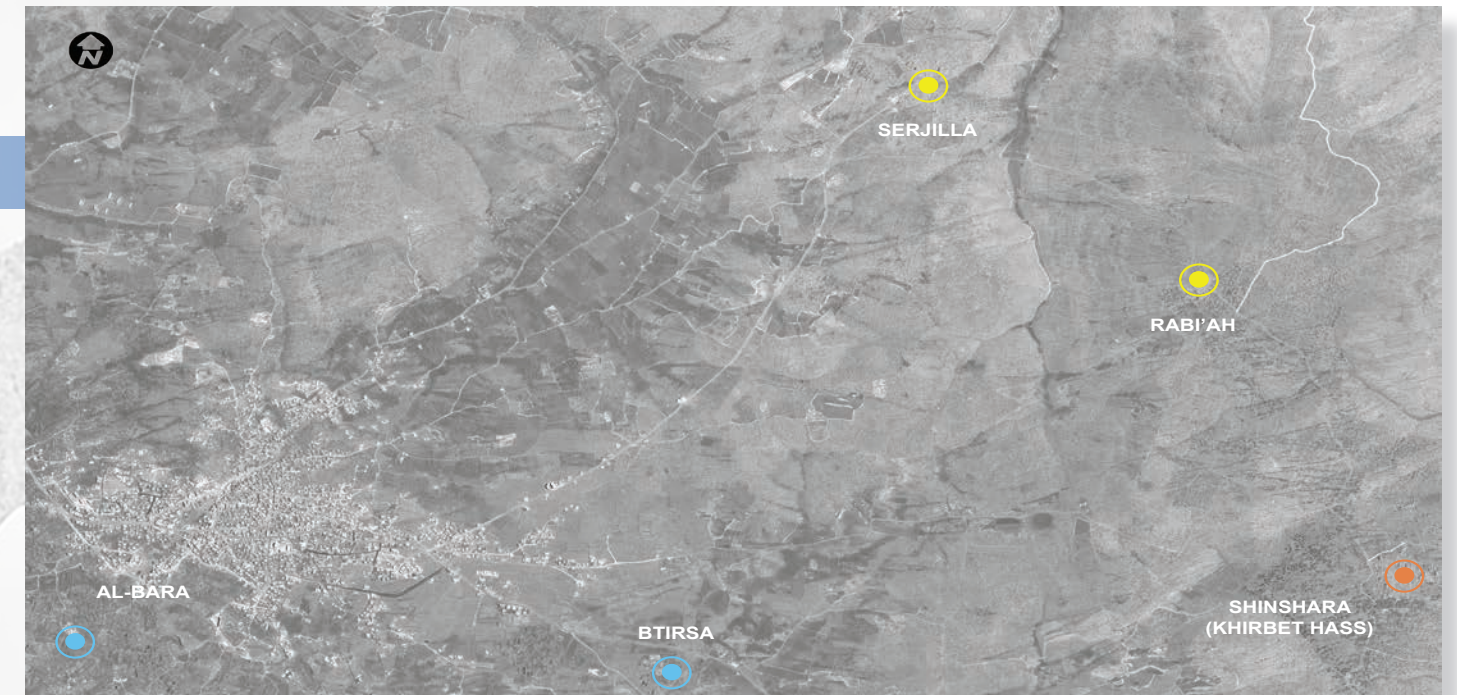
FIGURE 11. Overview of Bara and damage of cultural heritage locations.

The ruined Byzantine settlements of Mujleya, Btirsa, Bshilla, Ba'uda, Dalloze, Serjilla, Rabi'ah and Shinshara (also called Khirbet Hass) also fall within this area of interest and are discussed in this report. All of them are part of the World Heritage Site called the Ancient Villages of Northern Syria, inscribed in 2011 and composed of eight archaeological parks. Those listed are in Archaeological Park 4 (Jebel Zawiya, in the Ma'aret Al-Nu'man and al-Bara provinces). Today, many remain in an exceptional state of preservation, particularly Serjilla; some buildings still have two stories, and much of the surrounding cultural landscape is also preserved, including some field boundaries, wine presses and other such installations (see figure 11).

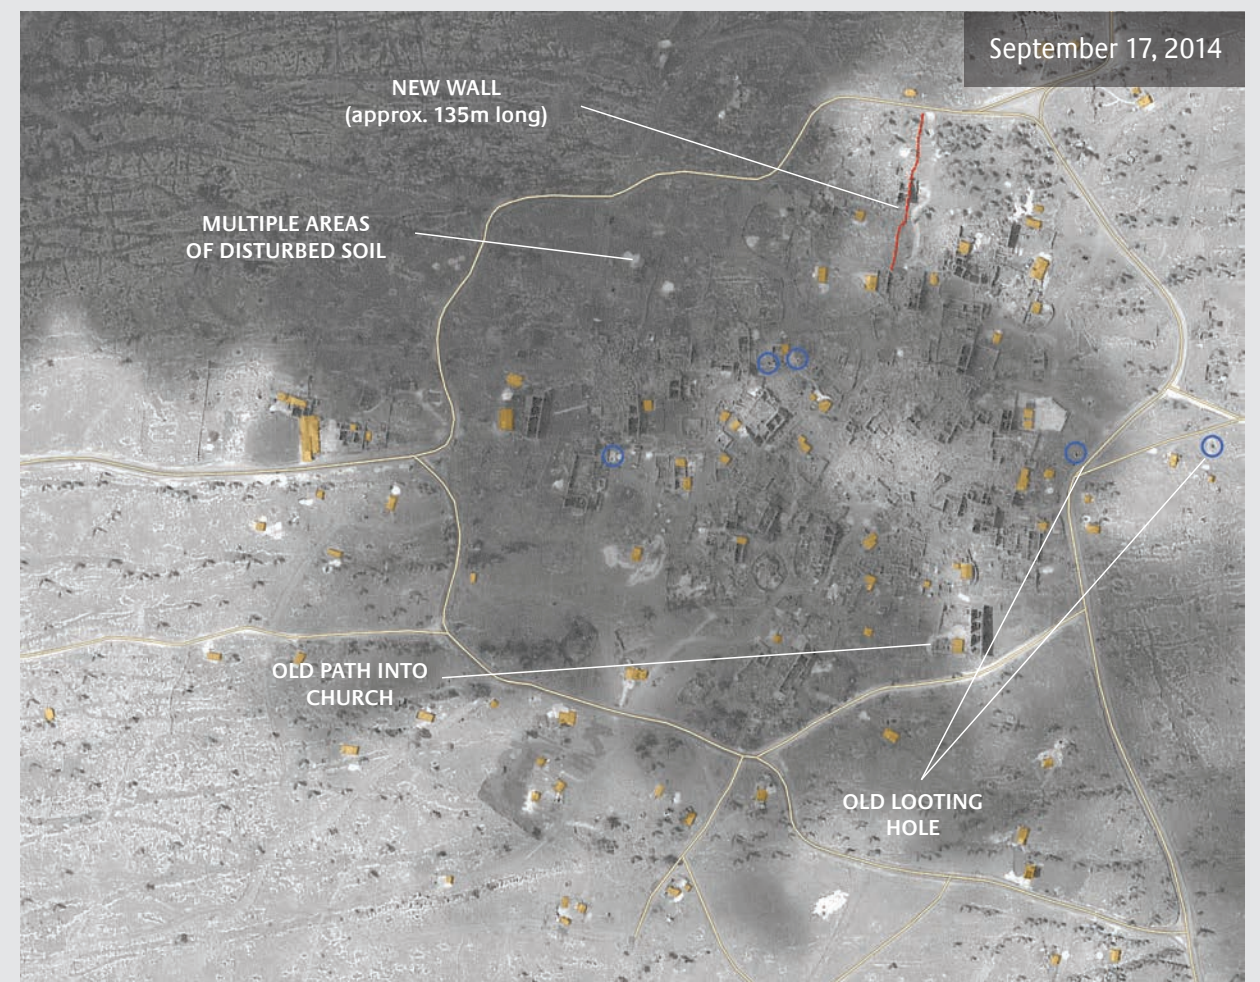
FIGURE 12. Shinshara Roman/Byzantine village showing signs of new structures and disturbed soil. New structures are marked in orange.

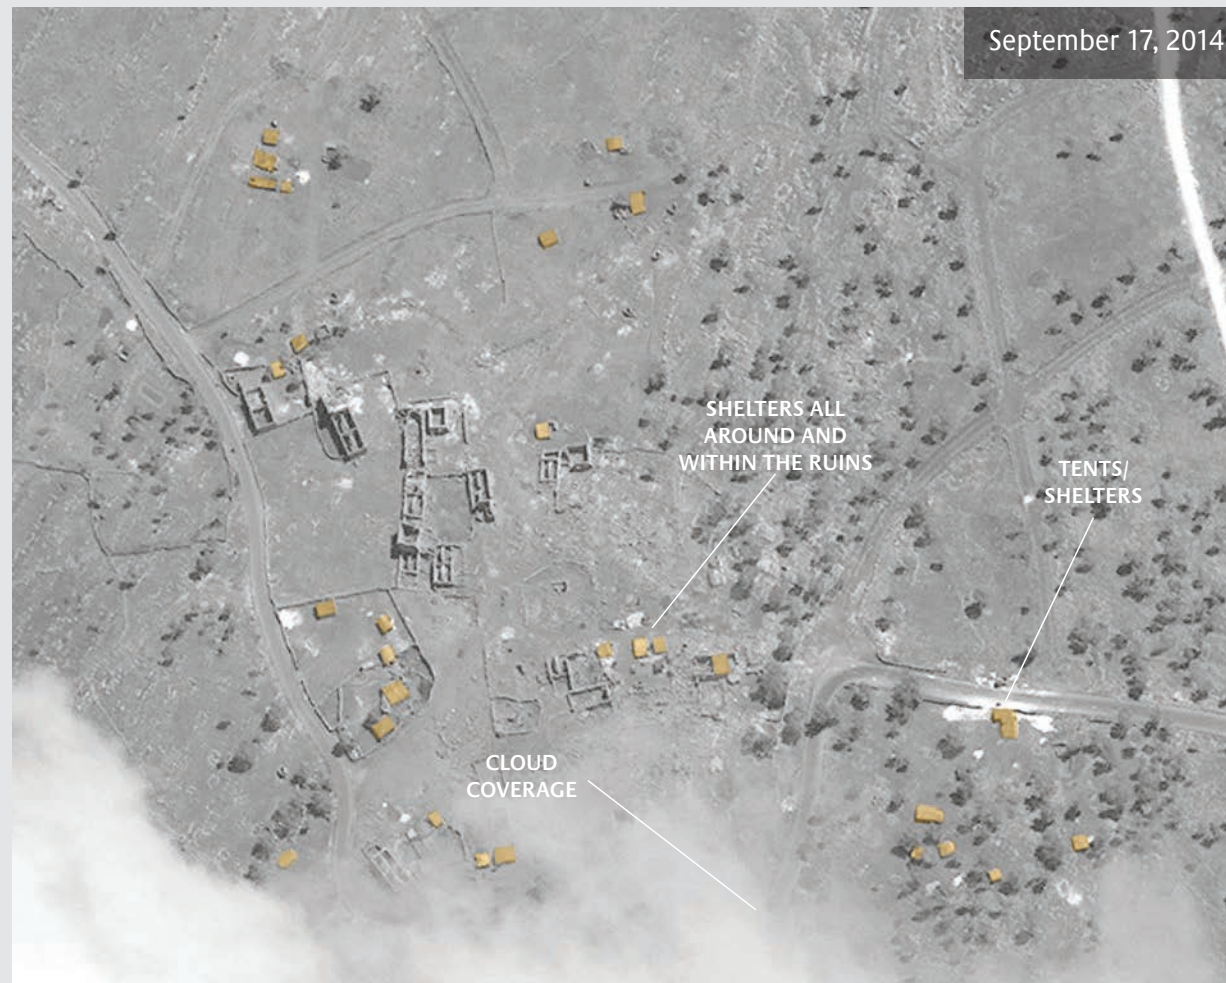
FIGURE 14. Rabi'ah Byzantine settlement showing shelters and tents within the ruins. New structures are marked in orange.

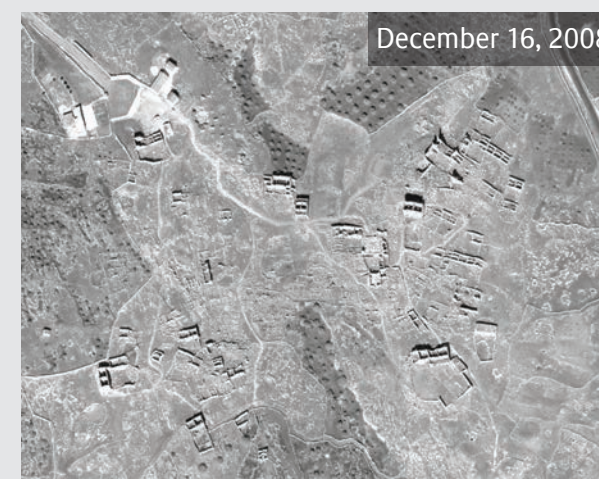
FIGURE 17. Serjilla Byzantine settlement.

Approximately 22 shelters and one new structure had been placed in and around the ruins as of 17 September 2014 (see figures 16 and 17). Most of these structures were placed between January 2013 and September 2014. The level of damage to the site cannot be determined at this time. However, it is likely the activity has affected the ruins and archaeological levels.^(ix) No looting was visible in the imagery.^(x)

Approximately 22 shelters and one new structure had been placed in and around the ruins as of 17 September 2014 (see figures 16 and 17). Most of the structures were placed between January 2013 and September 2014. The level of damage to the site cannot be determined at this time. However, it is likely the activity has affected the ruins and archaeological levels.^(xxi) No looting was visible in the imagery.^(xxii)
