Satellite-based Damage Assessment to Cultural Heritage Sites in Syria

The United Nations Institute for Training and Research

UNOSAT

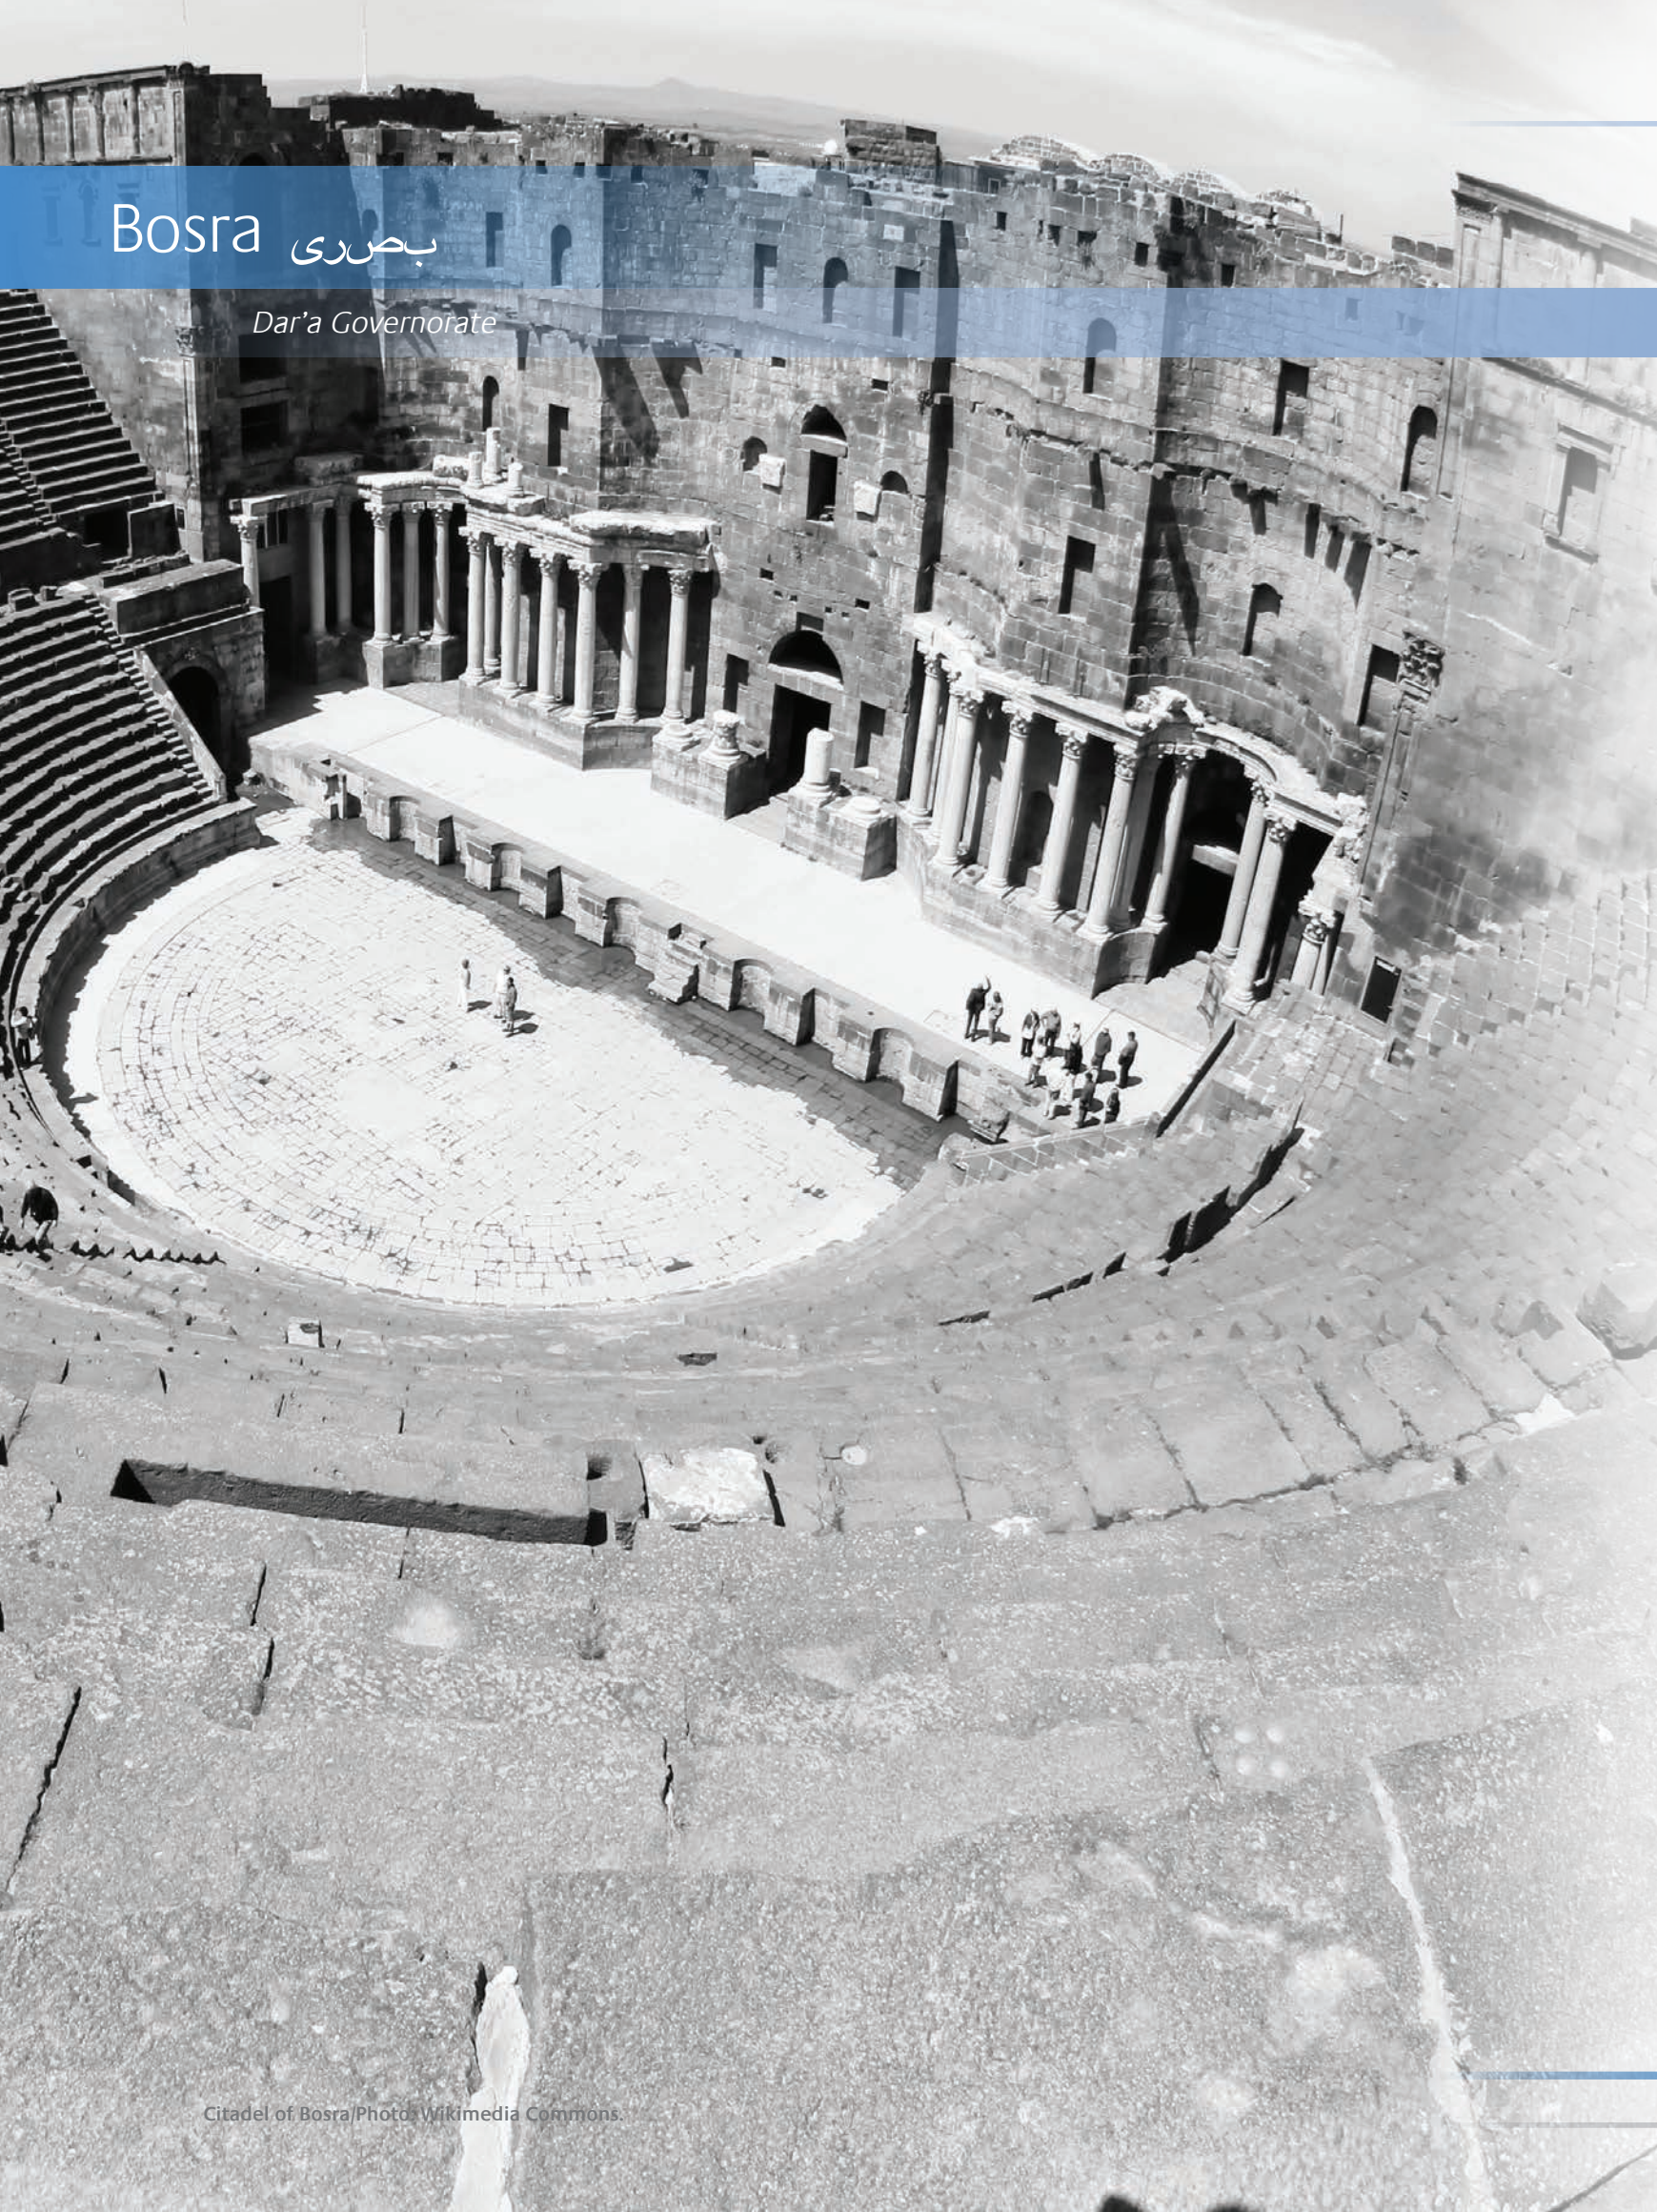
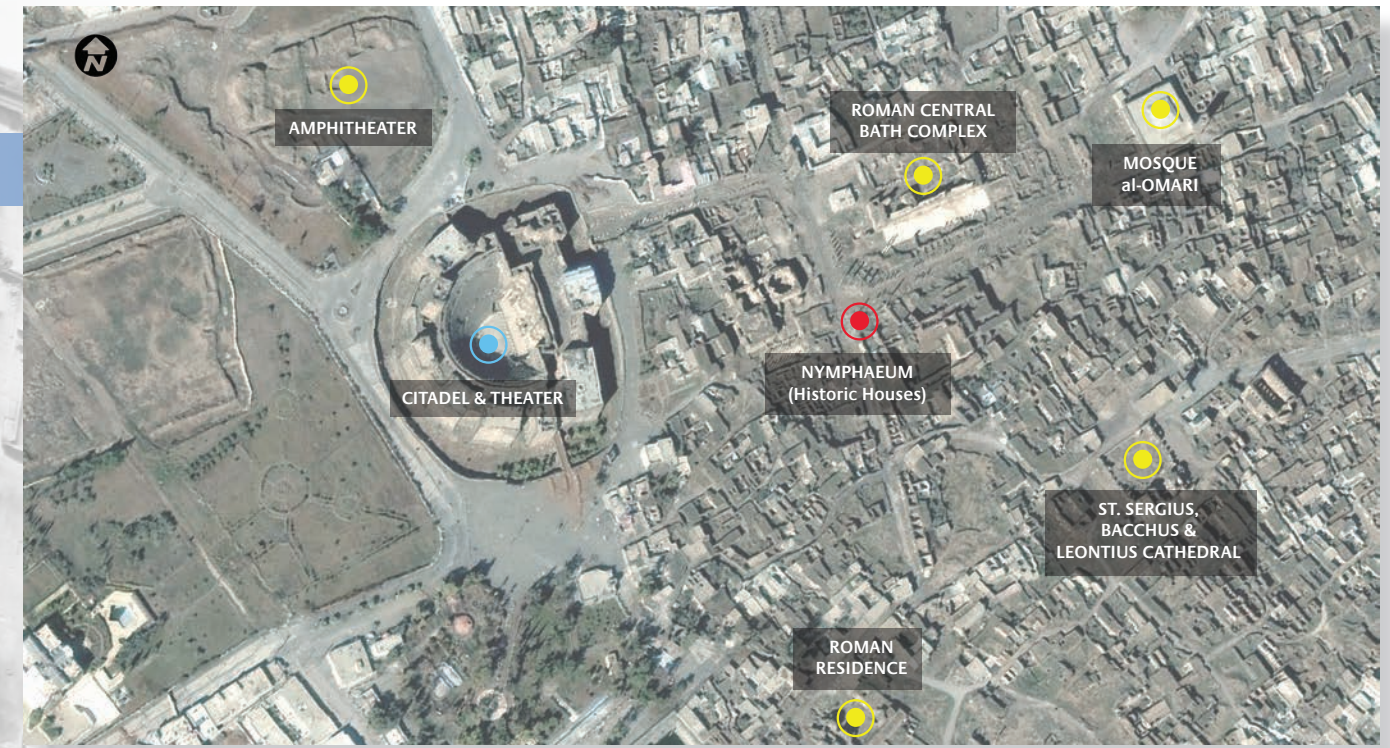
FIGURE 18. Overview of Bosra and locations where damage has occurred and is visible

A review of satellite imagery indicates extensive fighting has occurred in the area. Shelling damage appears to be concentrated in the area of the historic residences, some of which are still occupied today. More than 50 structures showed holes in the roofs or roofs that have partially or completely collapsed (see figure 18).

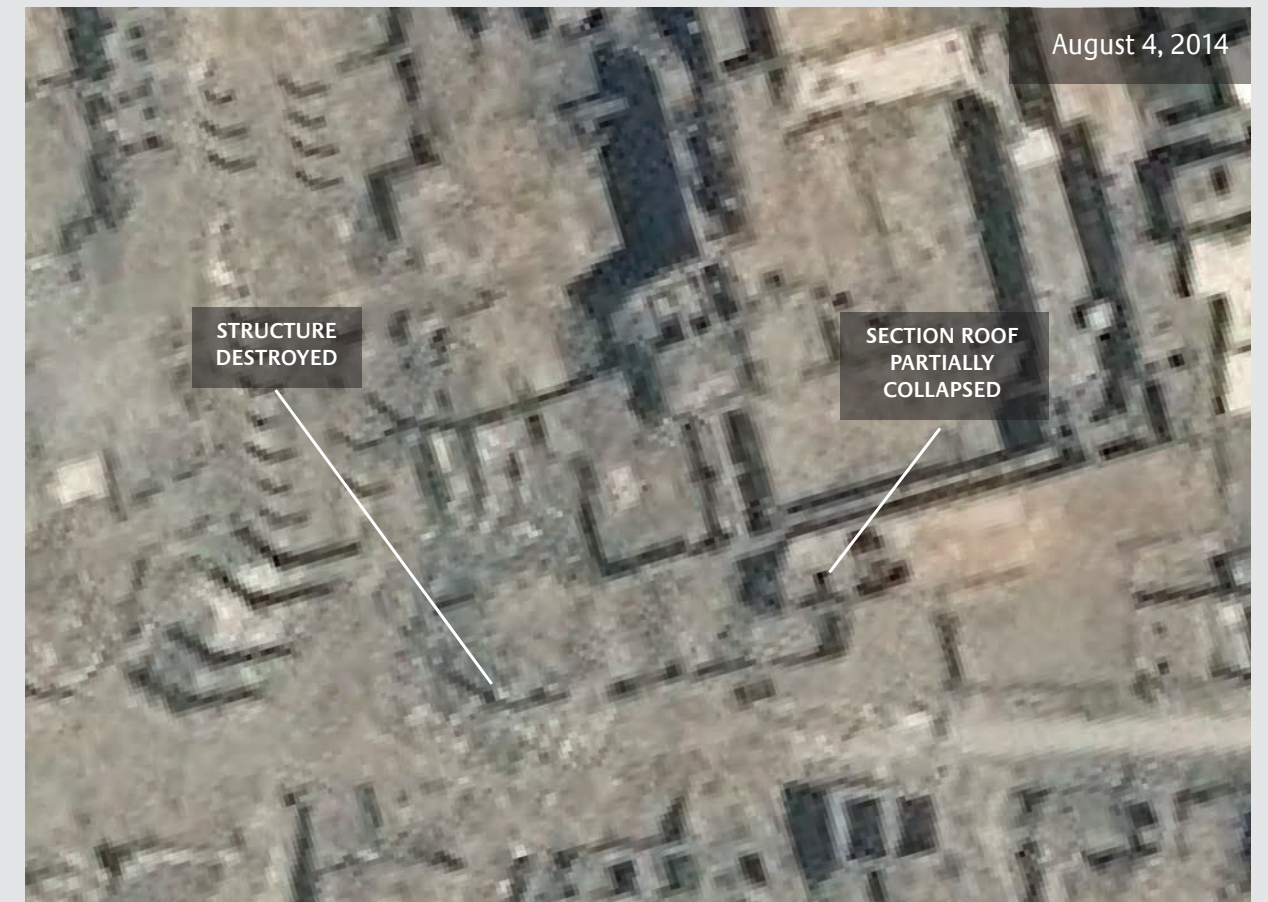
FIGURE 19. Destruction of the Nymphaeum and structural damage to the surrounding buildings.

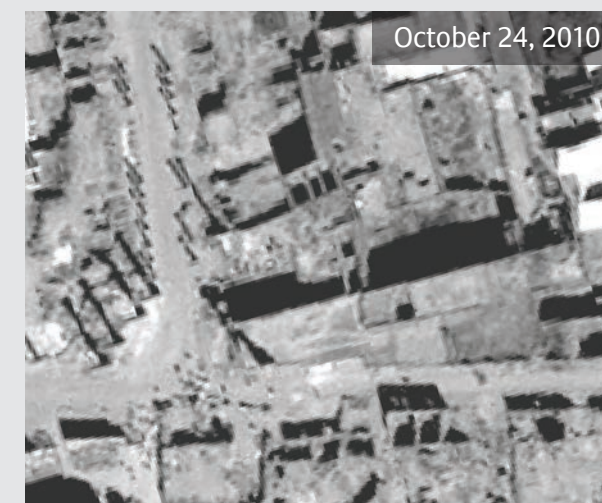
FIGURE 20. The Nymphaeum and surrounding buildings.

Satellite imagery indicates the structure has been destroyed and the surrounding buildings are severely damaged—the roofs have partially or completely collapsed (see figures 19 and 20). This is thought to have occurred during or shortly before October 2012.⁽⁶⁾

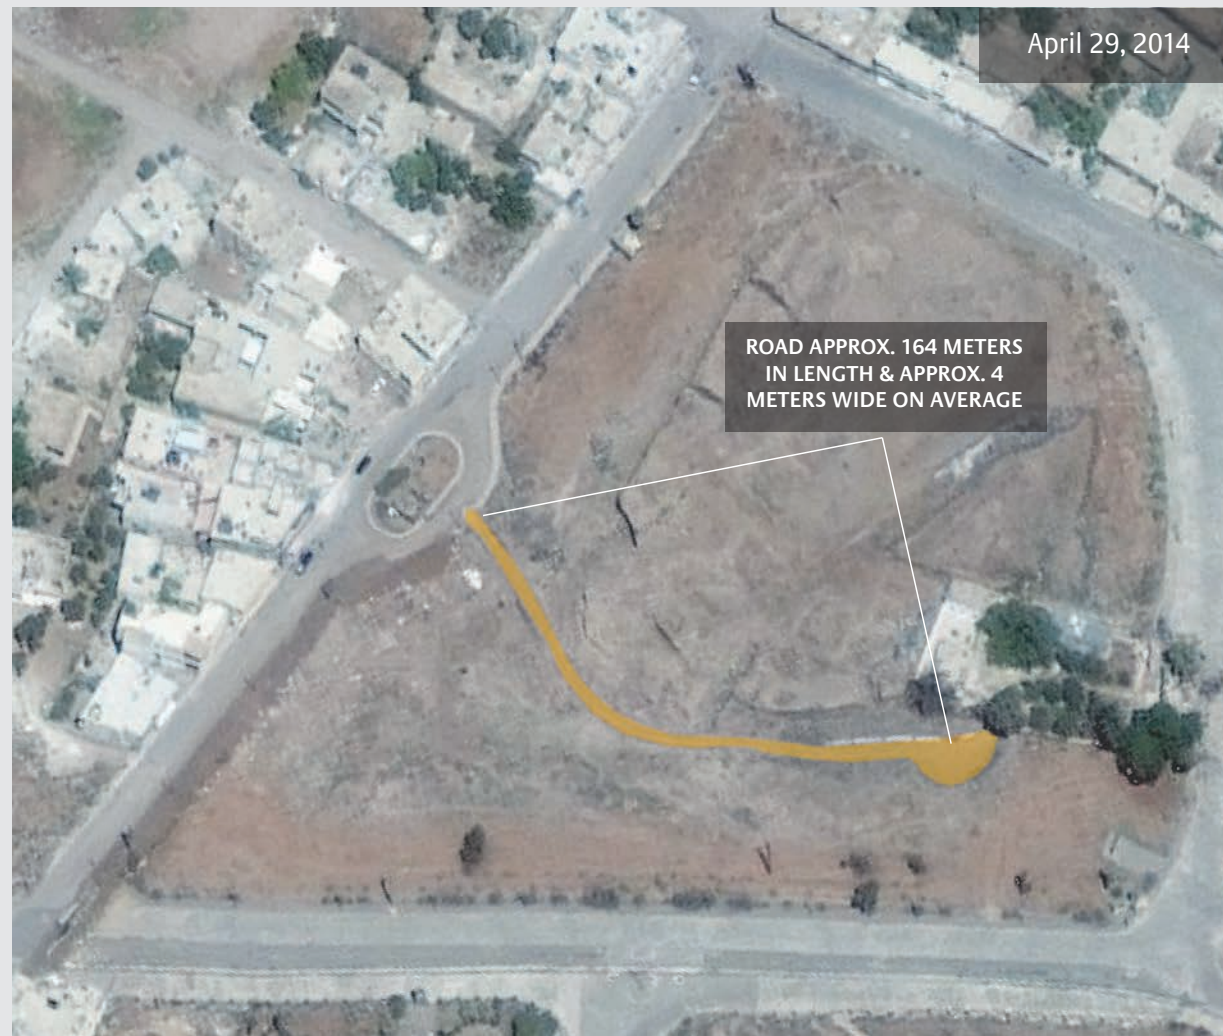
FIGURE 21. Bosra Amphitheatre.

A dirt road, 164 m in length, has been dug through the south of the amphitheatre, avoiding most of the excavated structure (see figures 21 and 22).

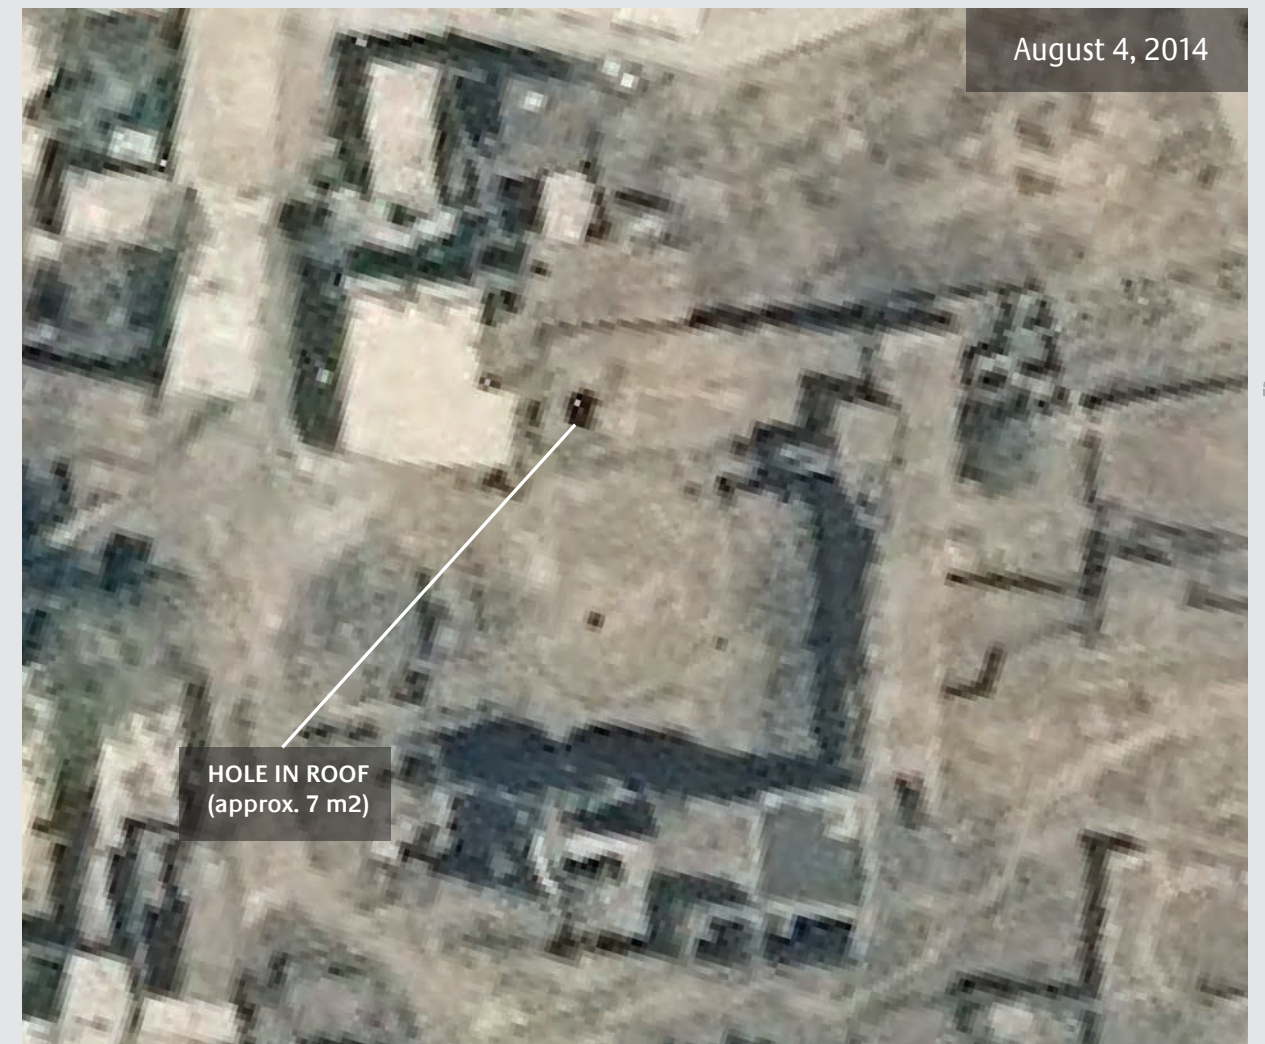
FIGURE 23. Roman Residence at Bosra.

A hole approximately 7 m² is visible in the roof of the northern rooms around the courtyard (see figures 23 and 24).

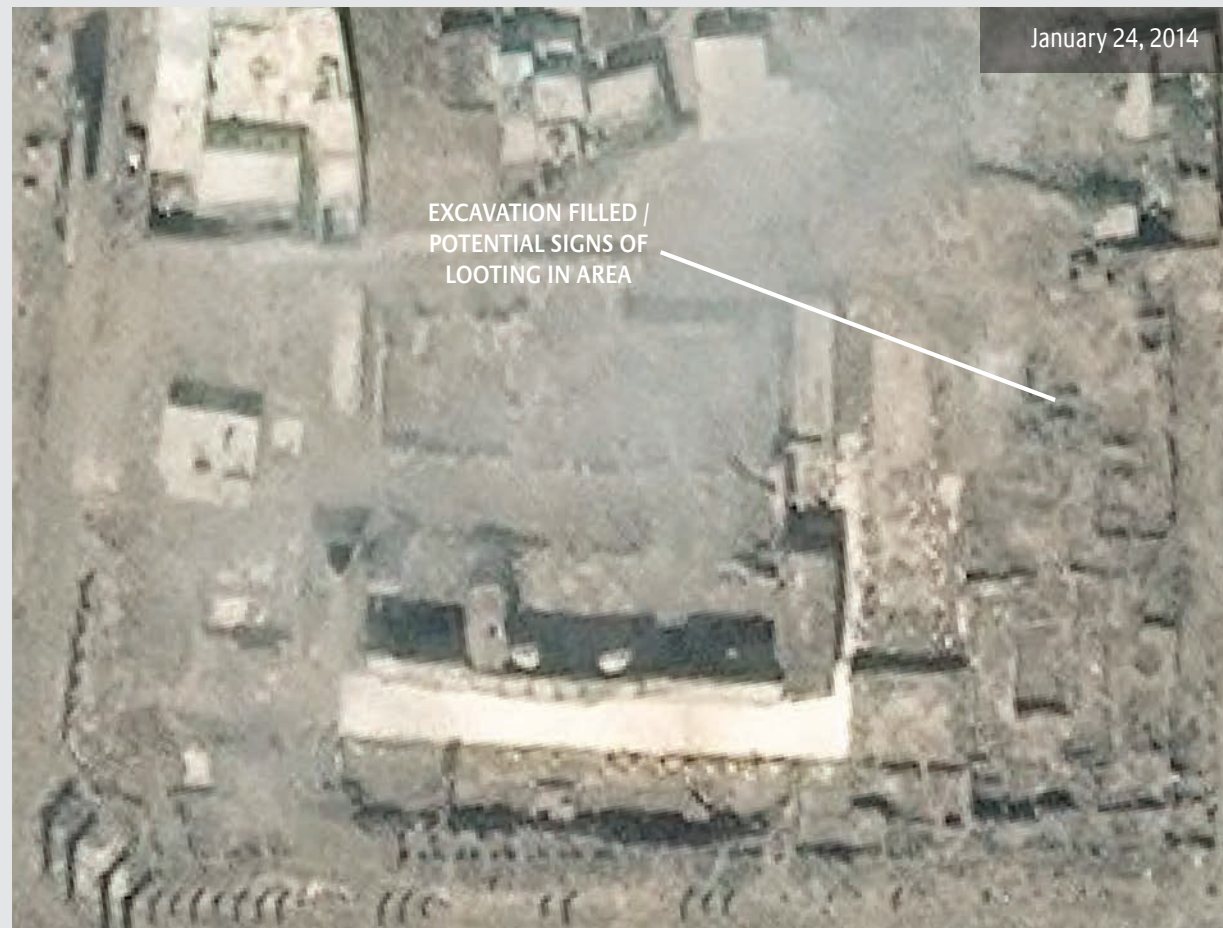
FIGURE 25. Possible signs of looting at the Roman central bath complex.

The soil in the northern end of the complex appears to have been disturbed; parts of the excavation at this site have been covered with dirt between the acquisitions of the two satellite images from 24 October 2010 and 24 January 2014. This is a potential sign of looting (see figures 25 and 26).

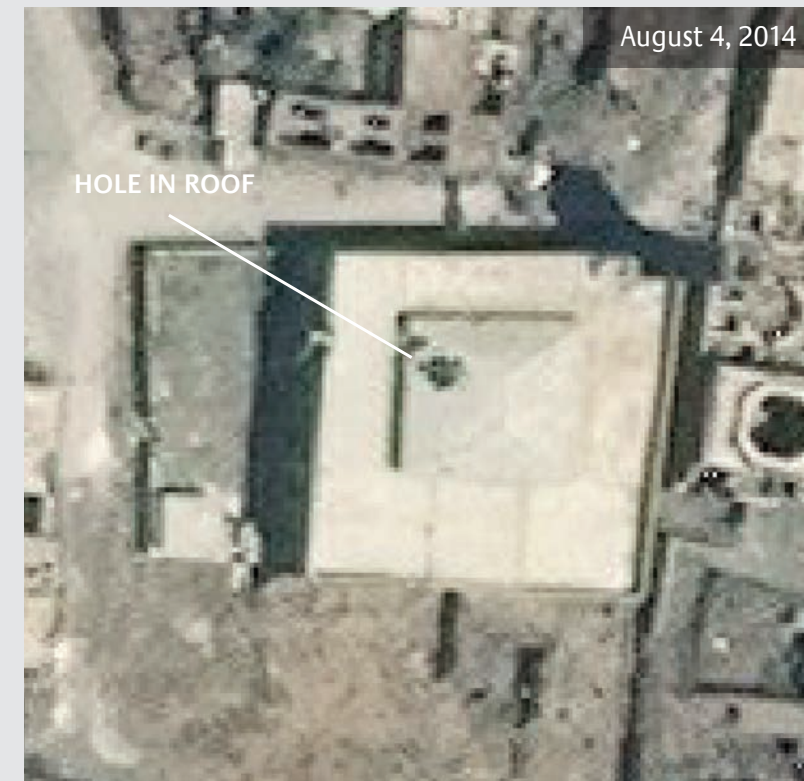
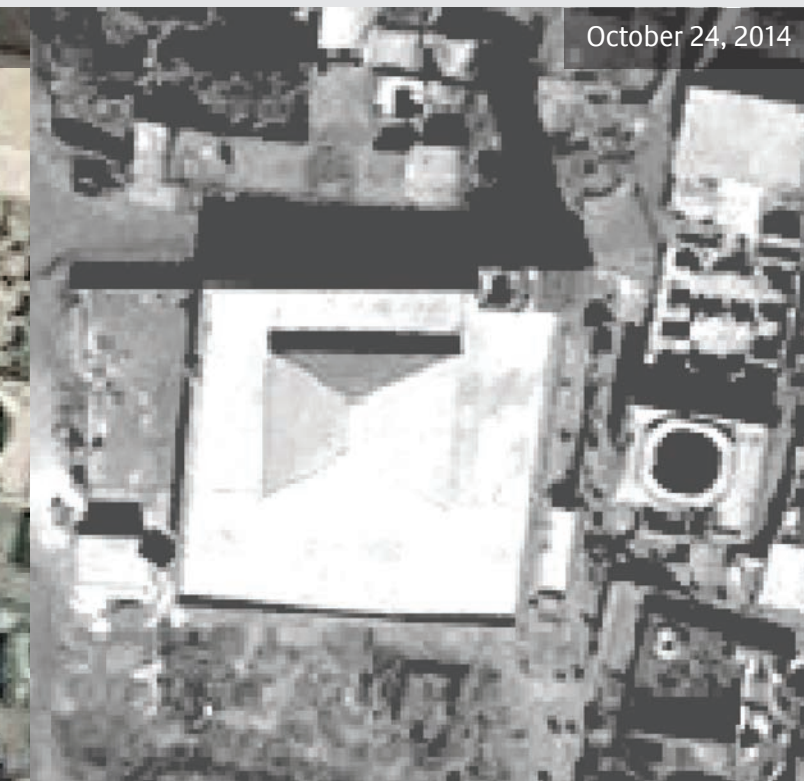
FIGURE 27 & 28. Omari Mosque before and after damage.

The buildings around and next to the mosque have suffered severe structural damage and collapse (see figures 27 and 28). There is a hole on the roof of the mosque visible as of August 2014. It is highly likely the mosque has sustained other damages, however, damage may be internal or to the facade and not visible on imagery.^(v)

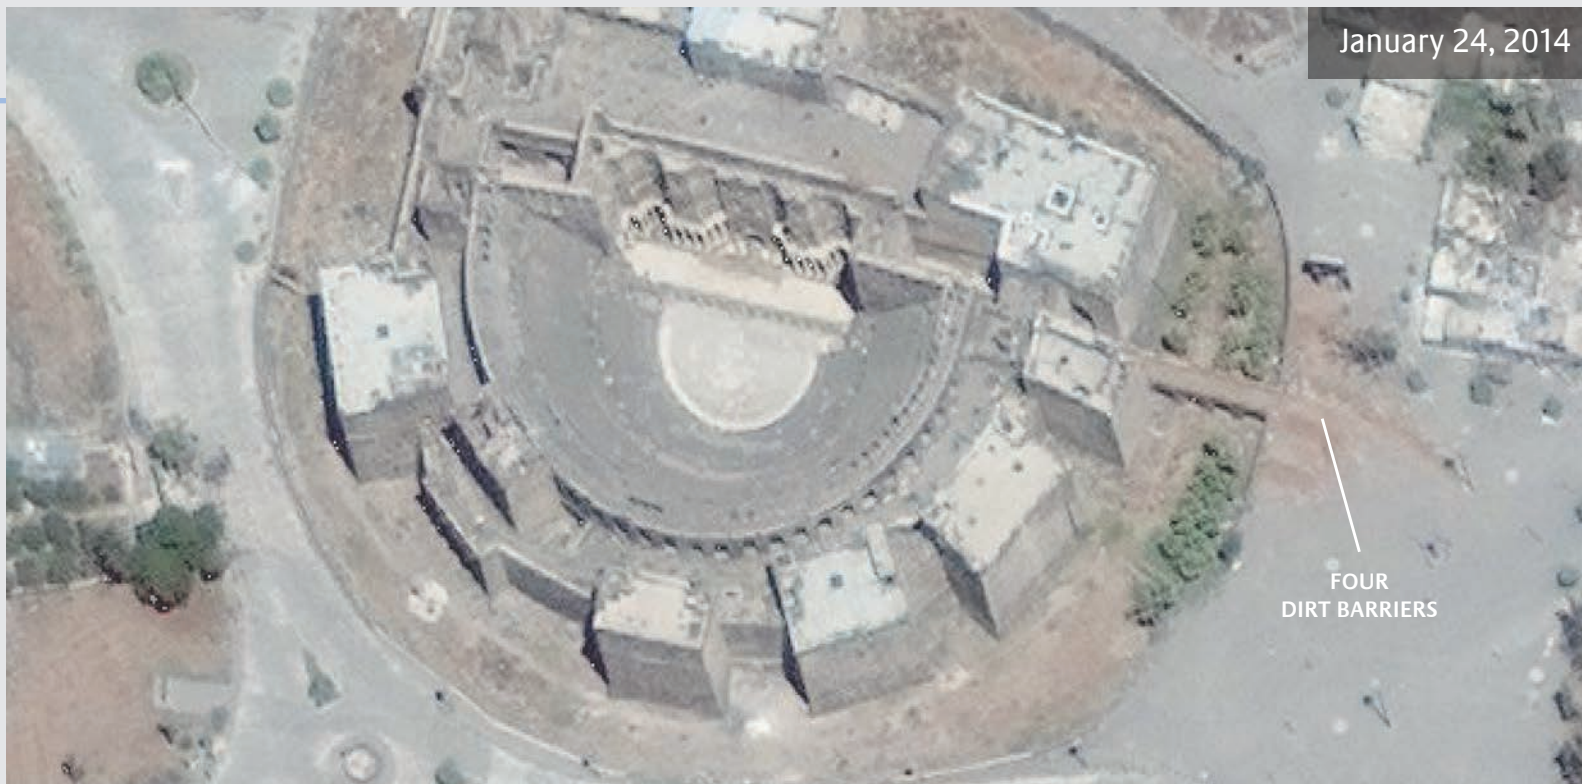
FIGURE 29. Citadel/Theatre.

Satellite imagery shows that four dirt barriers/embankments have been built at the entrance to the Citadel indicating potential military use of the building (see figures 29 and 30).^(vii)

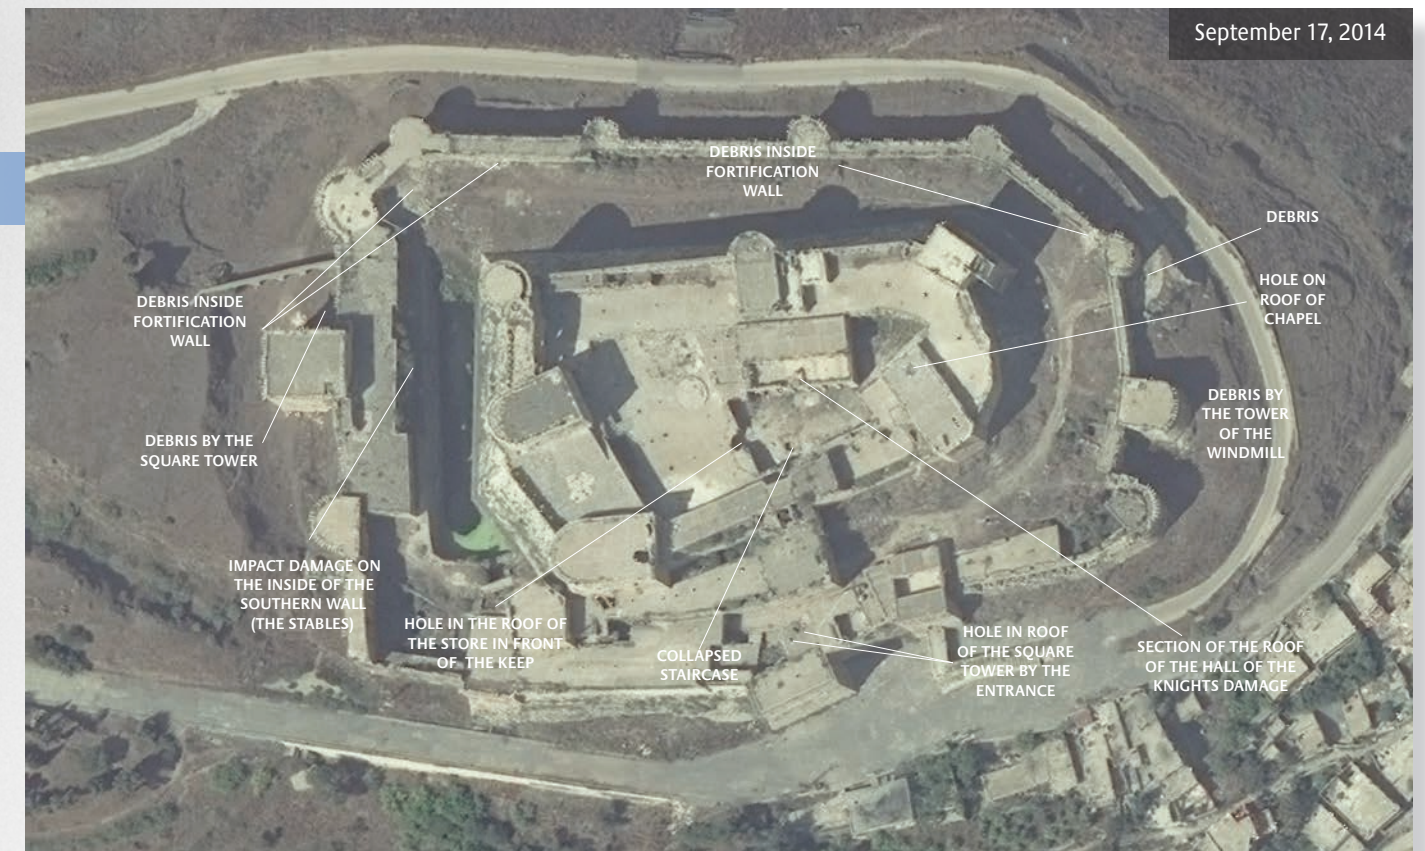
FIGURE 31. Overview of Crac des Chevaliers and locations where damage has occurred and is visible.

A review of the satellite imagery indicates that extensive fighting has occurred in the area. Shelling damage appears to be concentrated on and in the castle, but is also visible in the surrounding town, some of which dates back to the sixteenth century AD. Shelling of the castle has been reported since July 2012;⁽ⁱⁱⁱ⁾ an airstrike^(iv) occurred in July 2013, during the siege of Homs,^(v) and a further airstrike was reported in October 2013.^(vi) After further bombardment and fighting, the citadel changed hands in March 2014.^(vii) This has caused severe damage, visible on the satellite imagery (see figures 31 and 32)

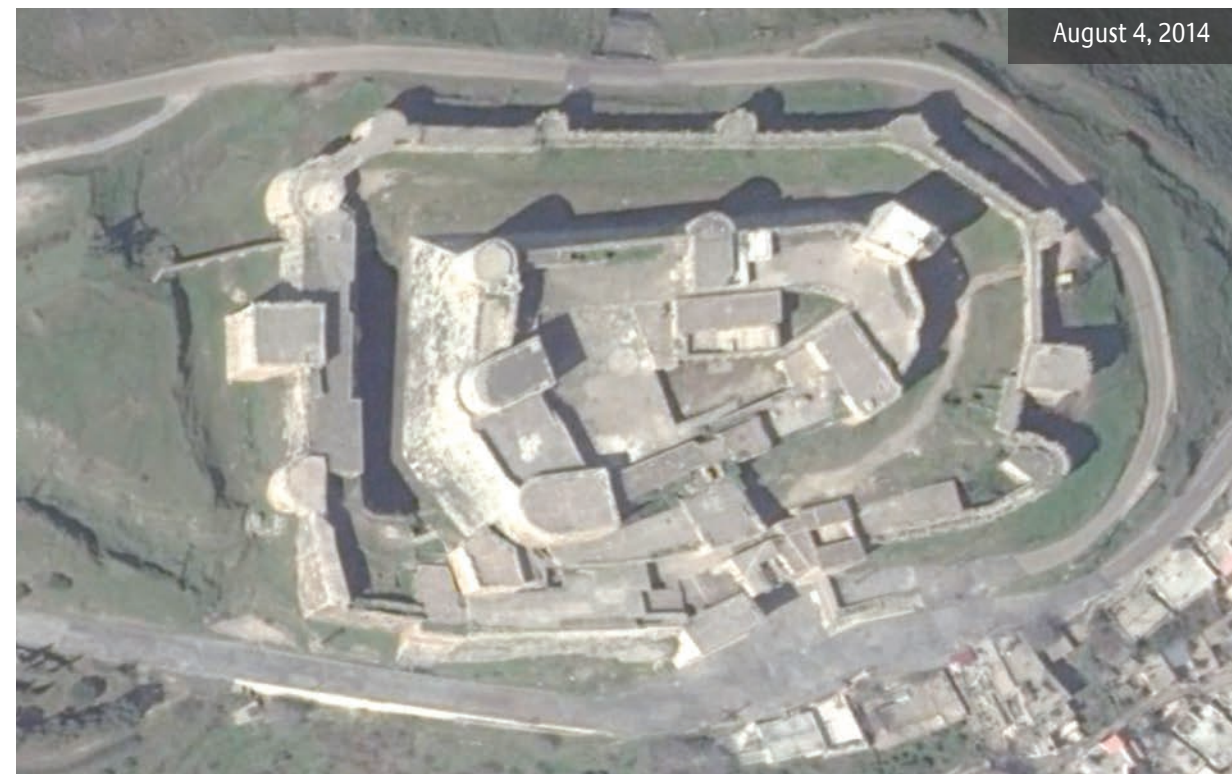
FIGURE 32. Overview of Crac des Chevaliers before damage occurred.

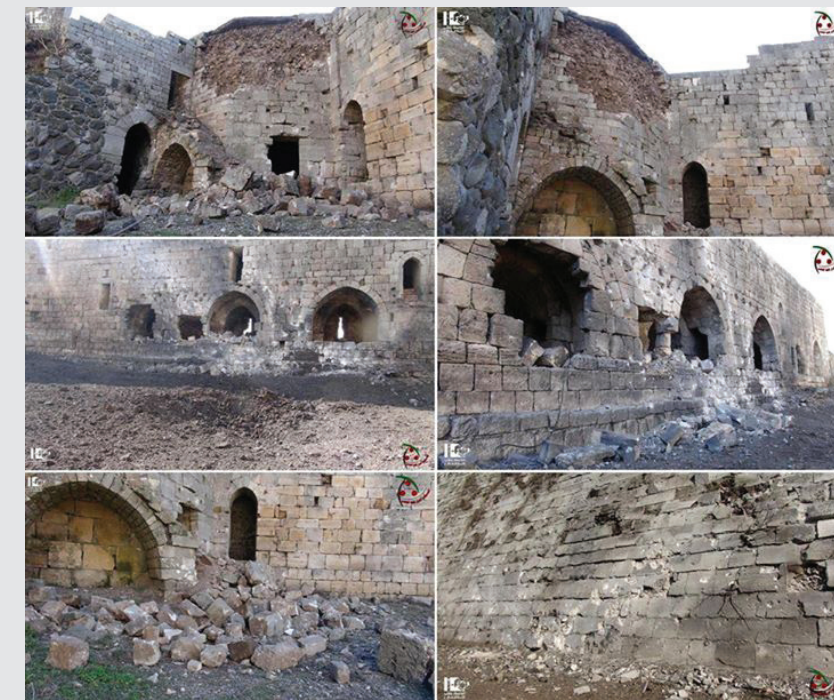
Effects of bombings on the citadel, 19 February 2014/ Photo: Le patrimoine archéologique syrien en danger community, Facebook

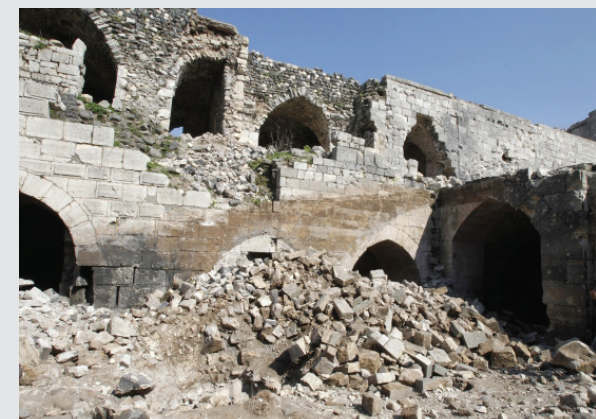
Debris inside fortification wall from collapsed stairs, 21 March 2014 / Photo: REUTERS/Khaled al-Hariri

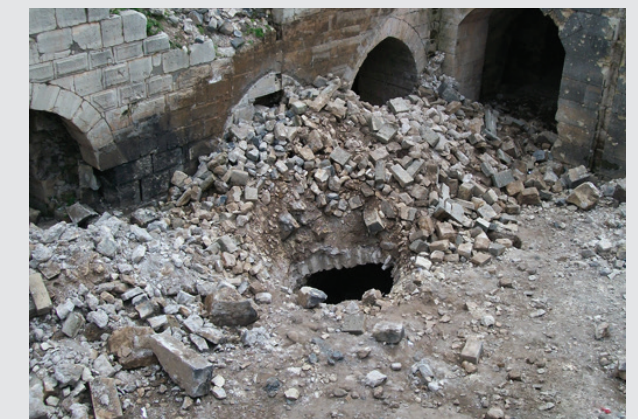
Image of the inner courtyard where the stairs have completely collapsed/Photo: DGAM, 03 July 2014

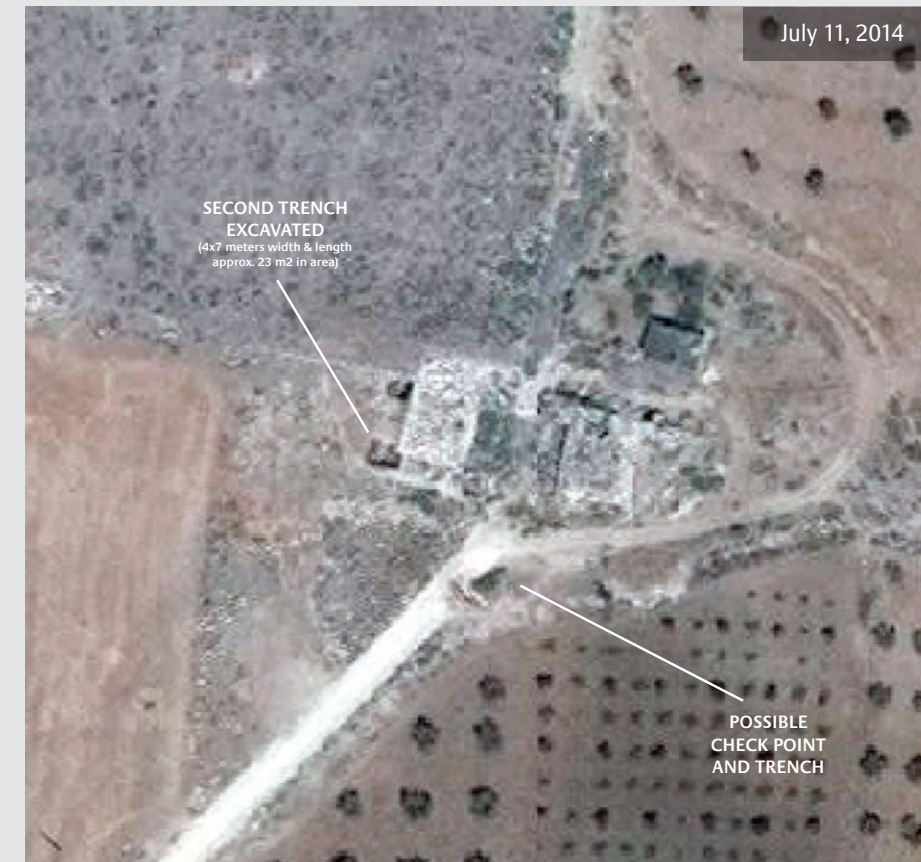
FIGURE 34. Creation of a trench at the South Gate of Cyrrhus (4 x 7m).

The imagery indicates that a small trench measuring 4 x 7 m has been dug on the southeast side of the gate, indicating possible looting (see figure 34 and 35). It is unclear how this trench has affected the gate itself.

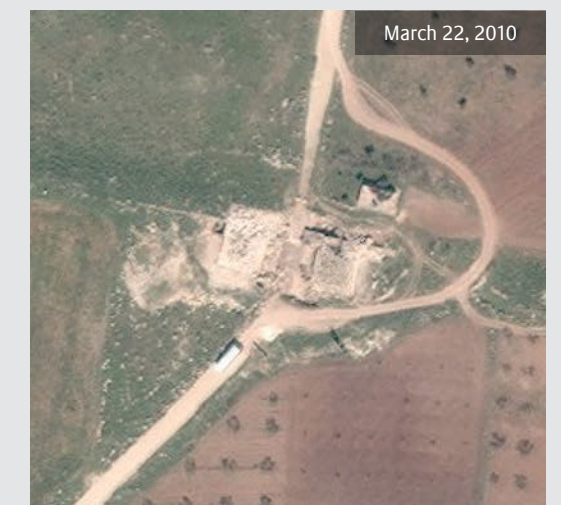
FIGURE 35. Creation of a trench at the South Gate of Cyrrhus (4 x 7m).

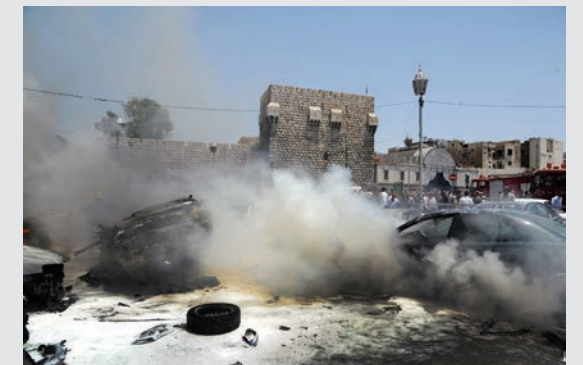
Car bombing at the entrance of the Damascus Citadel/ Photo: European Press Photo Agency; Syrian Arab News Agency.

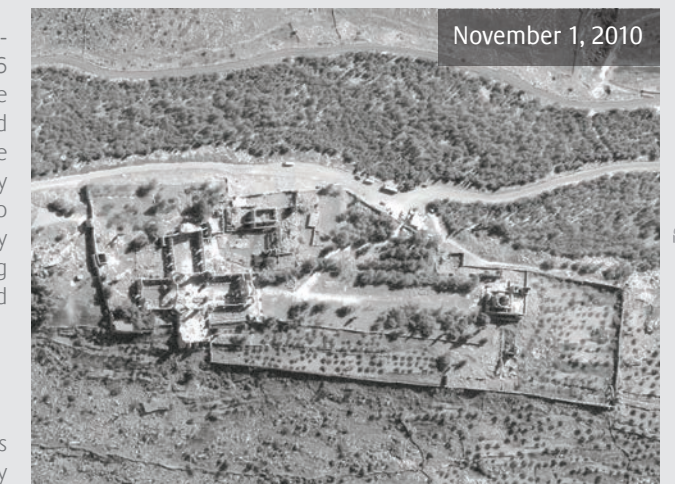
FIGURE 39. Qal'at Sem'an.

A number of small holes (no more than a couple of metres wide) are visible across the site, particularly in the ancillary buildings, which provided accommodation for pilgrims to the west and southwest of the baptistery, in the grounds between the basilica complex and the baptistery, and the area north of the north wall. Other possible holes are visible in the eastern chapel as well as the monastery and cloister. The looting was first reported in February 2013^(v) (see figures 38 and 39). No other damage was visible on either the 2013 or the 2014 imagery.^(vi)

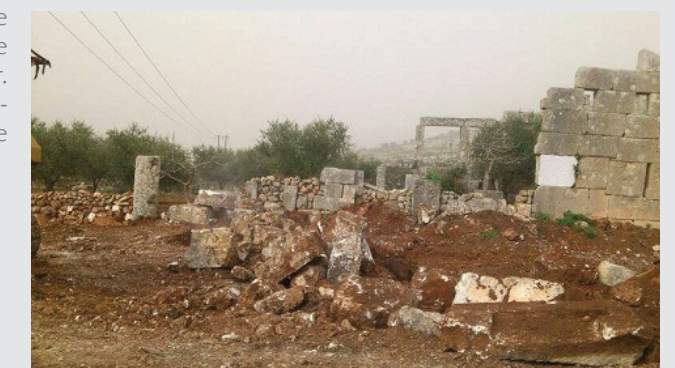
Damage to St Simeon Stylites/Photo: Directorate General of Antiquities and Museums DGAM, 2014.

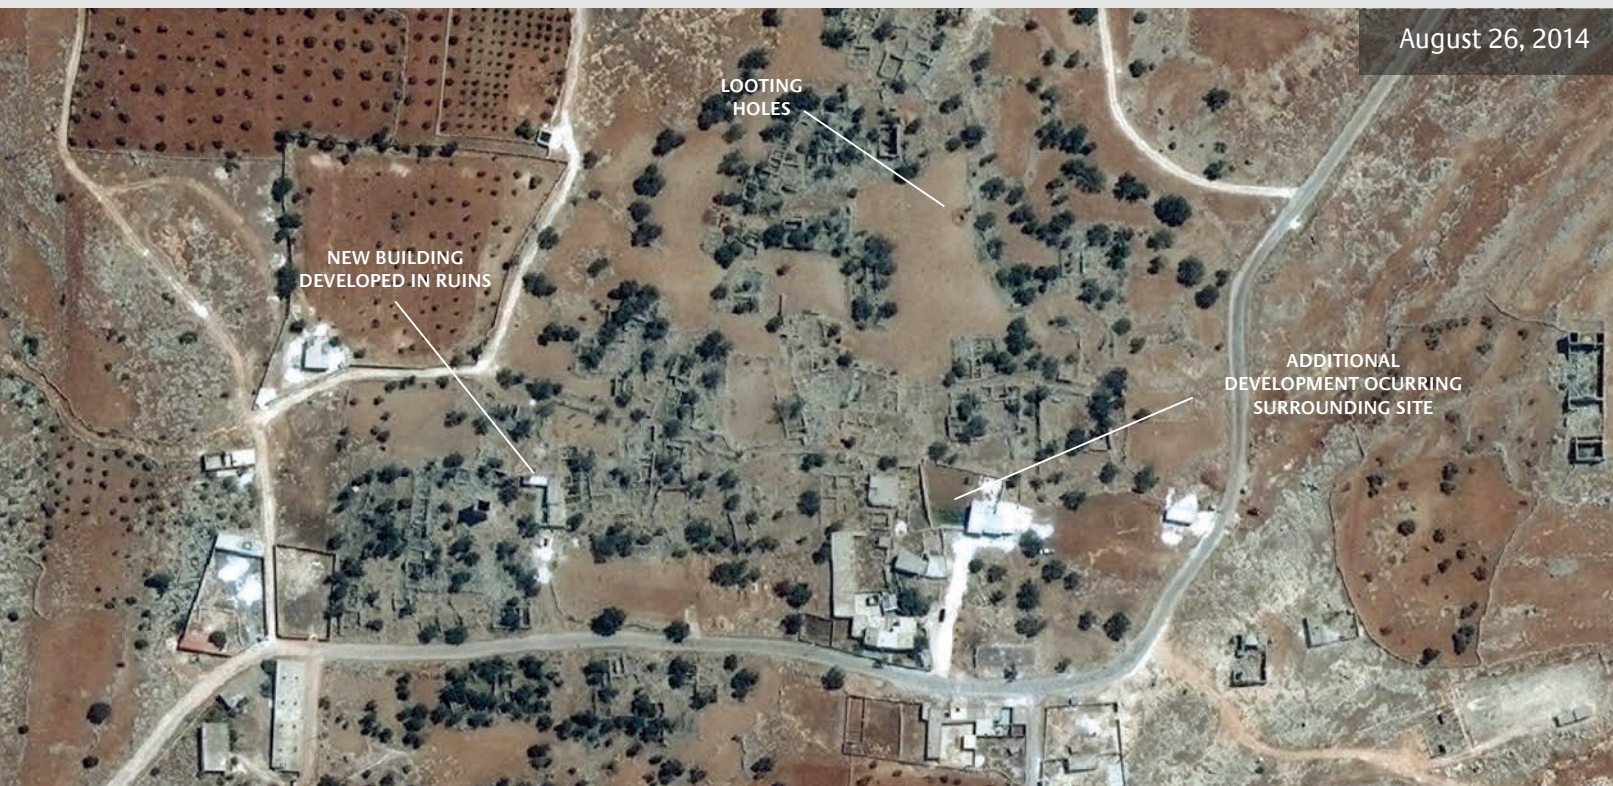
FIGURE 40. Sheikh Suleiman.

Prior to the conflict, several new buildings had been erected within the ruins. A review of the imagery demonstrates that between 2012 and 2014, two of the buildings have been extended, and further development has occurred around the ruins, threatening them. In addition, a looting hole (approximately 3 m across) is visible in a clearing in the centre of the ruins (see figure 40). No other damage was visible, however artillery damage was reported.^(vii)

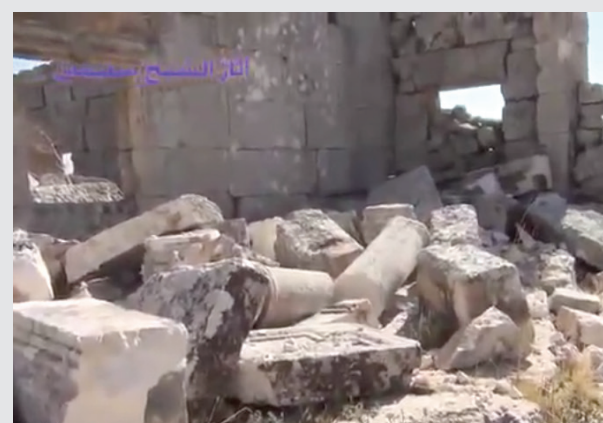
Artillery damage at Shiekh Suliman village ruins/Photo: Flash News Network.

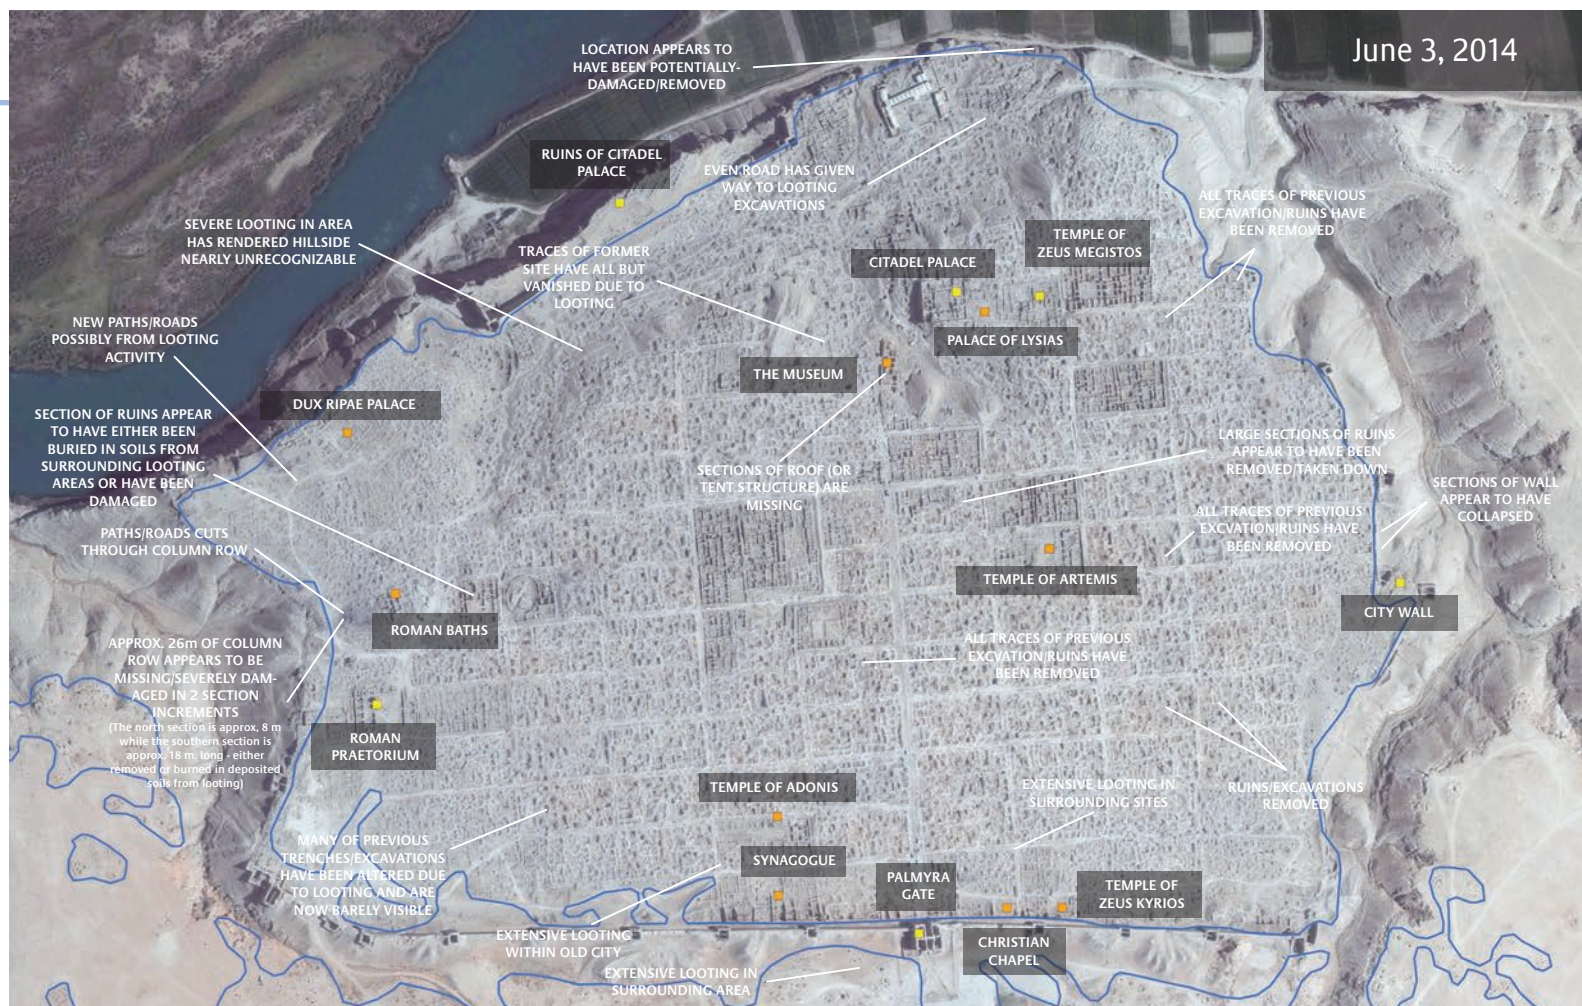
FIGURE 43. This image shows the damage in the area of the Palace of the Strategion/Old Citadel. Some ruins are completely removed and there are many looting holes around and inside the buildings. The looting holes have even removed the track. There is evidence of earth-moving machinery being used to excavate some areas (see Citadel Palace section). The damage to the museum is also visible (see The Museum section); one room has collapsed and most of the roof has been removed.

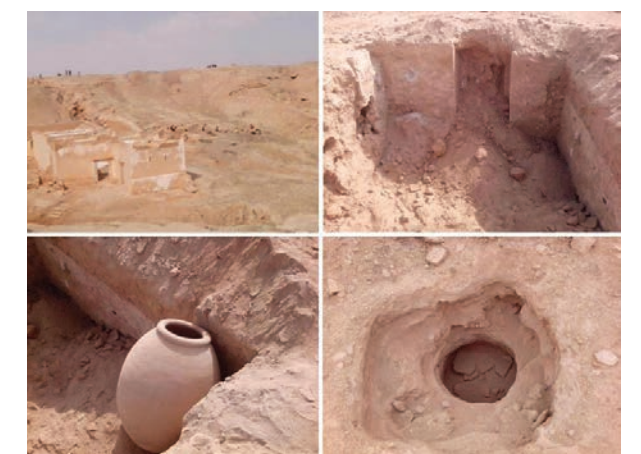
This image shows illegal excavations at Dura Europos/
Photo: Endangered Antiquities of Syria.
