Satellite-based Damage Assessment to Cultural Heritage Sites in Syria

The United Nations Institute for Training and Research

UNOSAT

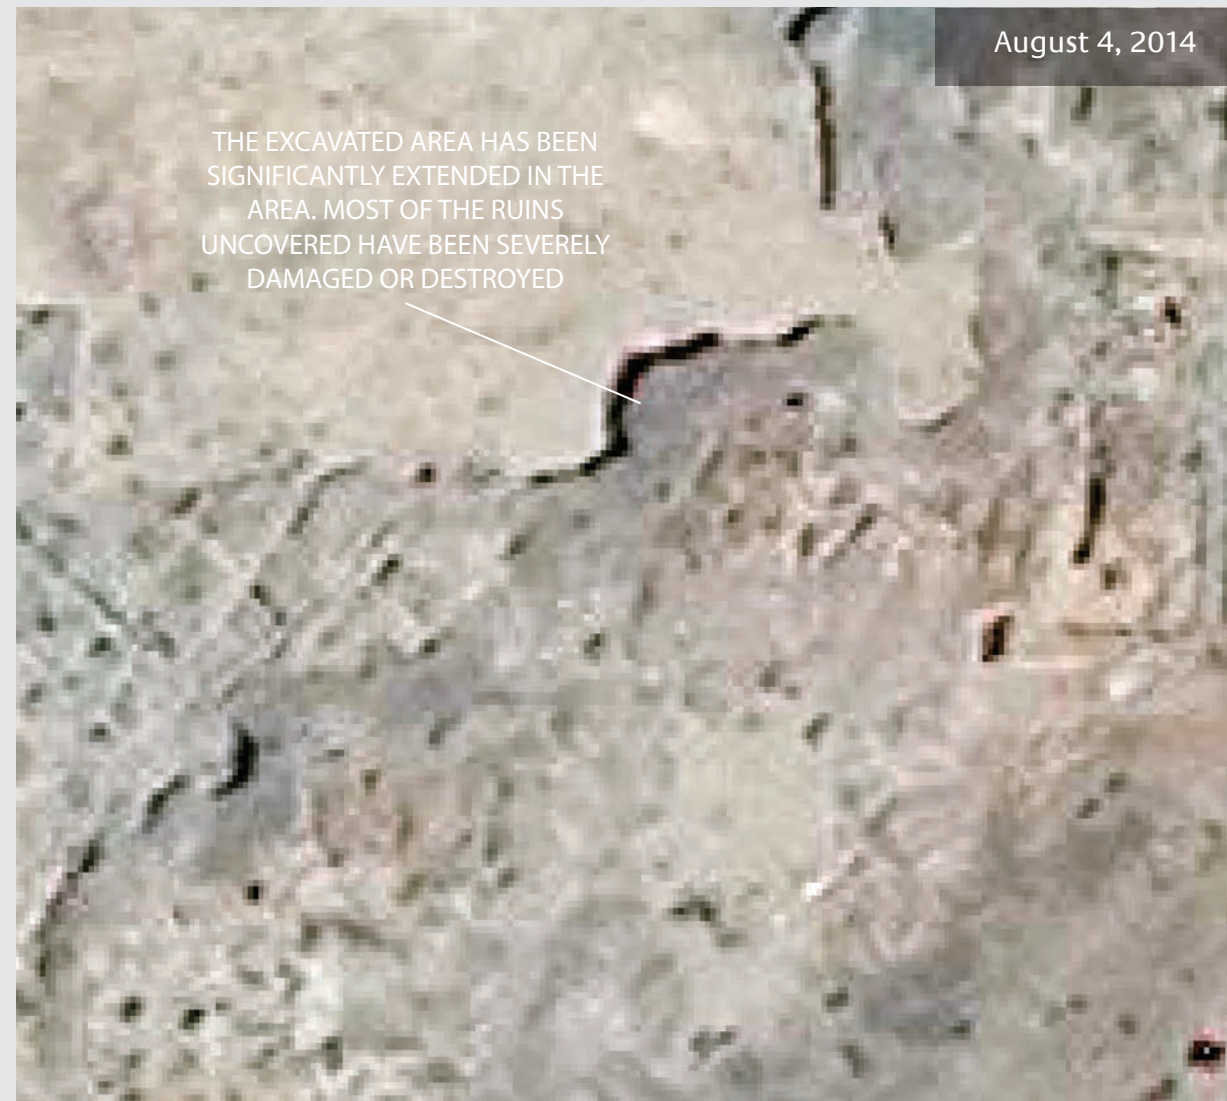
FIGURE 47. The excavated area has been significantly extended. Most of the uncovered ruins have been severely damaged or destroyed.

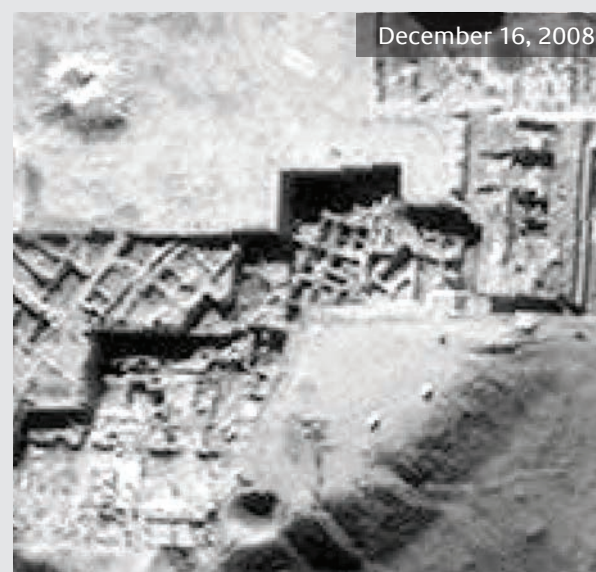
This area of Ebla has been heavily damaged. A comparison of the satellite imagery from December 2008 and August 2014 indicates that only the faintest traces remain of legitimately excavated features in this area. Furthermore, substantial parts of the acropolis around this area and extending south have been dug up, most likely with heavy machinery (see figures 47 and 48).

FIGURE 48. Area F before damage.

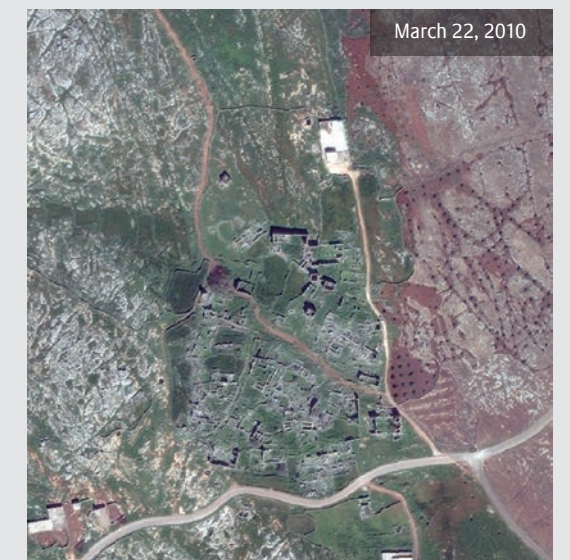
A review of imagery confirms that most of the ruins on the site have been destroyed or severely damaged (see figures 50 and 51). The development in the northeast corner of the site has been rebuilt and substantially increased in size, destroying some original walls and potentially disturbing archaeological levels. The eastern road to the building has been widened by approximately 4 m, covering some ruins. The southern-most ruins (an area of approximately 3,000 m²) have been cleared to increase farmland, and the farm next to them has also been enlarged. No cause of damage can be identified for the rest. In addition, a wall had been added to the western road, which has also been lengthened. There is no evidence of looting, though it has been reported.⁶⁾

FIGURE 51. Image of Dar Qita before damage.

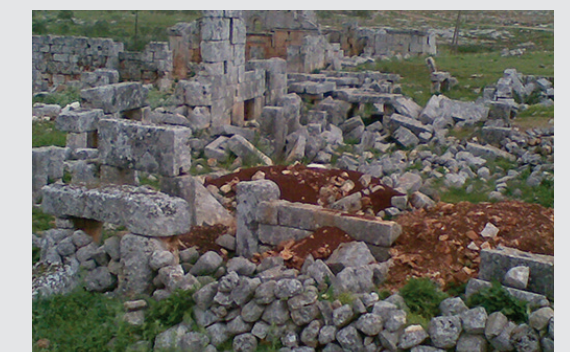
Excavation at Dar Qita/Photo: DGAM, 2013.

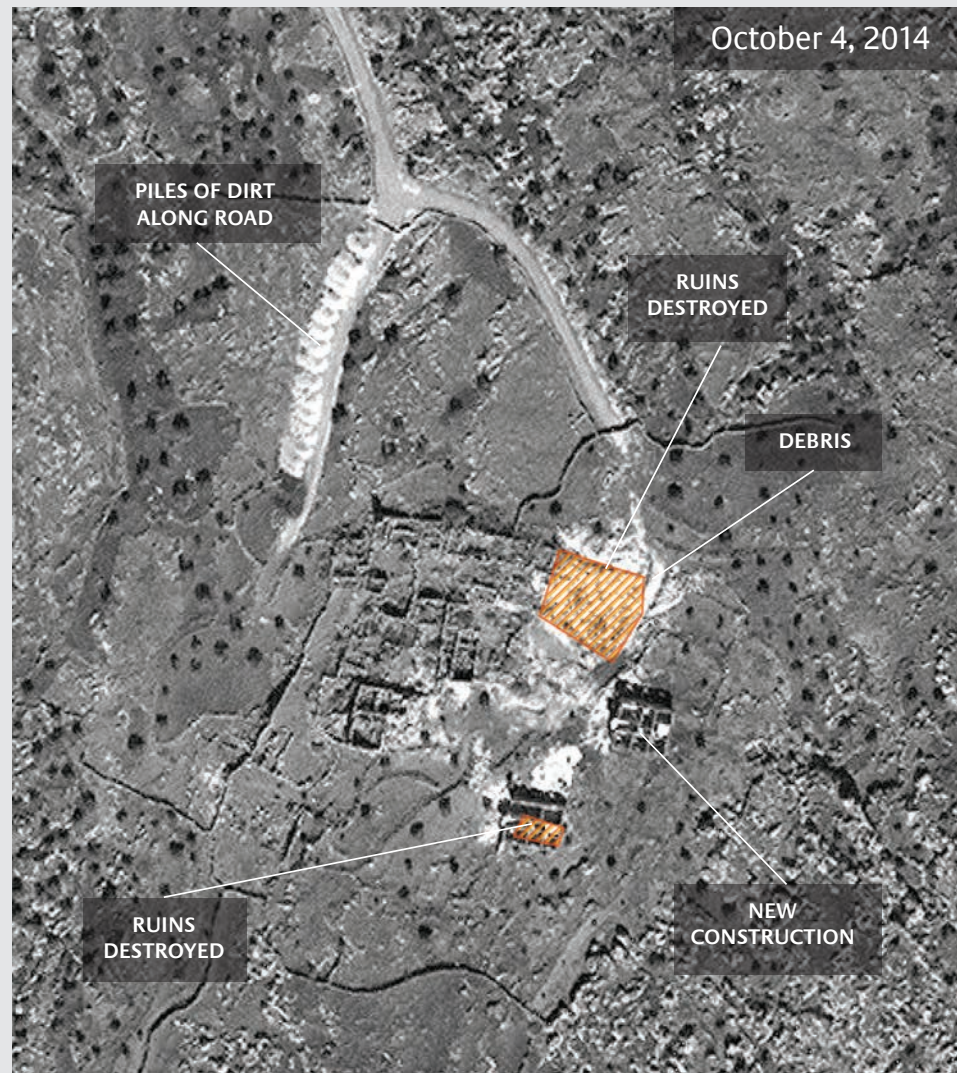
FIGURE 52. Bab Aynan.

There are two new constructions to the south and east of the village, in addition to a number of new constructions on the road leading to the site. An area (approximately 2,000 m²) of the eastern ruins has been cleared, destroying them. Soil has also been piled up along the western branch of the road that leads to the site (see figures 52 and 53).

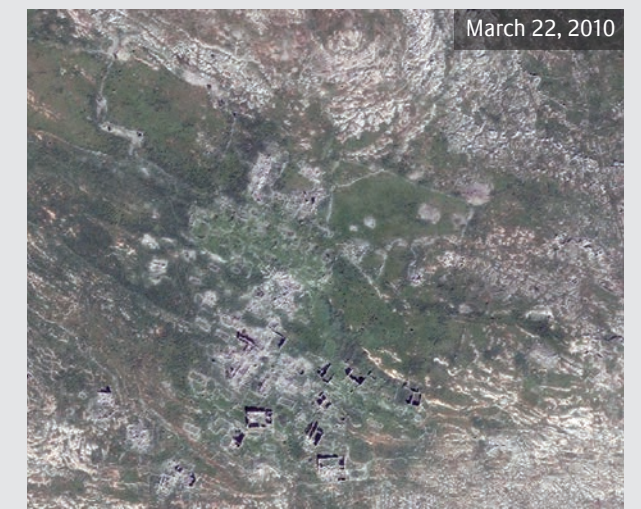
FIGURE 55. Qasr Iblisu.

A review of the imagery shows extensive looting within and around the ruins. Imagery also indicates a heavy concentration of looting occurring to the northwest section of the ruins (approximately 1,000 m²). There are also signs of illegal excavations within the ruins which may likely be related to looting activities. An additional smaller number of looting holes are apparent to the northeast section of the ruins (see figures 54 and 55).

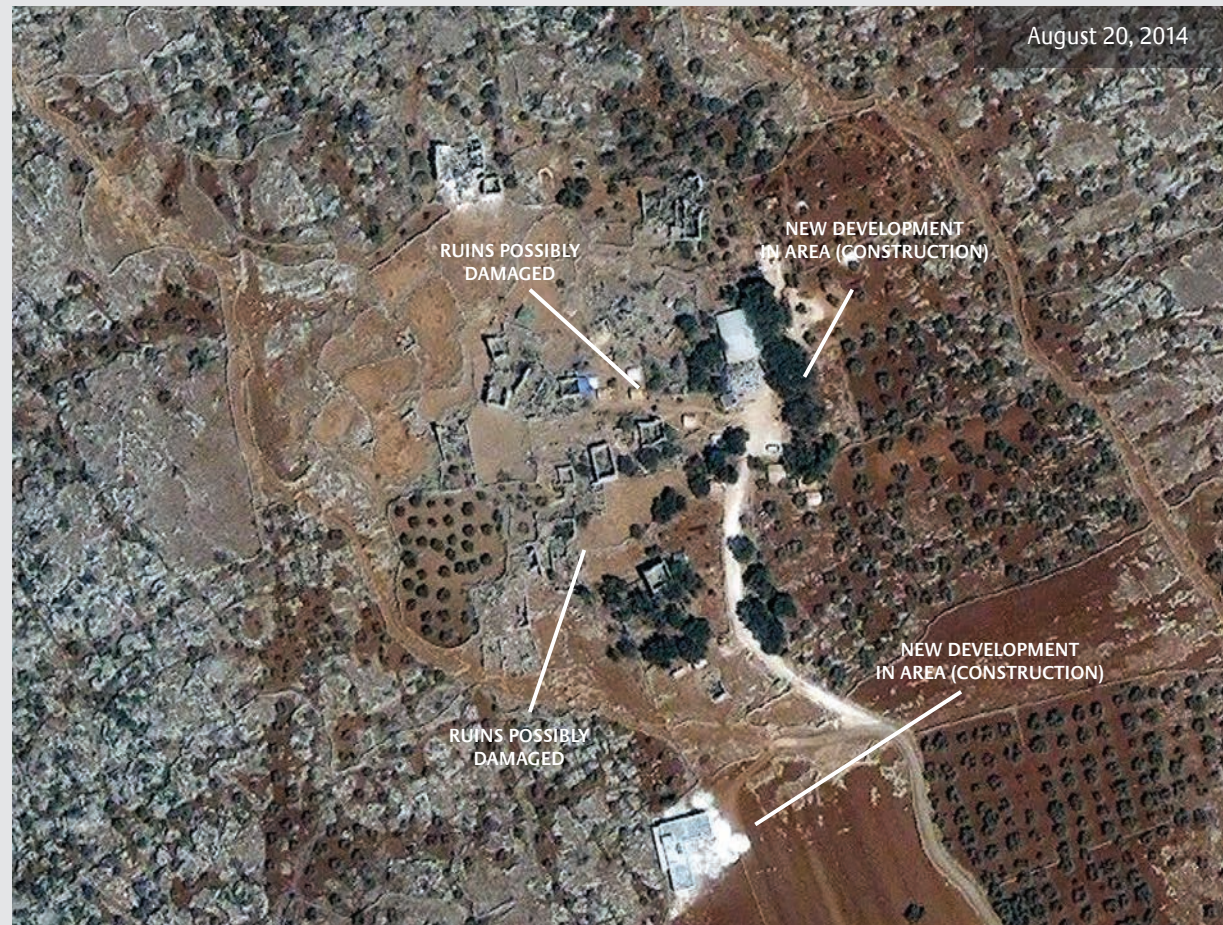
FIGURE 60. Bamuqqa.

The car park was redeveloped and covered by 2014, and a number of large vehicles (possibly trucks) are visible on the site. Four small structures (approximately 6 x 6 m) have been built in the clearings among the ruins, as well as a large number around them (see figures 60 and 61). However, none of the visible ruins seem to have been disturbed.

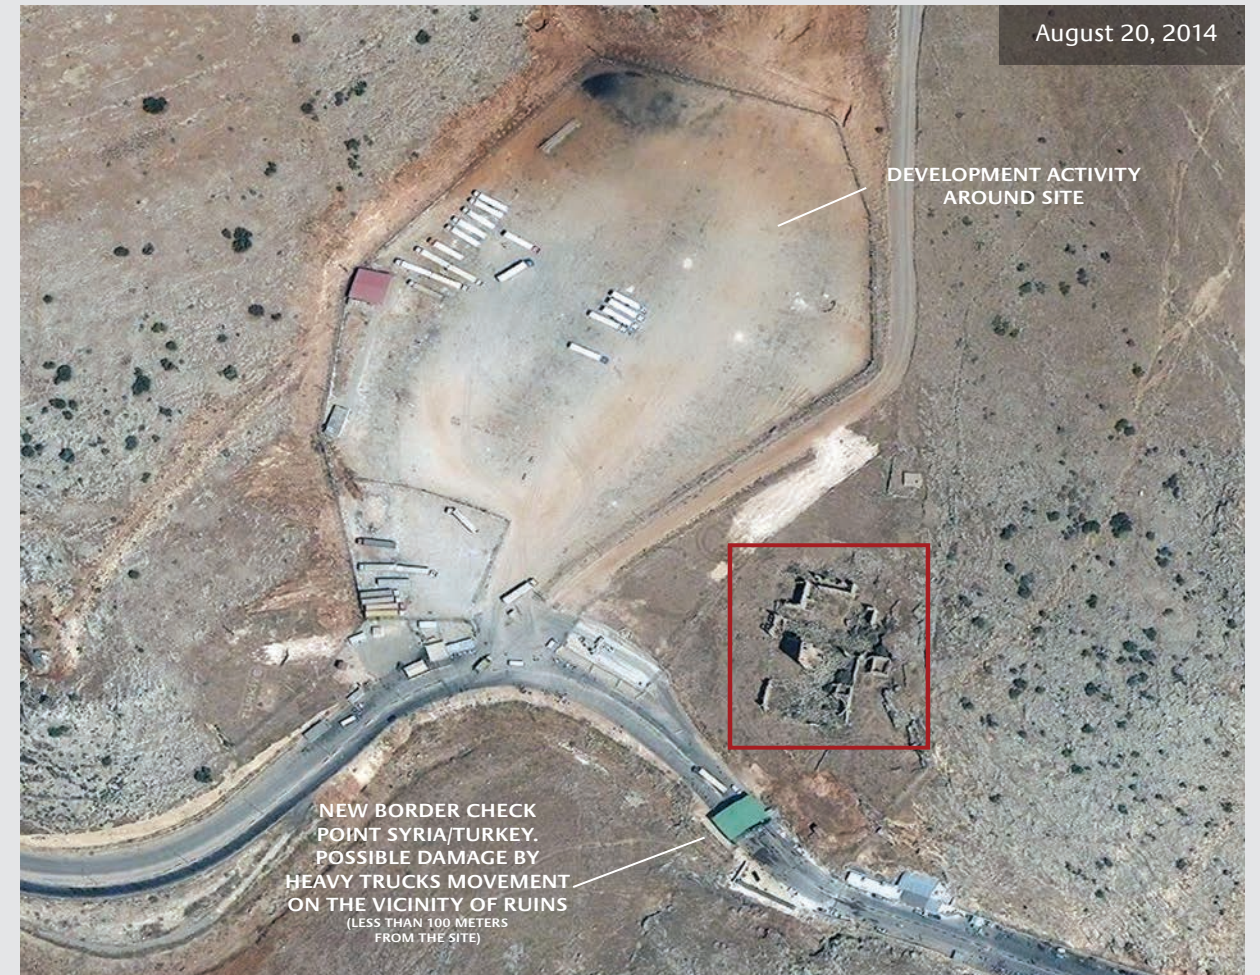
FIGURE 62. Qasr al-Banat.

Damage Assessment - A review of the imagery shows extensive new construction and development around the site, which is extremely close to the border crossing with Turkey. Although it appears undisturbed, the possibility remains that the site has been damaged from development activities (see figures 62 and 63).

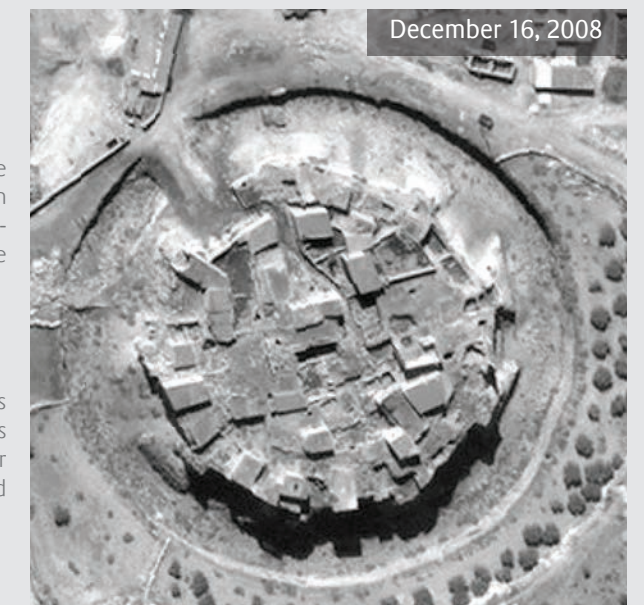
FIGURE 66. Citadel.

A comparison of satellite imagery reveals the Citadel appears to have sustained severe damage. By 2013, multiple structures within the Citadel have been severely damaged and another was destroyed, presumably from shelling (see figures 65 and 66).⁽ⁱⁱⁱ⁾

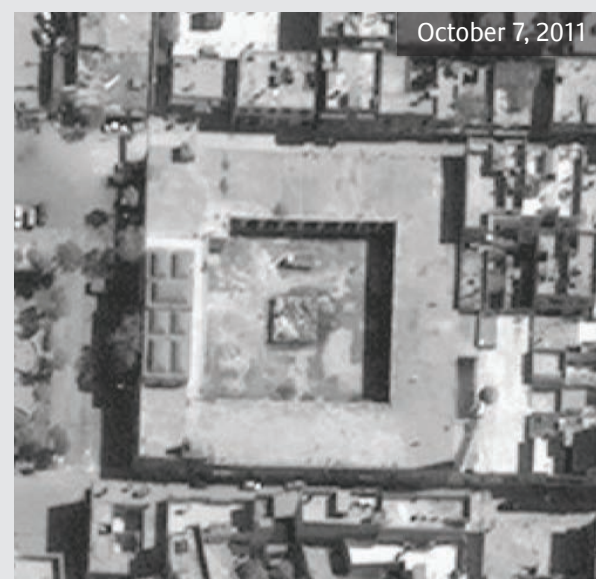
FIGURE 68. Damage to Khan Assad Pasha Al-Azem.

A review of satellite imagery confirms that the building appears to have sustained moderate damage. There is a hole approximately 8 m in diameter in the eastern gallery roof and damage to the southwest corner of the roof (see figures 67 and 68).

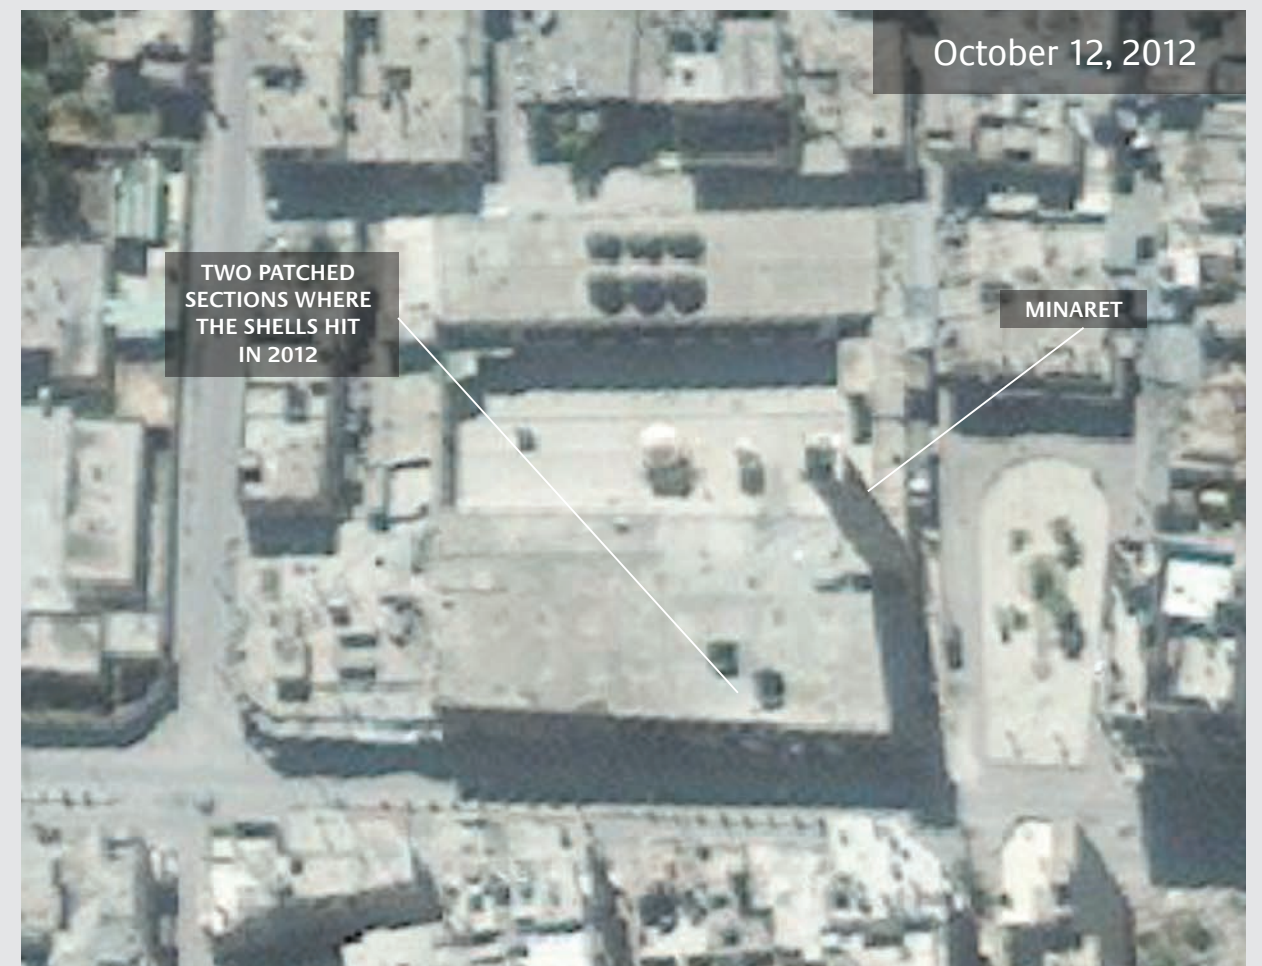
FIGURE 69. The Great Mosque and Minaret.

A review of satellite imagery shows patched repairs to the roof of the northern gallery where two shells hit it in 2012. The light damage sustained by the courtyard at that time is not visible on imagery. A comparison with satellite imagery on Google Earth suggests that this damage may have occurred after 6 September 2012 (see figures 69 and 70).

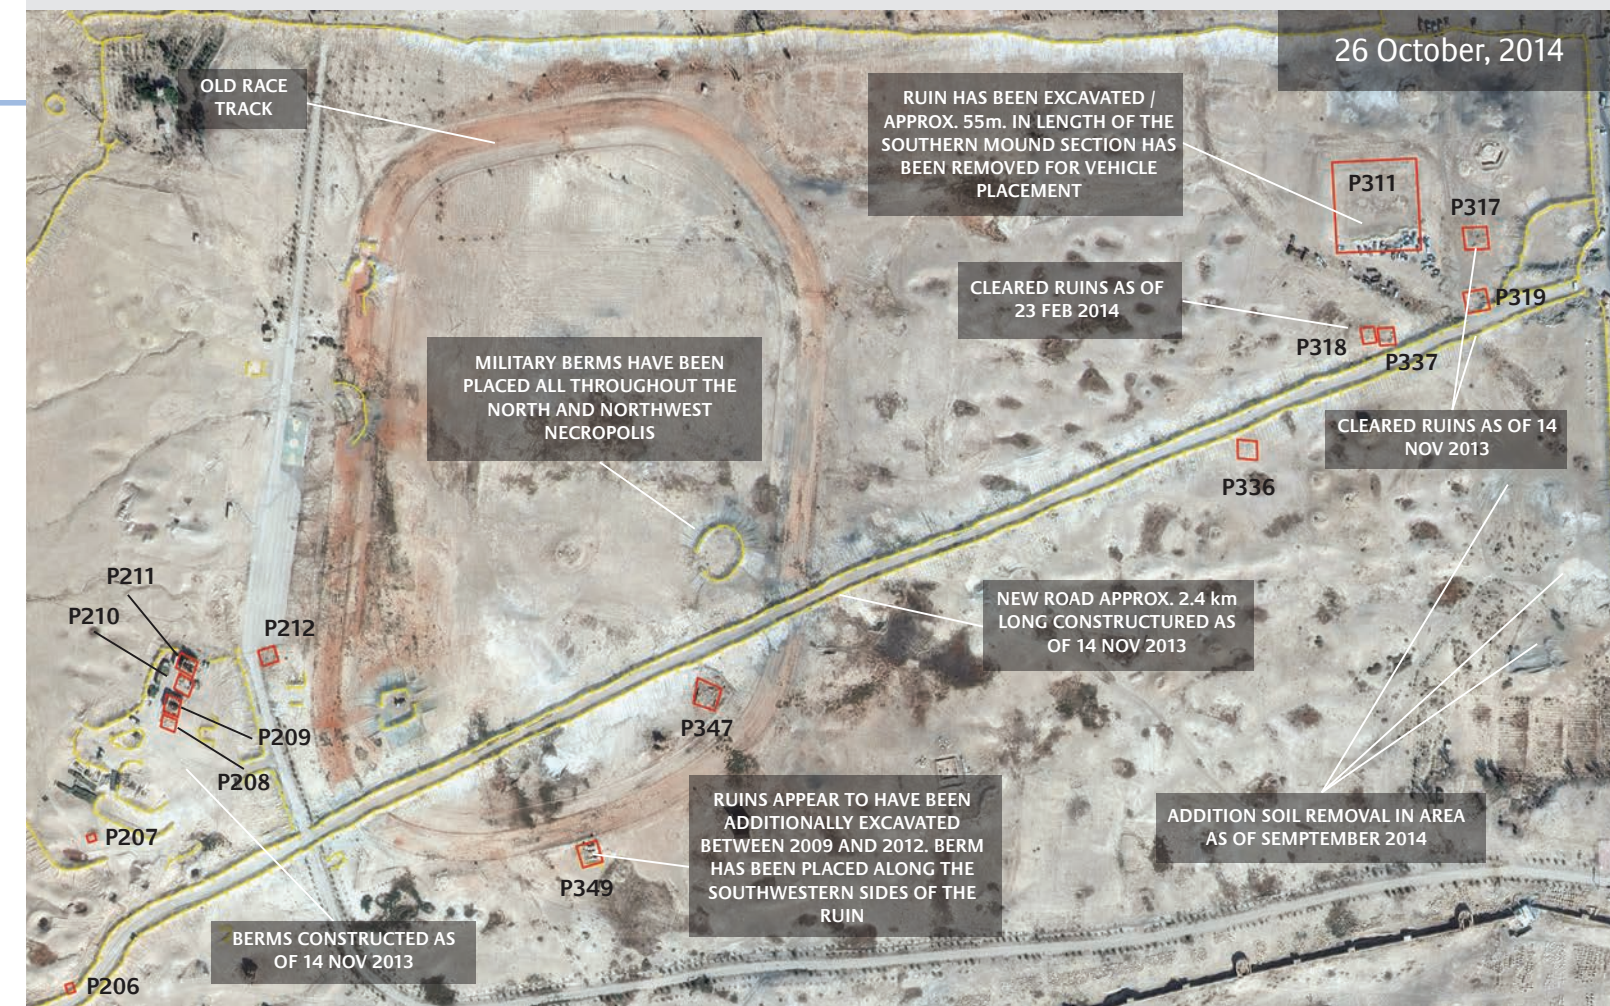
FIGURE 72. Northwest Necropolis.

The new road is clearly visible on the imagery. It was built between 01 September 2012 and 14 November 2013 and remains in use as of 26 October 2014 (see figure 72). Coming directly down from where the original road to the citadel branches to the communications/radio mast, the new road cuts through the northwest and northern necropolises to the tarmac road on the eastern edge of the modern town of Tadmur. This new road is approximately 2.4 km long. A secondary section, 579 m long, branches off from the main road in the northwest necropolis. It cuts through it to the rise at the eastern-most point of the walls. Here a small clearing has been excavated against and through the walls; an area of wall approximately 44 m long has also been removed (see figures 72 and 73). Soil from the surrounding areas, including the archaeological areas, has been piled up all along the road to provide a walled embankment.^(vi) This embankment also disturbs the line of the Hellenistic wall running to the Bel Hammon Temple. The road is dirt, rather than tarmac, which will cause far less damage as it does not require such deep foundations, and no chemicals were used which would leach into the archaeological soils. However, it still requires the flattening of archaeological features, and the vibrations of heavy traffic will damage the archaeological remains. In addition, the tarmac road to the communications tower has been widened and resurfaced.

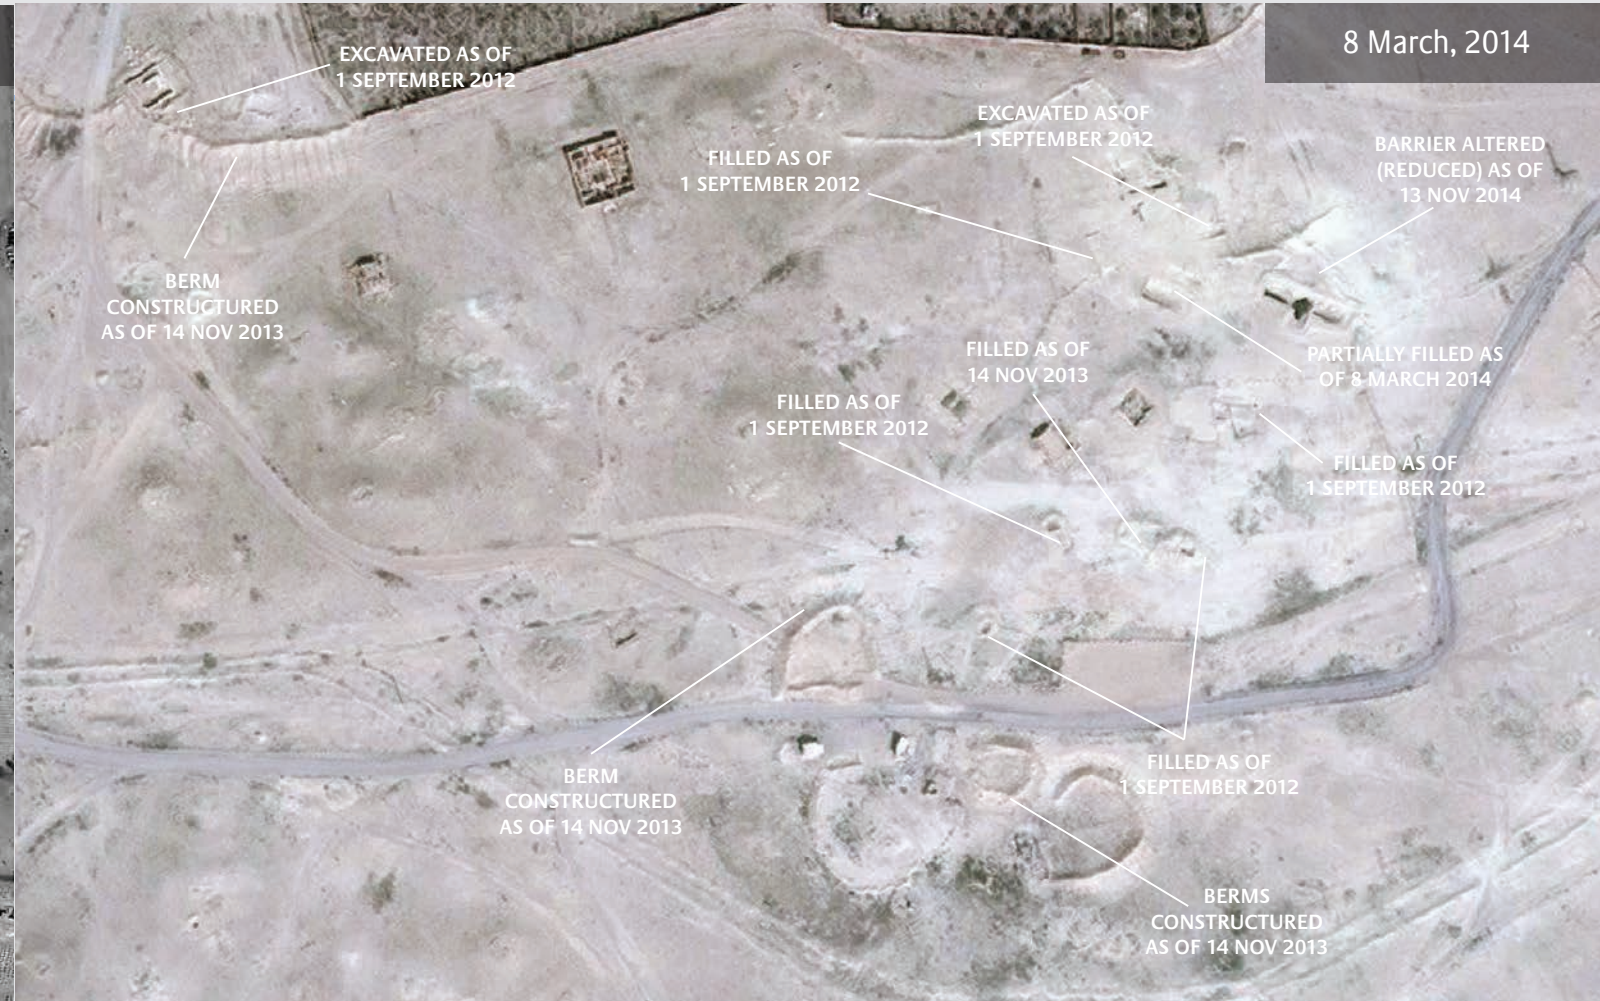
FIGURE 74. Tombs that were filled in as of 2012.

A comparison of the imagery from 2009 and 2012 shows the entrances to most of the main underground tombs in this area were filled in, presumably when the Syrian DGAM attempted to bury the entrances to the tombs in some of the cemeteries (including this one) in order to protect them.⁽⁶⁾ Unfortunately, analysis of the imagery also shows that at least three of those filled in—including the Tomb of Bolha⁽⁶⁾ and the Tomb of Bariki—were reopened between 2012 and 2013, as small holes became visible in the filling. The Tomb of Artaban was completely filled in during the period between 2012 and 2013 (see figures 74 and 75). However, soil heaps are visible around the tomb in 2012, suggesting it was possibly looted and then recovered more thoroughly later. A fourth tomb, tomb C, was filled in by March 2014 and at that point the holes into the tombs were no longer visible, supporting the hypothesis that the tombs were reburied, again in an attempt to protect them. There is also evidence of earth being moved in this area throughout the period under examination. Funerary temple S103 was excavated in the northeast area of the site at some point between October 2010 and September 2012. Though the clarity of the excavation suggests it is legitimate, given the timing,⁽⁶⁾ illicit excavation cannot be ruled out.

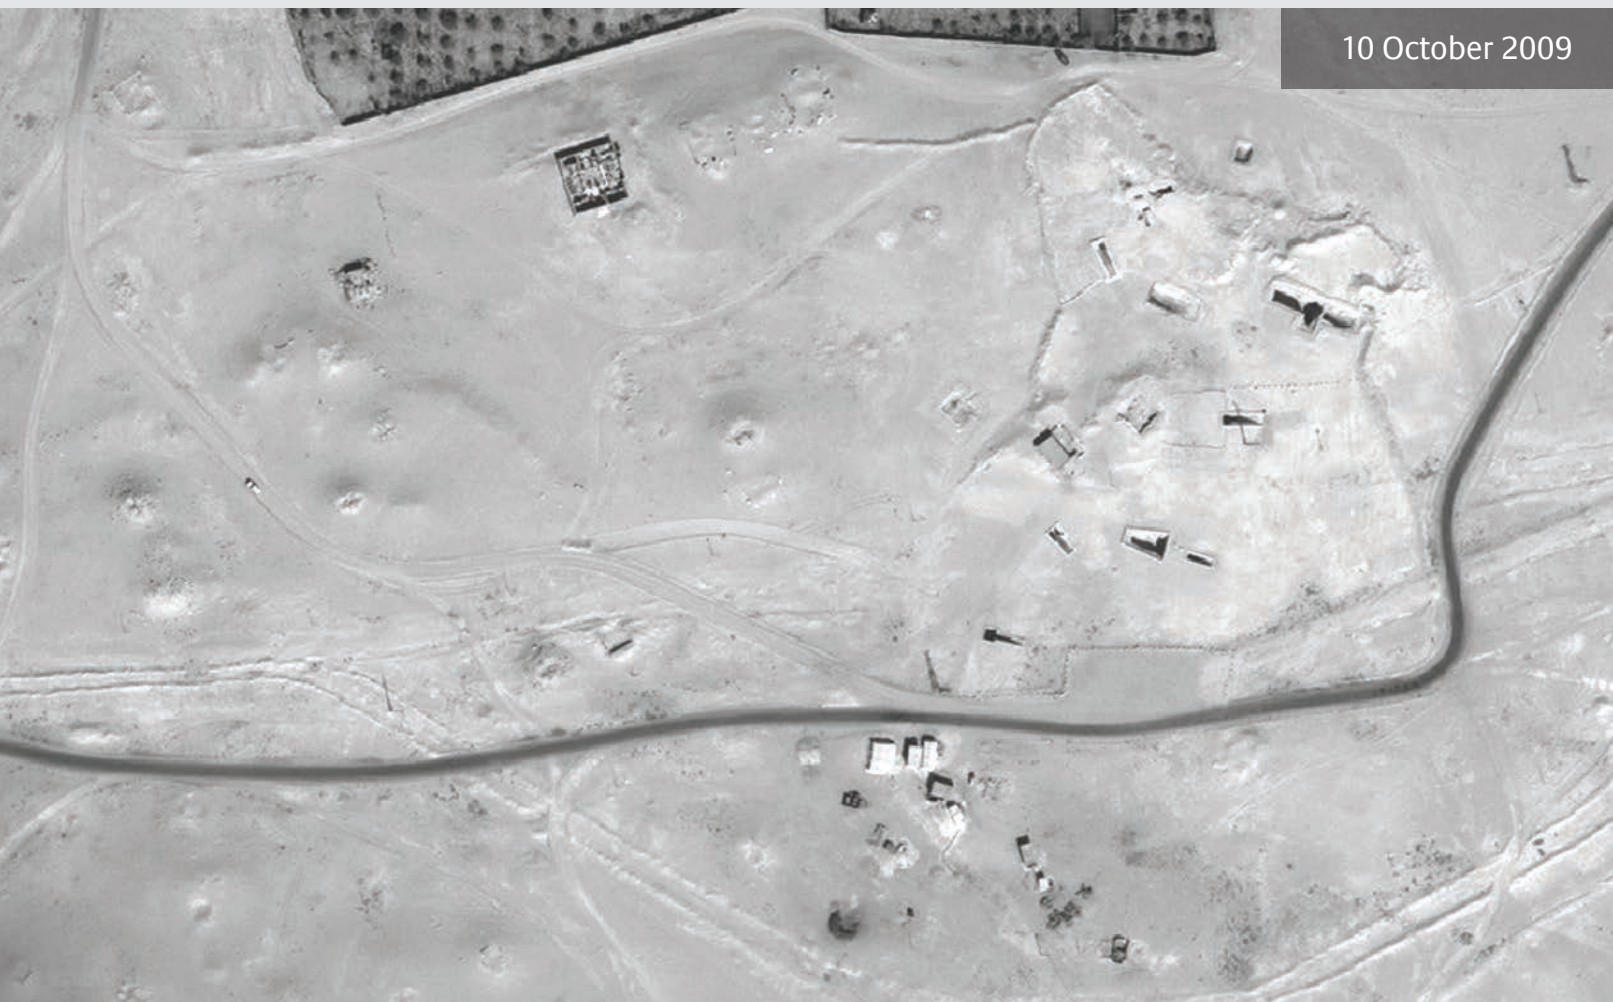
FIGURE 75. Location of tombs, open in 2009, and of later military emplacements.

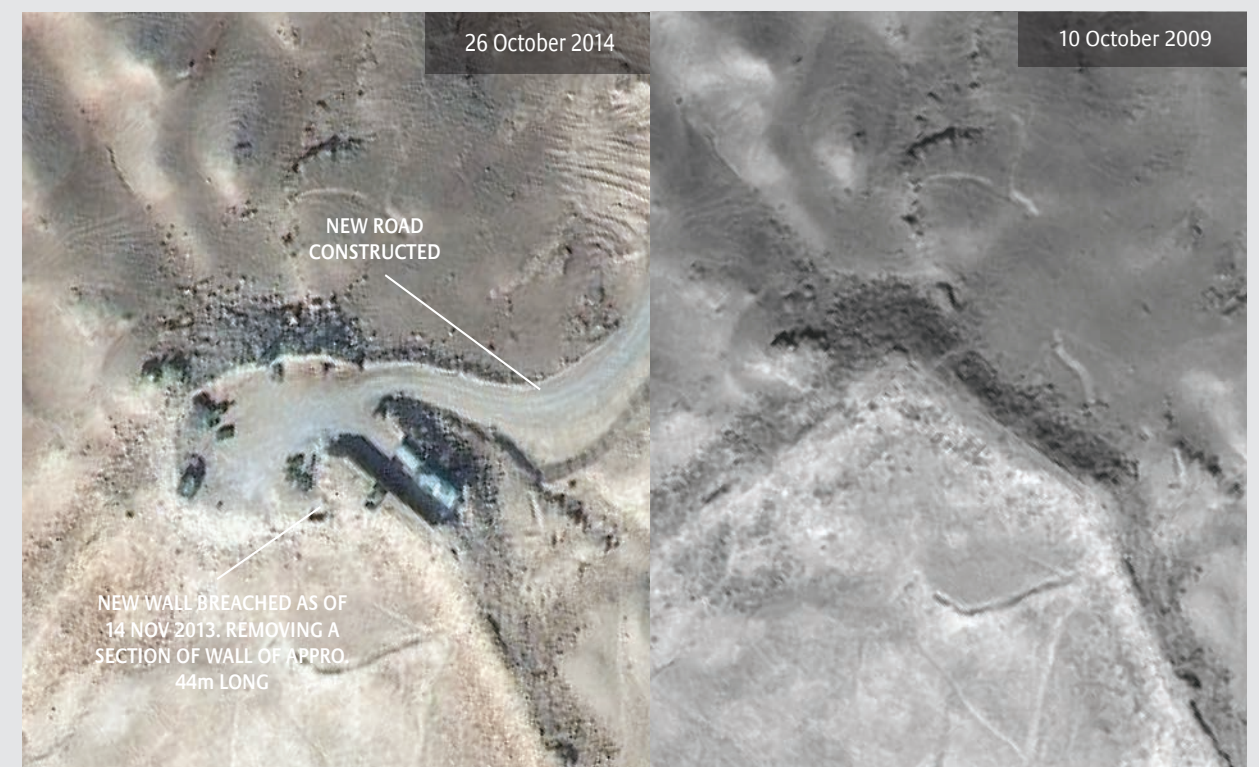
FIGURE 76 and 77. Old city walls and new road leading to 44-meter-wall breach caused by emplacement.

With the exception of the small removed area (see figures 76 and 77 – New Road), the walls are remarkably intact. Two of the funerary temples on the north wall were excavated between 2009 and 2012, and two towers appear to have been rebuilt. However, the rebuilding work is the result of legitimate restoration work conducted between 2009 - 2010 by the DGAM.^(xix) It is probable the excavations are likewise legitimate.

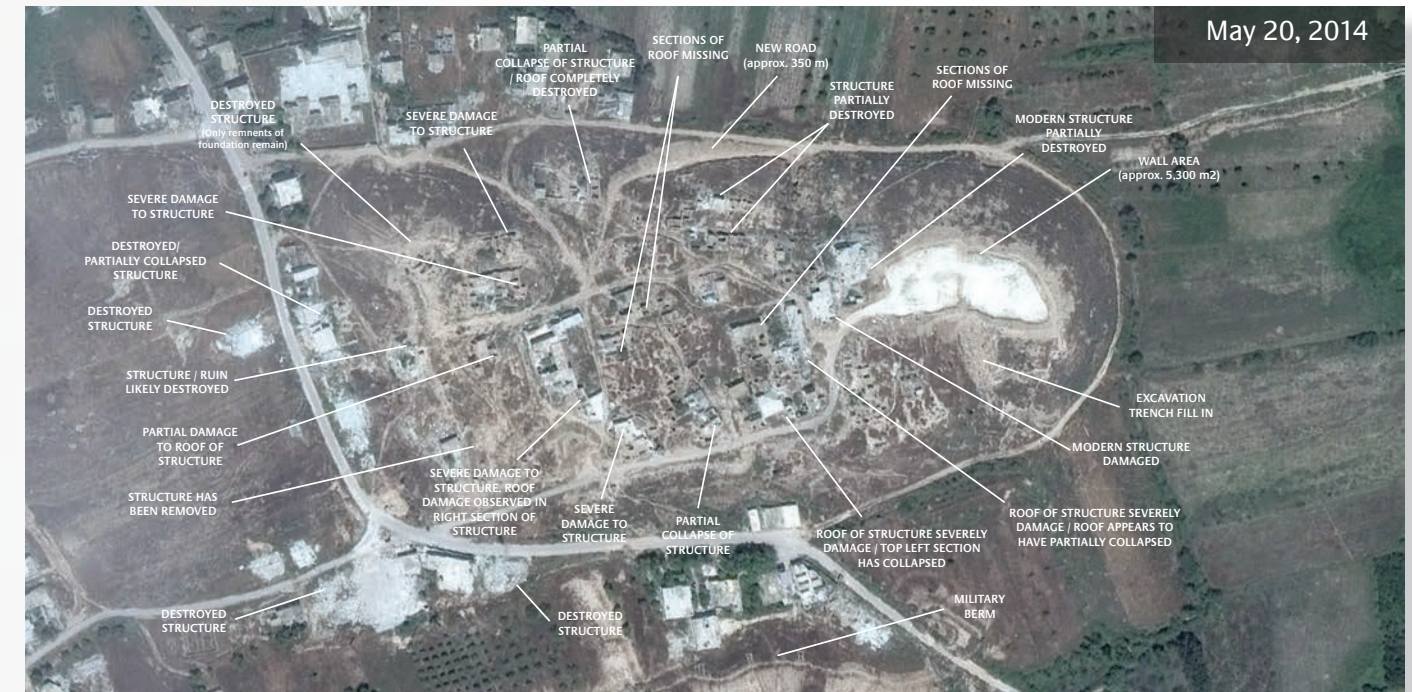
FIGURE 78. Extensive damage to Qadesh.

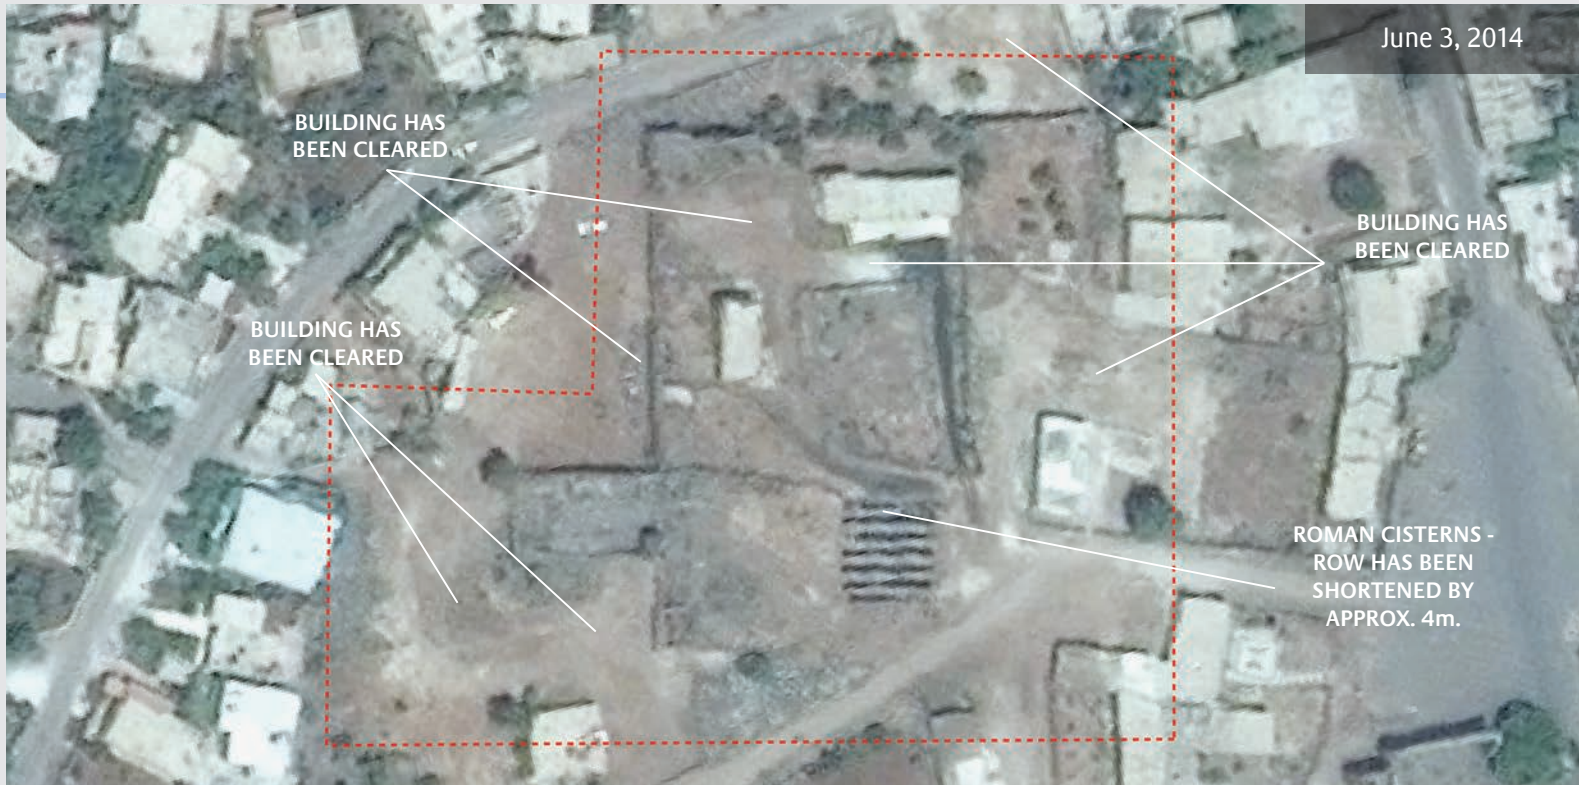
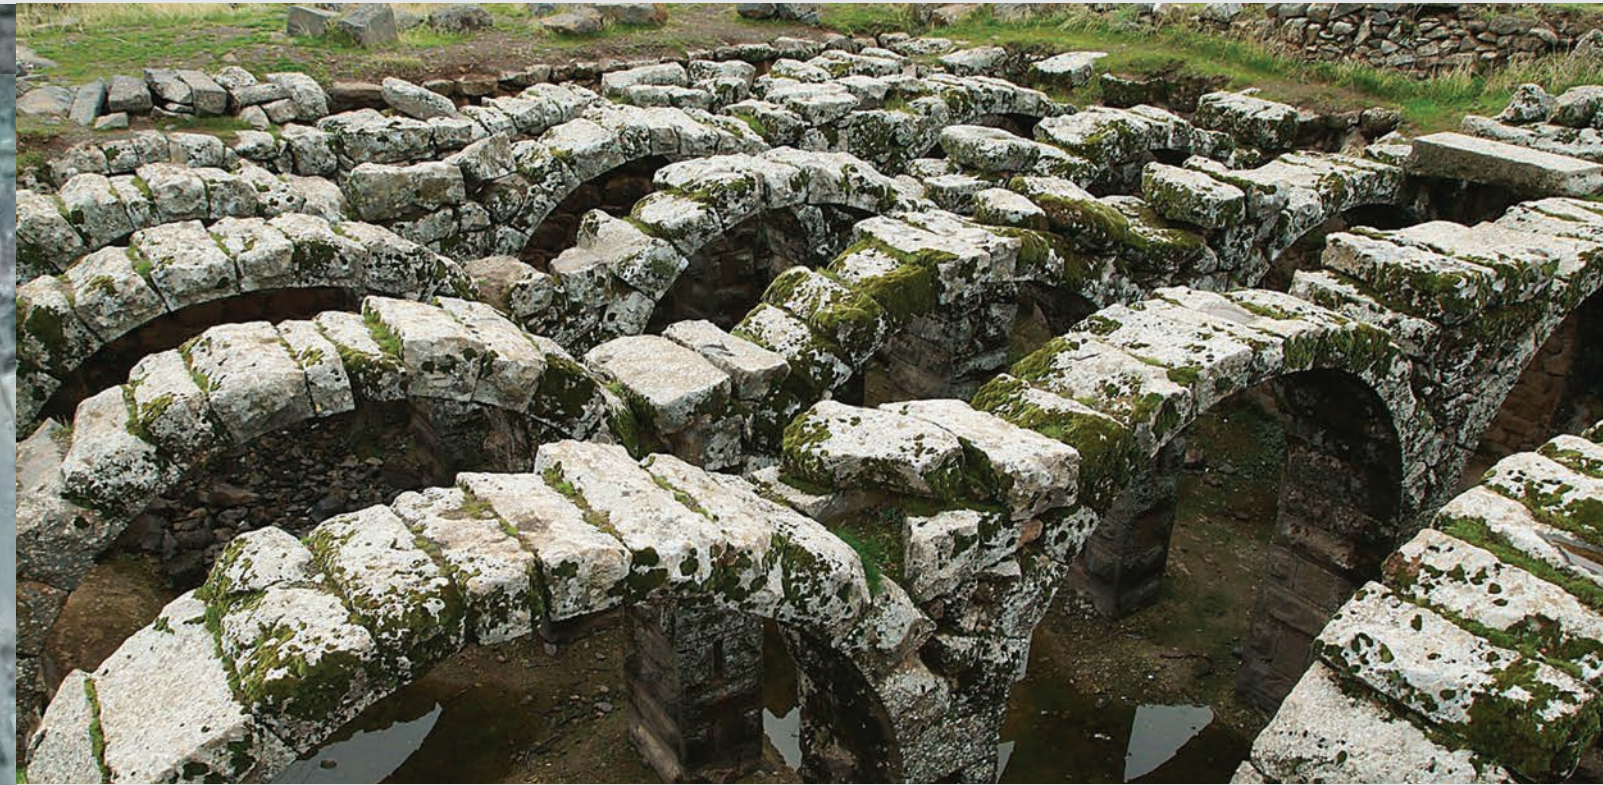
FIGURE 81. Damage to the Temple. Outer red line indicates the approximate extent of the temple.

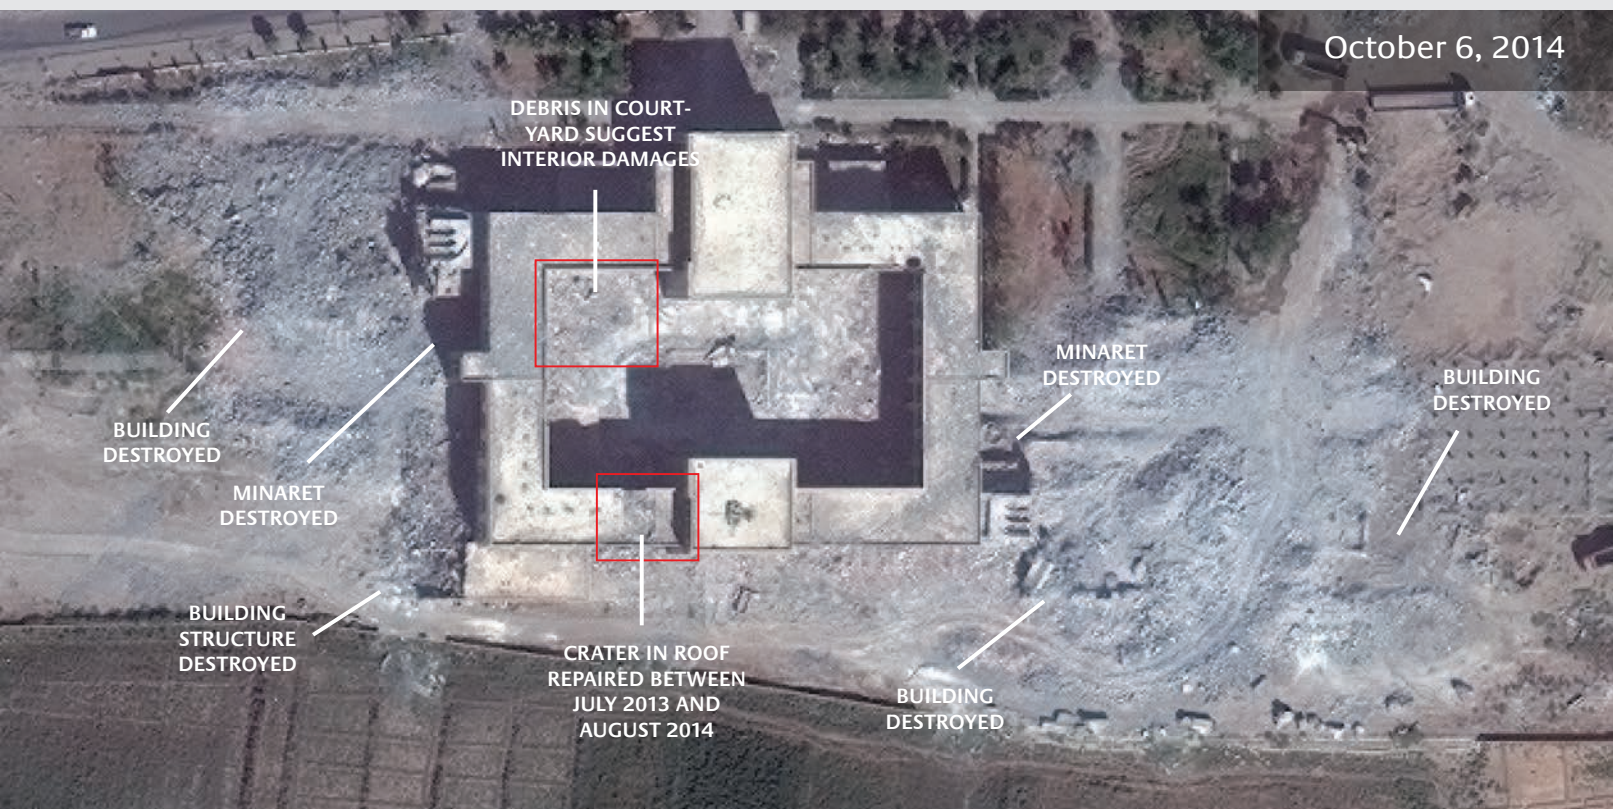
FIGURE 84. Shrine to Uwais al-Qarani and Ammar Bin Yasser. Extensive damage to shrine buildings and structures.

The [Uwais al-Qarani] shrine has been severely damaged. Satellite imagery shows that all three tombs, their minarets and a section of the linking arcaded precinct have been destroyed. Remnants of a few walls of the eastern tomb and some of the central precinct are still standing, though they were likely damaged by the explosions.

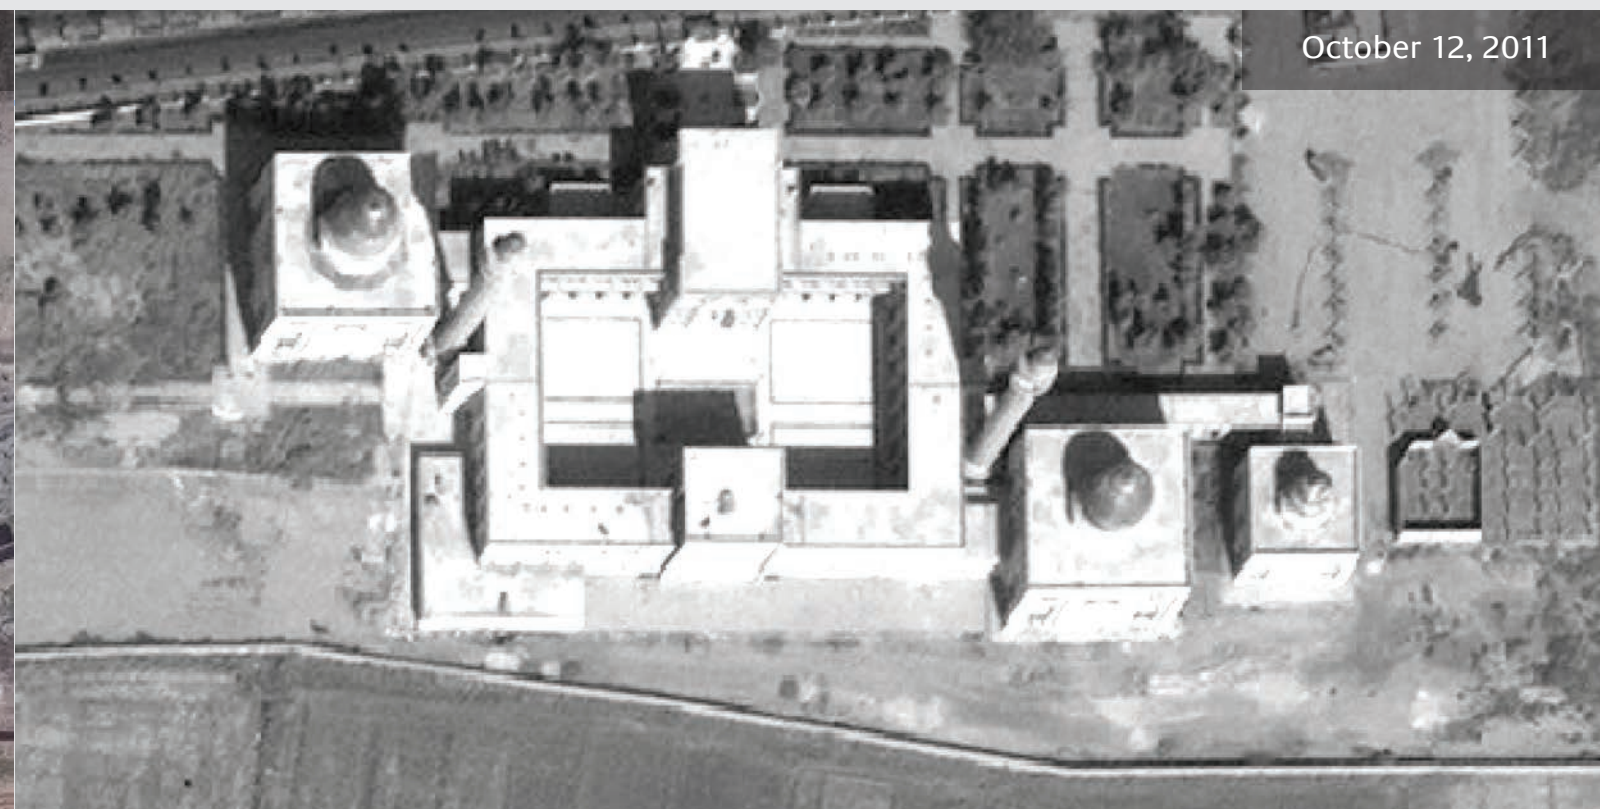
FIGURE 85. Shrine to Uwais al-Qarani and Ammar Bin Yasser. Shrine buildings and structures before damage.

The shrine has been severely damaged. Satellite imagery shows that all three tombs, their minarets, and a section of the linking arcaded precinct have been destroyed. Remnants of a few walls of the eastern tomb and some of the central precinct are still standing, though they were likely damaged by the explosions. The demolition (using explosives) dates to May 2014.⁽ⁱⁱⁱ⁾ The central precinct roof (southwest side) was also punctured by a shell in June 2013.^(iv) This appears to have been patched as only minor scarring is visible on the imagery (see figures 84 and 85).

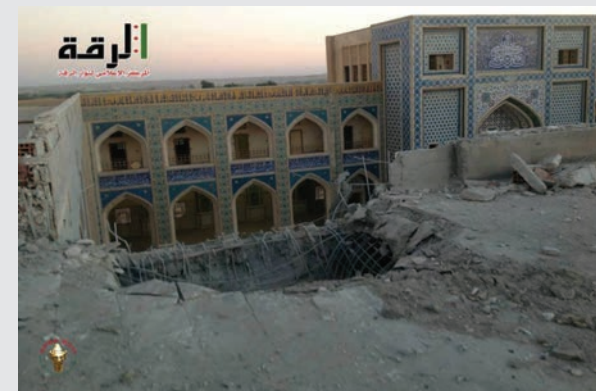
Shrine to Uwais Al-Qarani & Ammar Bin Yasser. Crater on the roof of the mosque caused by alleged bombing/Photo: APSA (The Association for the Protection of Syrian Archaeology), MCR/ar-Raqqa, 30 July, 2014.
