Satellite-based Damage Assessment to Cultural Heritage Sites in Syria

The United Nations Institute for Training and Research

UNOSAT

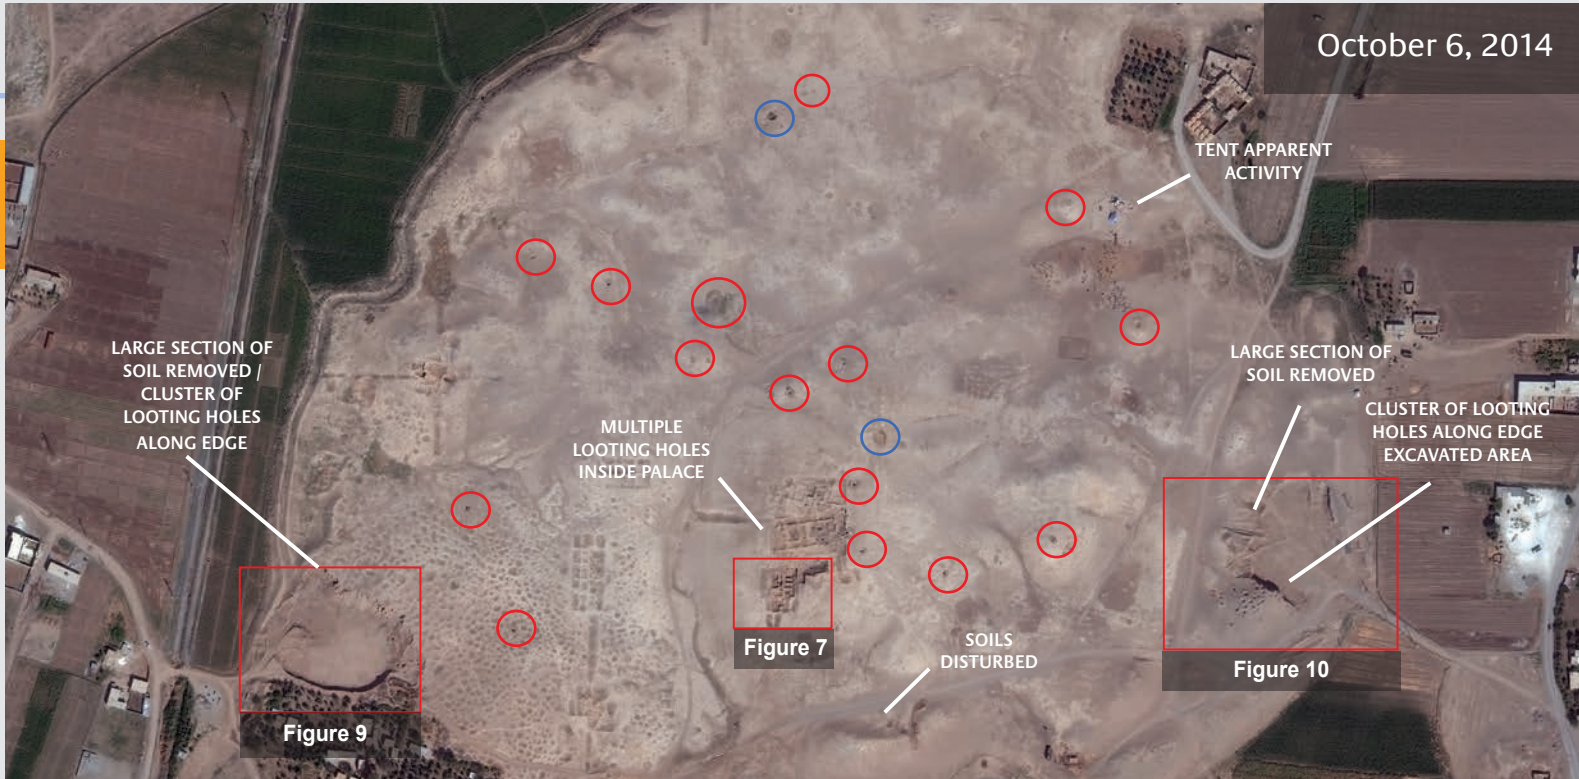
FIGURE 86. Tell Bi'a. Extensive looting and excavated areas at Tell Bi'a. Looting occurred between 19 June and 9 October, 2014.

Although there was looting in Tell Bi'a in the past, in recent years the tell has experienced a dramatic increase of heavy looting, particularly between June and October 2014. In addition, between the acquisition of the satellite images, entire sections have been excavated, causing severe damage.

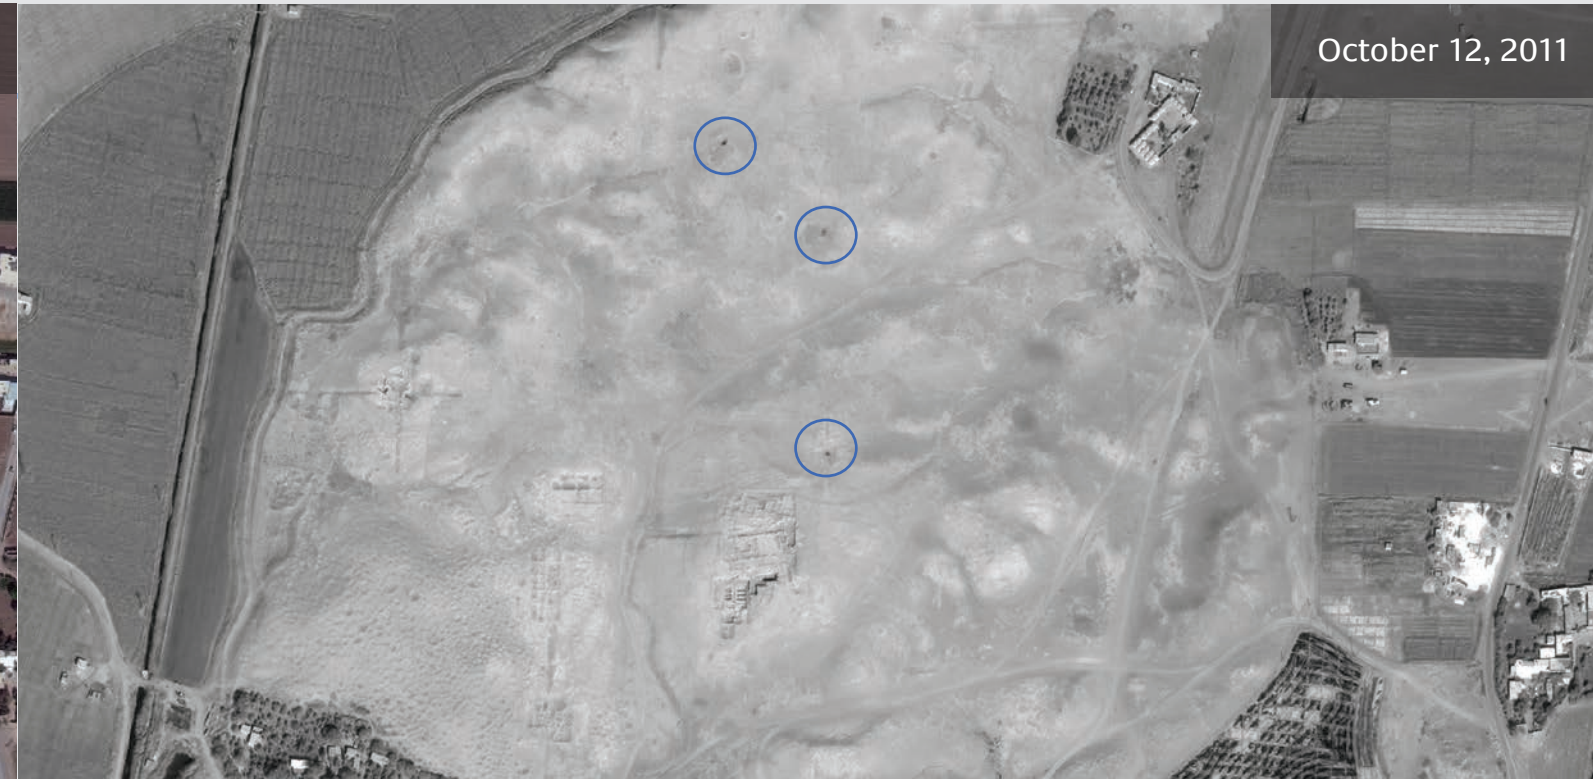
FIGURE 87. Tell Bi'a. Excavated areas and old looting holes at Tell Bi'a.

A review of imagery shows intensive looting concentrated on the Hellenistic, Roman and Byzantine settlement in the southwest part of the site covering approximately 10 ha. Minor looting was present in 2011 (see figure 86) and has dramatically increased between June and October 2014 (see figure 86 and 87). There are multiple, small new holes in the excavated palace (Bronze Age). A few of the holes from previous looting in 2011 are distinctively darker and larger, suggesting they have been reopened. Numerous additional looting holes have appeared throughout the site, mostly isolated holes, with clusters of holes concentrated within the palace and along excavated areas (see figures 88 and 89). There are two areas which have been completely excavated with earth moving machinery. One area, approximately 7,000 m², has been removed from the Hellenistic, Roman and Byzantine area that was previously looted in 2011. The other area is on the far right of the site where an area of approximately 9,000 m² has been removed. The reason is unknown; if it was to obtain earth, no spoil heaps or signs of construction are evident.

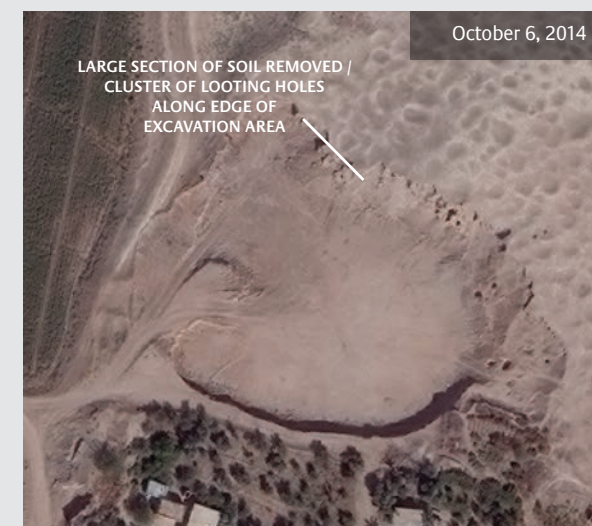
There are two areas which have been completely excavated with earth-moving machinery. One area approximately 7,000 m², has been removed from the Hellenistic, Roman and Byzantine area.

FIGURE 88. Excavation #1 At Tell Bi'a Tutul. Large section of soil removed and cluster of looting holes along edge of excavation area.

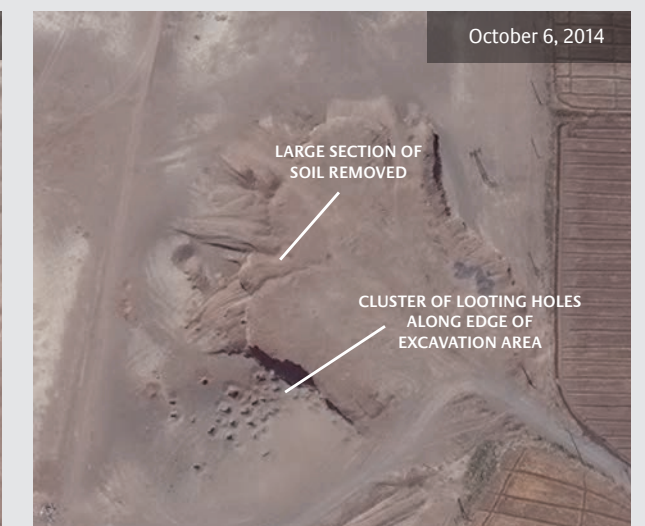
FIGURE 89. Excavation #2 At Tell Bi'a Tutul. Large section of soil removed and cluster of looting holes along edge of excavation area.

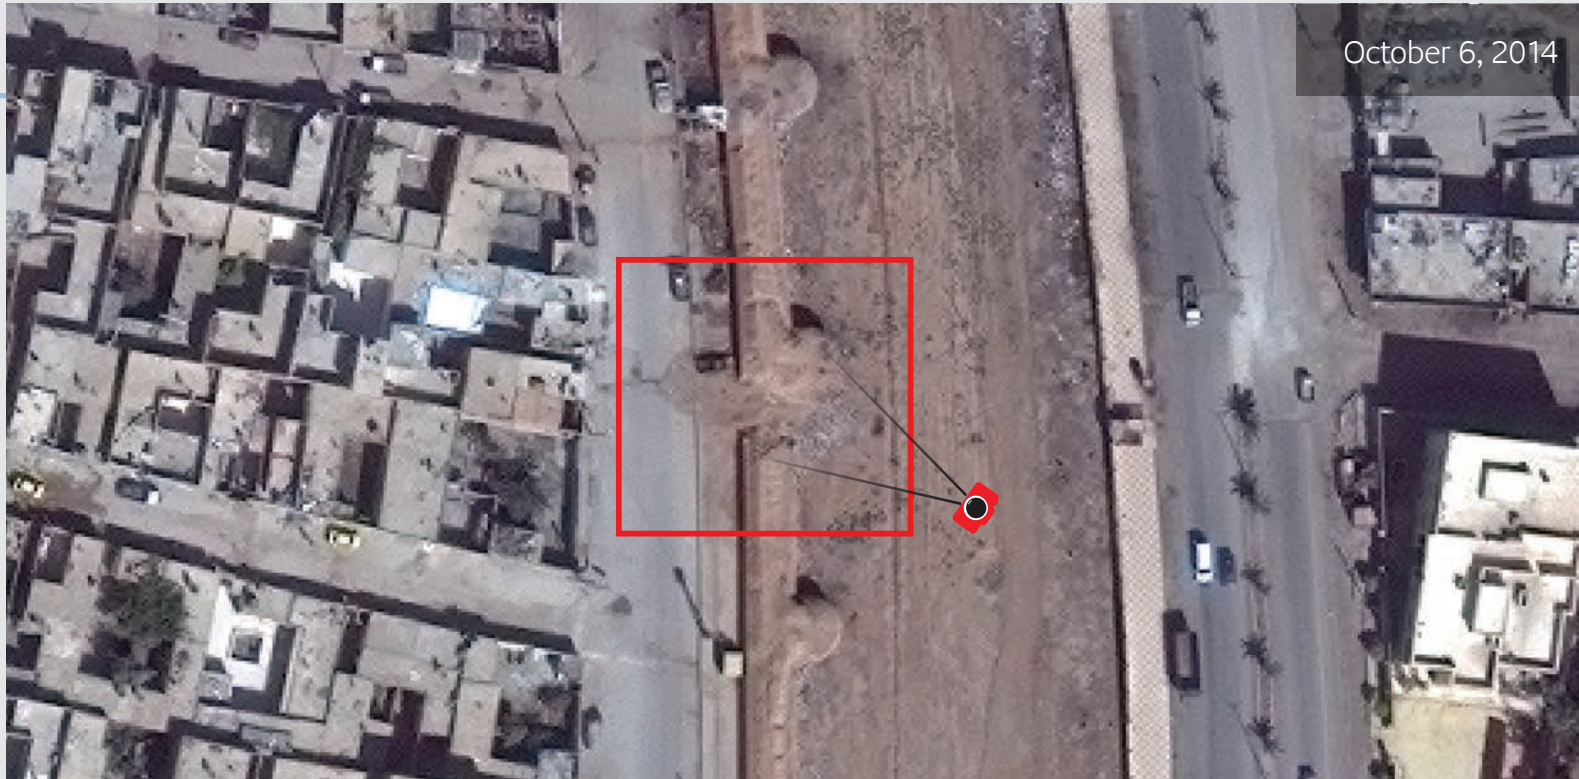
FIGURE 90. Archaeological walls. Destroyed section of tower and wall.

Imagery clearly shows damage to a small section, approximately 8 m, has been largely removed—only rubble remains. This damage is thought to have occurred at the beginning of May 2013⁽⁹⁾ (see figures 90 and 91). Imagery analysis also suggests that some of the turrets farther north on the wall have also been damaged, but this could not be verified.

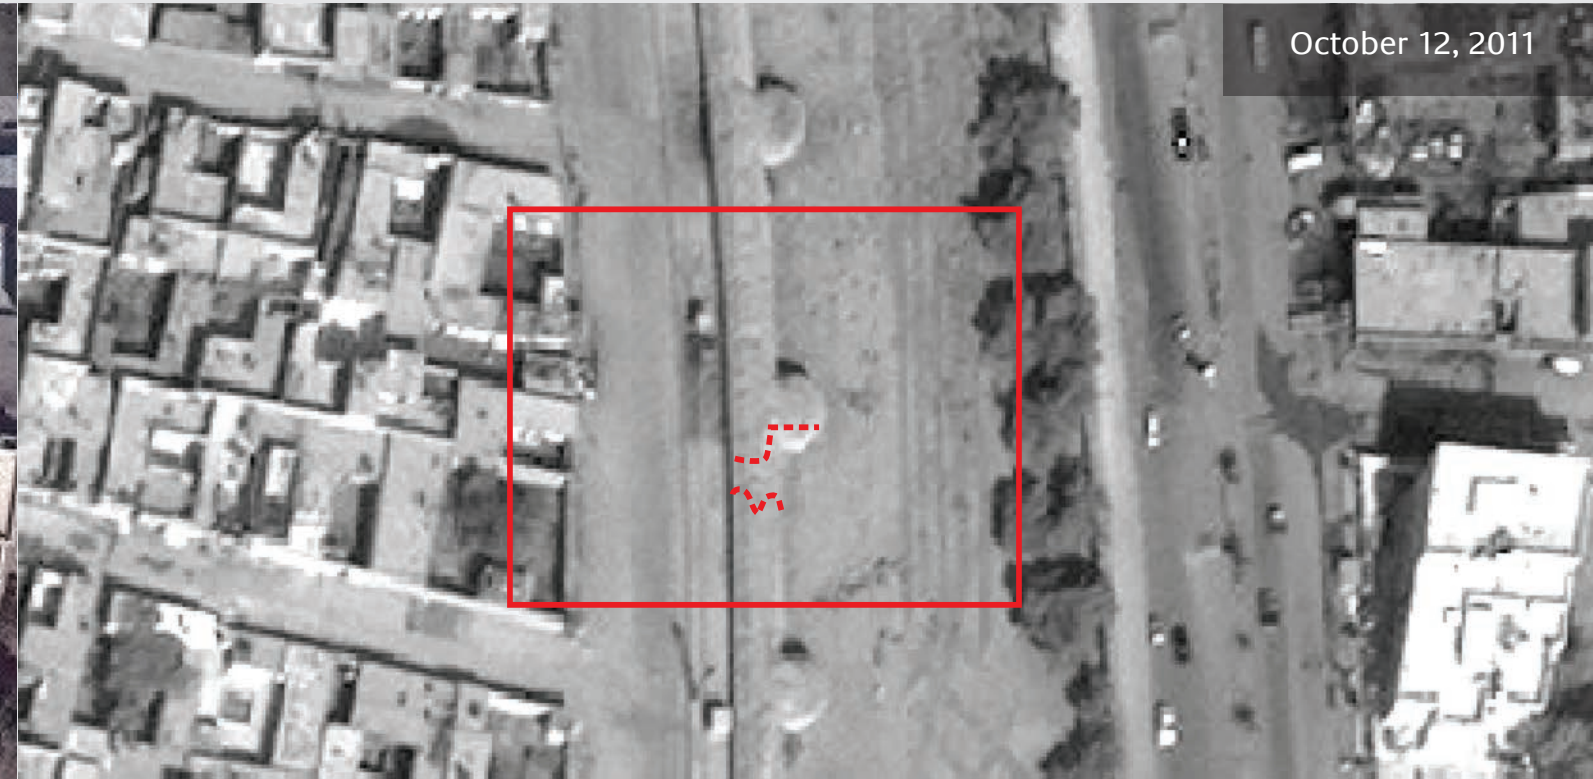
FIGURE 91. Tower and part of the wall before damage occurred.

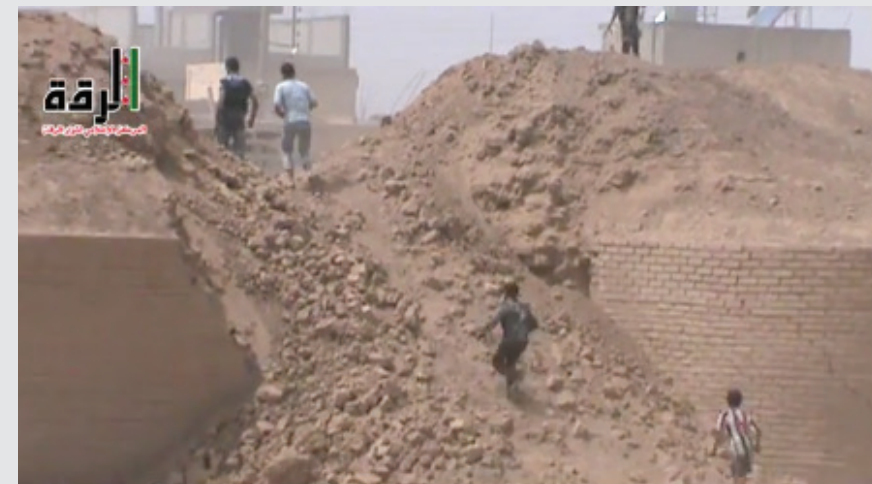
Destroyed section of Archaeological Walls/Photo: YouTube, Ar-Raqqa Media Centre, May 2013.
Video available at: <https://www.youtube.com/watch?v=OpDacVUxEzw>

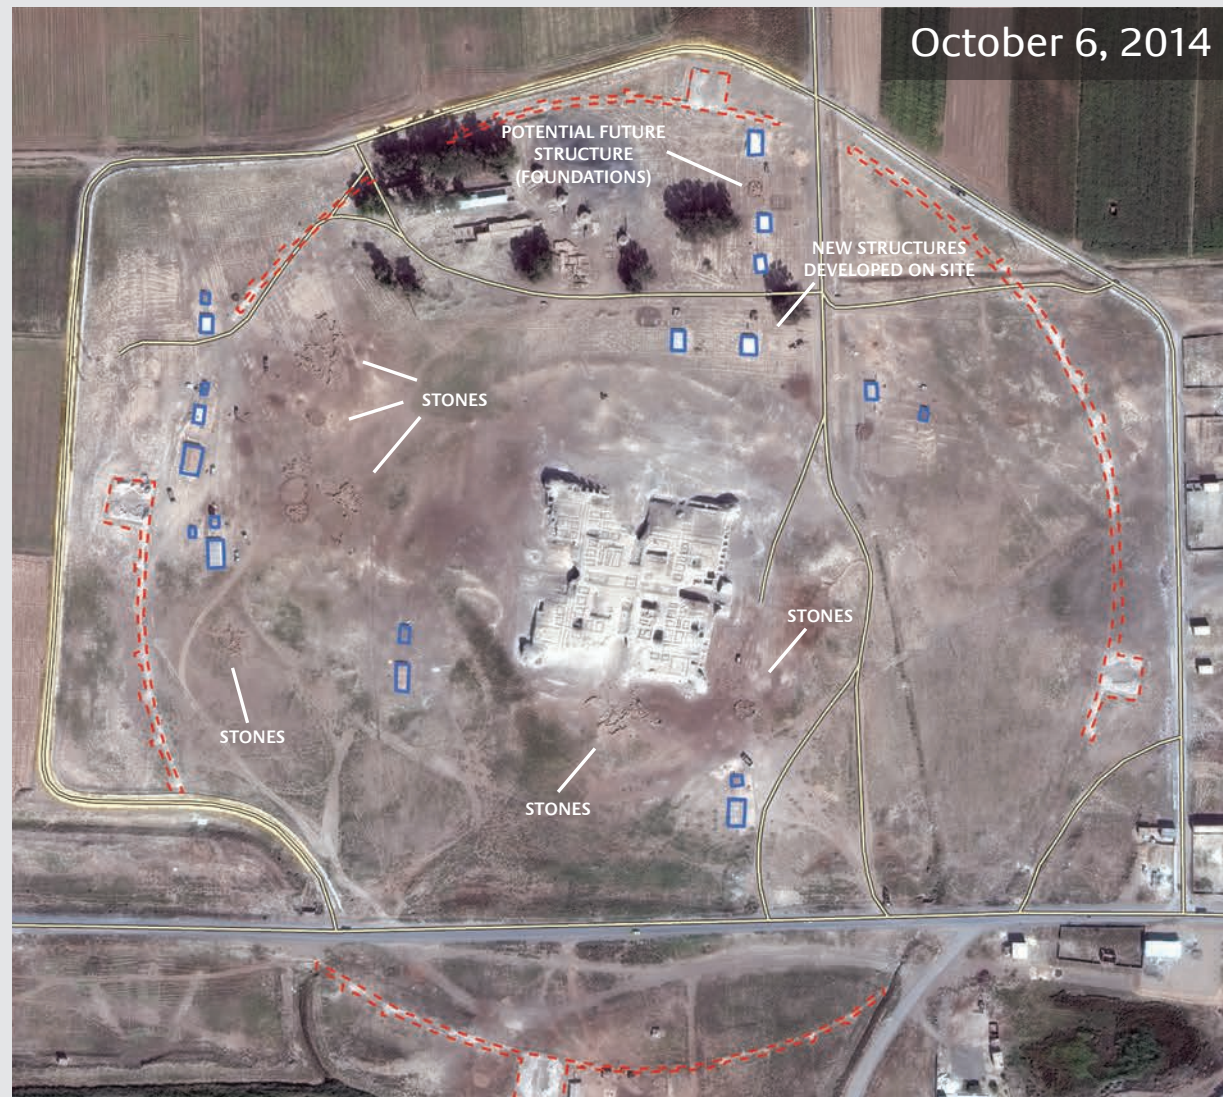
FIGURE 92. Imagery from 6 October 2014 shows new structures and collection of stones scattered throughout the Harqaleh site.

While the monument appears to be undisturbed, the area surrounding the monument has seen significant building development. Approximately 19 new structures have been built on the site between June and October 2014. Multiple collections of stones are visible to the east and immediately south of the monument indicating potential looting or the use of archaeological stones as building materials. New paths are also visible linking to main roads surrounding the perimeter of the site, potentially disturbing archaeological soils in addition to development activities (see figures 92 and 93).

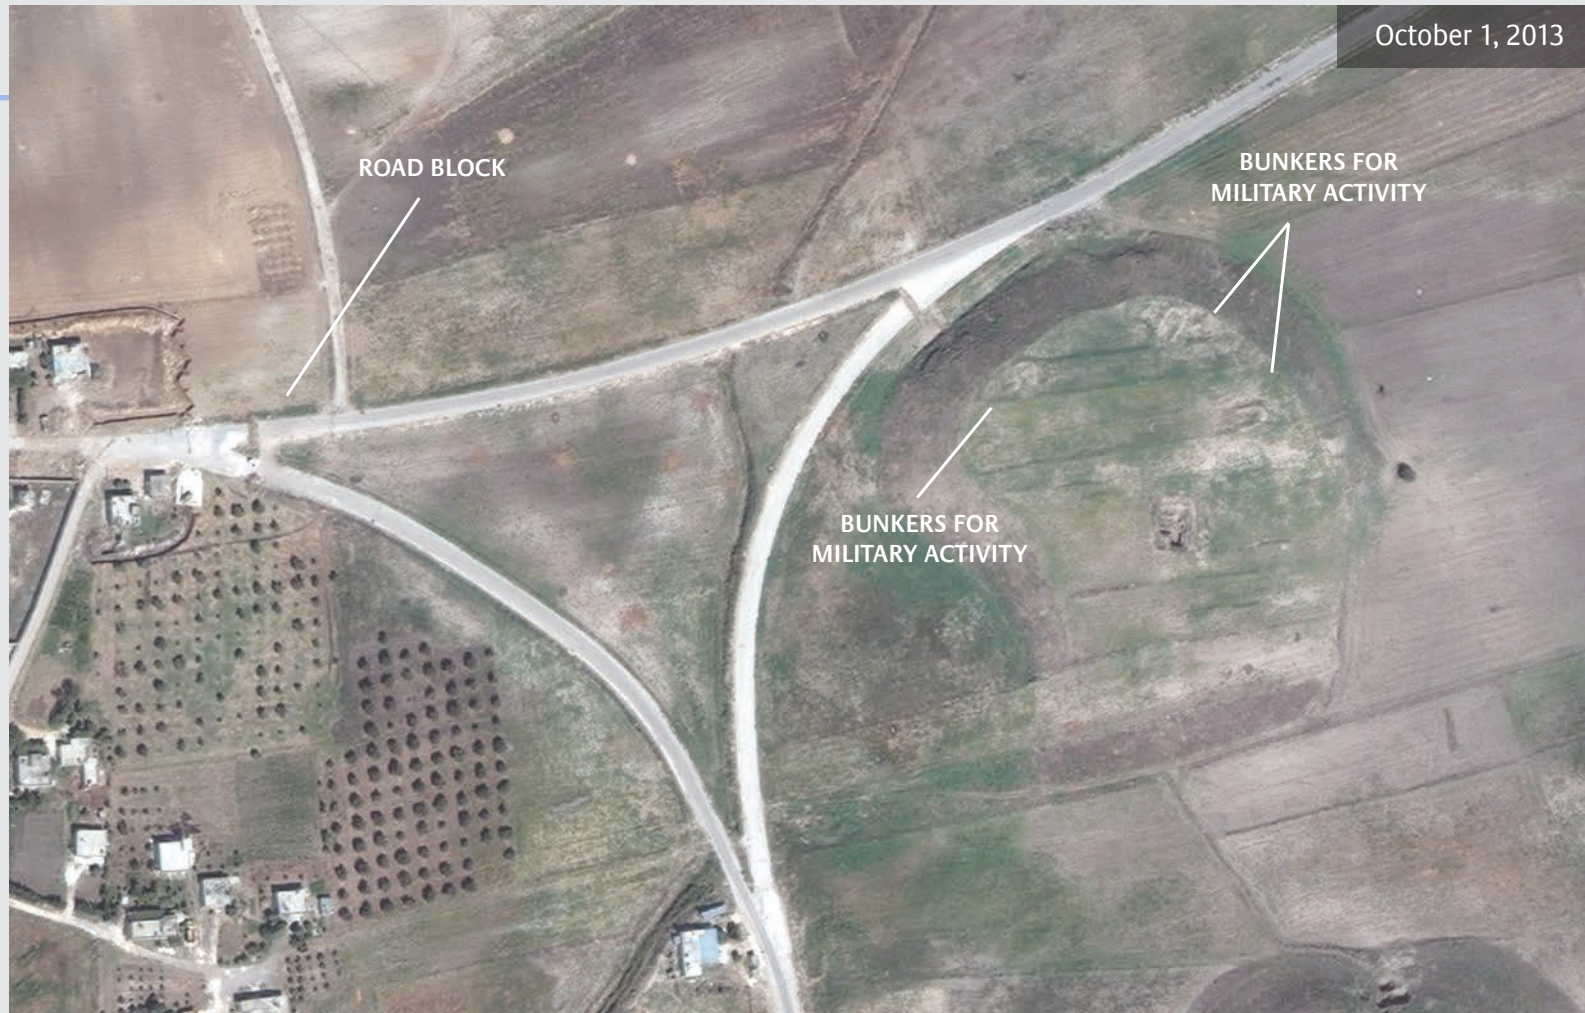
FIGURE 94. The roadblock and scars of the bulldozing used to create military emplacements, 01 October 2013.

There is no evidence of damage to the southern tell. However, the northern tell was briefly used as an emplacement for a military garrison, which has caused moderate damage. The scars of this emplacement can still be seen on a review of satellite imagery from 01 October 2013 (see figure 94, 95 and 96). Emplacements of this sort require bulldozing to create bunkers and raised embankments, in order to provide cover for vehicles and artillery. In addition, stationing troops on a site can lead to damage to open excavations, or more severe damage to them, as seen at Qadesh.

ROAD BLOCK

BUNKERS FOR MILITARY ACTIVITY

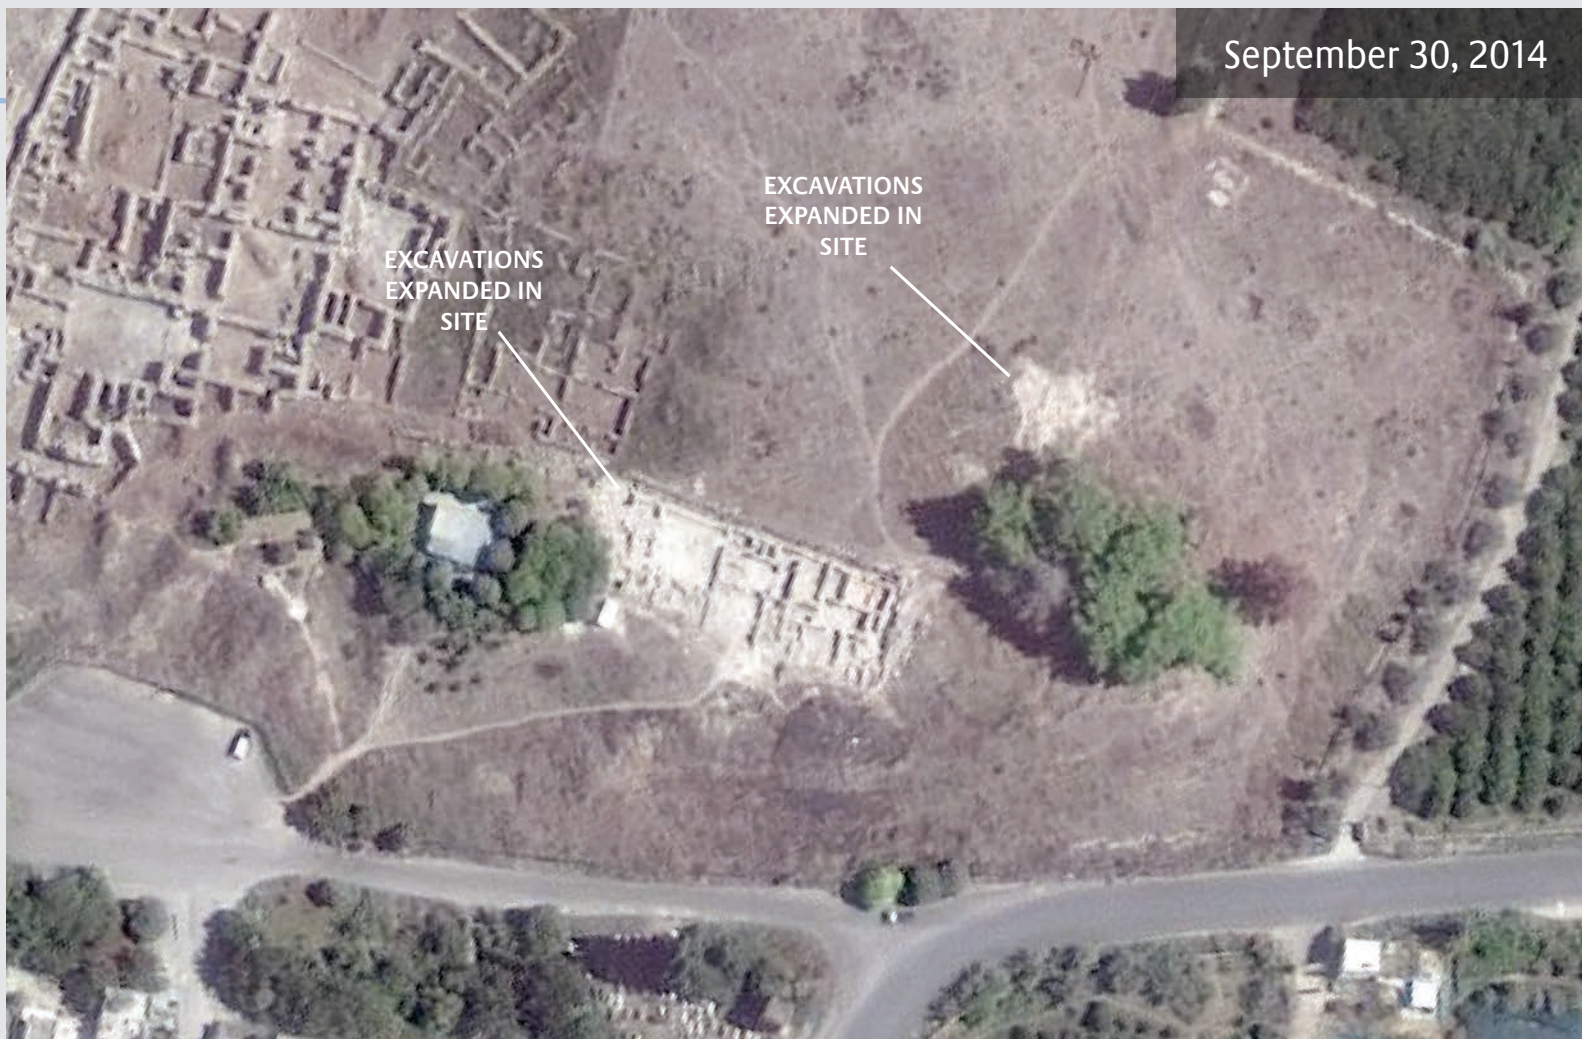
FIGURE 97. Expanded excavations at the structure south of the Royal Palace of Ugarit, 30 September 2014.

Excavations of this structure were extended between 18 June 2010 and 04 June 2014. These are likely to be legitimate as the excavated features are clear and the change is confined to a single location. This does not match the profile of illegal excavations seen elsewhere, such as Dura Europos and Apamea. However, a small area of approximately 300 m² near the structure has also been disturbed (see figures 97 and 98). Illegal excavation is therefore a possibility, although the wider area is a secure one.

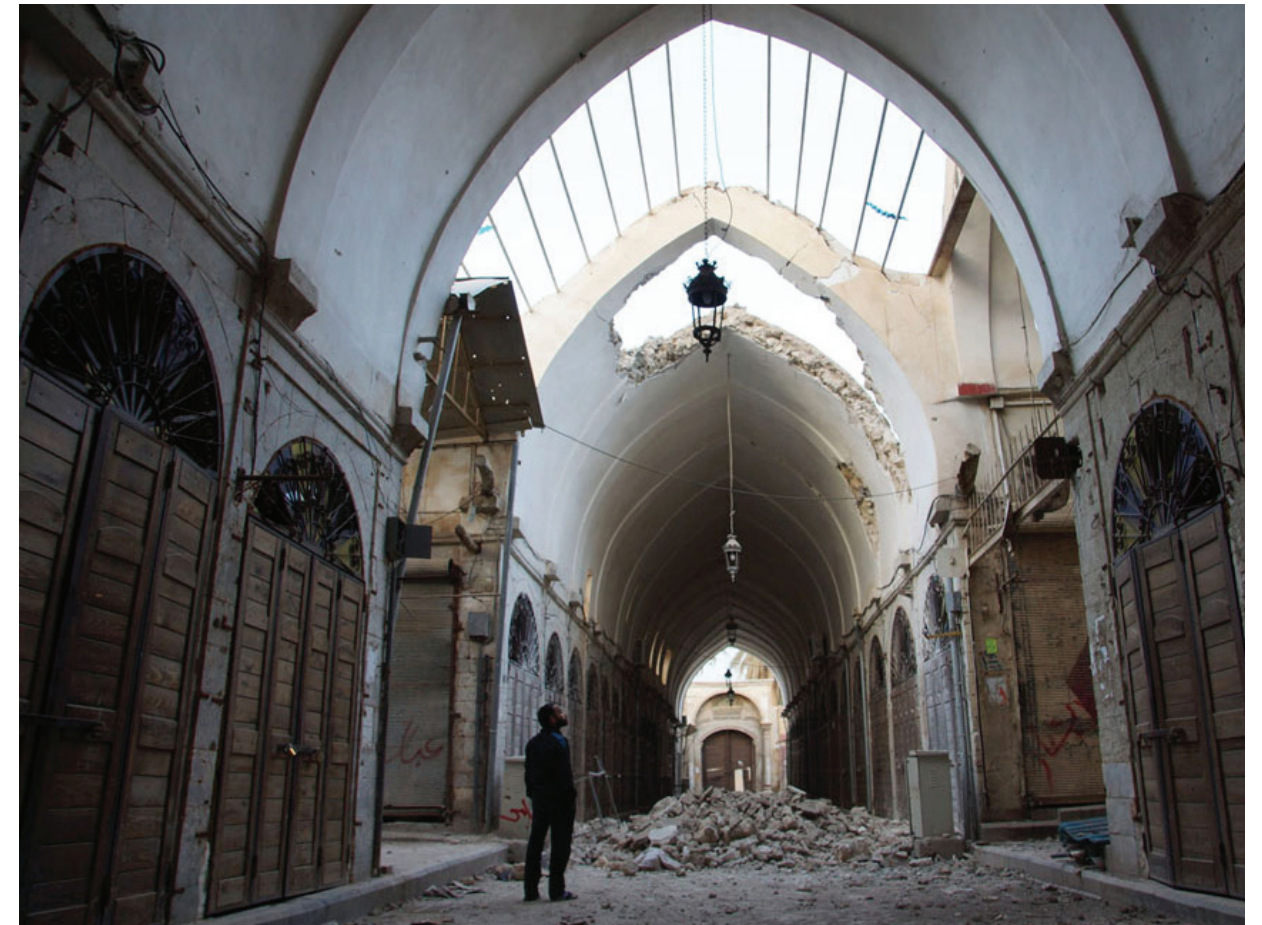
A resident inspects the damages at an ancient Souk caused, on March 9, 2013/Photo: Reuters/Khalil Ashawi.
